REFERENCE:	TSB: 23-028-25 GROUP: 23 - Body	Date:	July 16, 2025	REVISION:	-
VEHICLES AFFECTED:	2025 - 2026 (B1) Jeep Renegade This bulletin applies to vehicles built on or after January 05, 2025 (MDH 0105XX) and on or before June 04, 2025 (MDH 0604XX).			MARKET APPLICABILITY: <input checked="" type="checkbox"/> NA <input type="checkbox"/> MEA <input checked="" type="checkbox"/> SA <input type="checkbox"/> IAP <input type="checkbox"/> EE <input type="checkbox"/> CH NOTE: This bulletin applies to North America and South America markets	
CUSTOMER SYMPTOM:	Customers may comment on the following: <ul style="list-style-type: none"> Loose front door applique. 				
CAUSE:	Burr in the trim clipping area

This bulletin involves inspecting and possibly replacing one or both front door appliques.

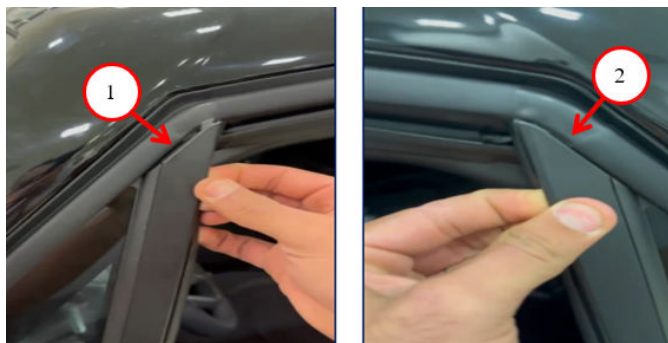
Fig. 1
Pull Door Applique Outward

1. Lower both front door windows.
2. Gently pull the left front door applique outwards [Fig. 1](#). Perform this same action on the right front door applique.

1 - Loose Door Applique
2 - Properly Fit Applique

-
3. Does either front door appliques come off easily [Fig. 1](#)?
 - YES>>> Replace the affected front door applique. Proceed to [Step 4](#).
 - NO>>> This bulletin has been completed. Use Inspection LOP (23-05-11-9B) to close the active RSU.

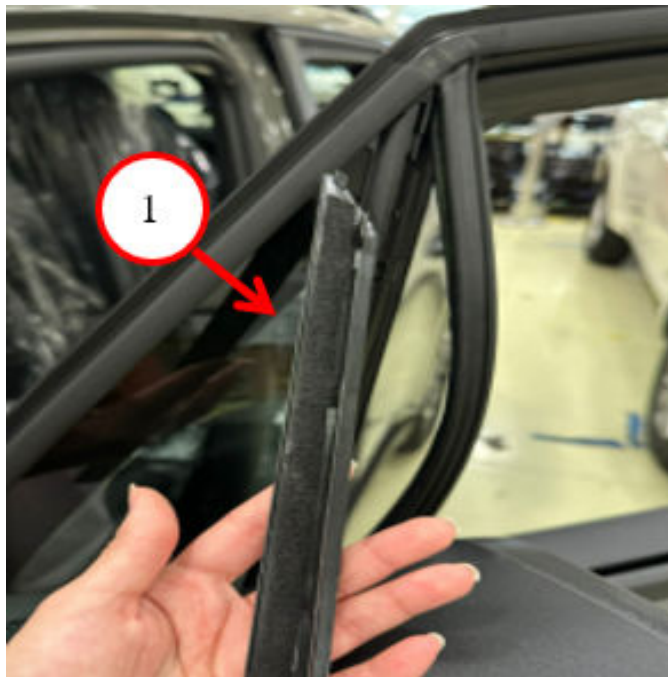
Fig. 2
Remove Door Applique

4. Remove the door applique [Fig. 2](#).

1 - Remove Door Applique

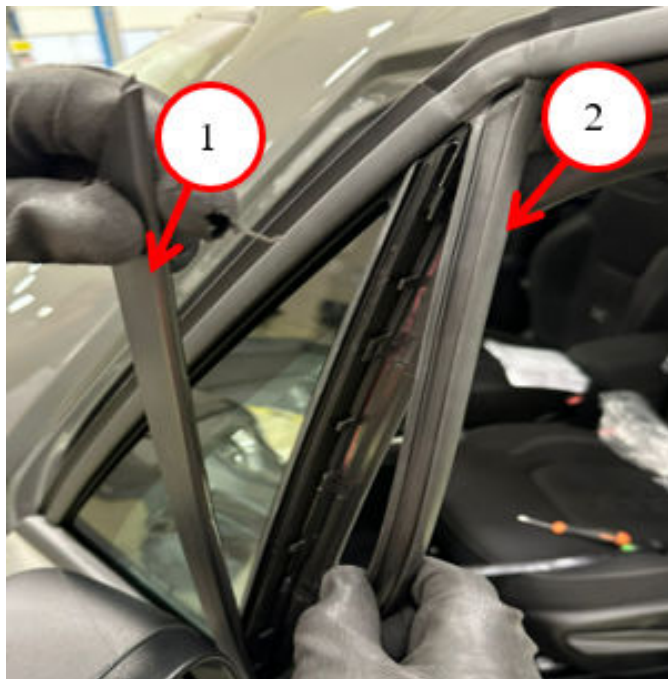
Fig. 3
Insert Door Applique

5. Pull the trim away; fitting the door applique from top to bottom [Fig. 3](#).

1 - Trim
2 - Door Applique

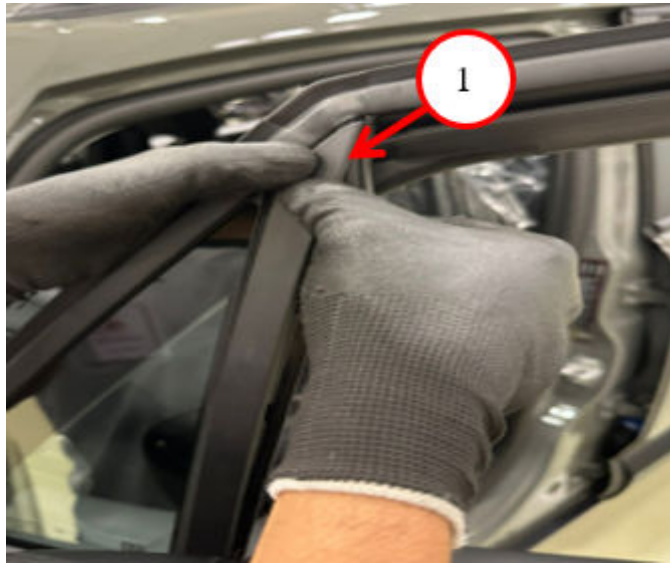
Fig. 4
Clip Door Applique

6. Clip the door applique on top [Fig. 4](#).

1 - Clip door applique

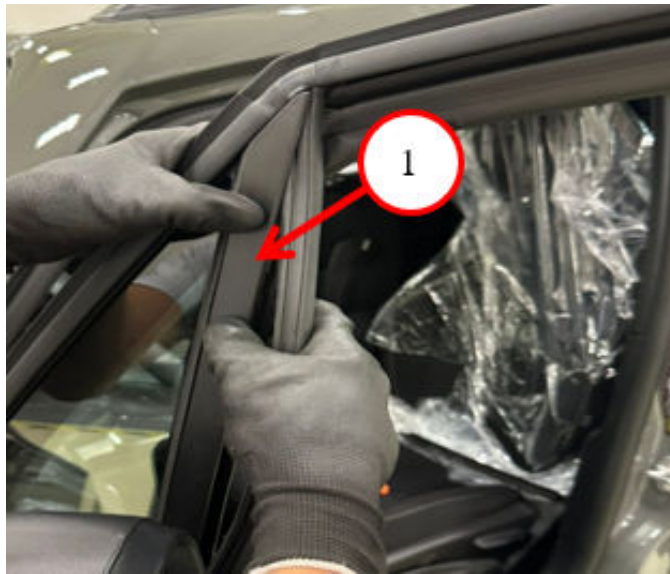
Fig. 5
Press Door Applique To Clips

7. Press the door applique to secure it to the clips [Fig. 5](#).

1 - Clipping Door Applique

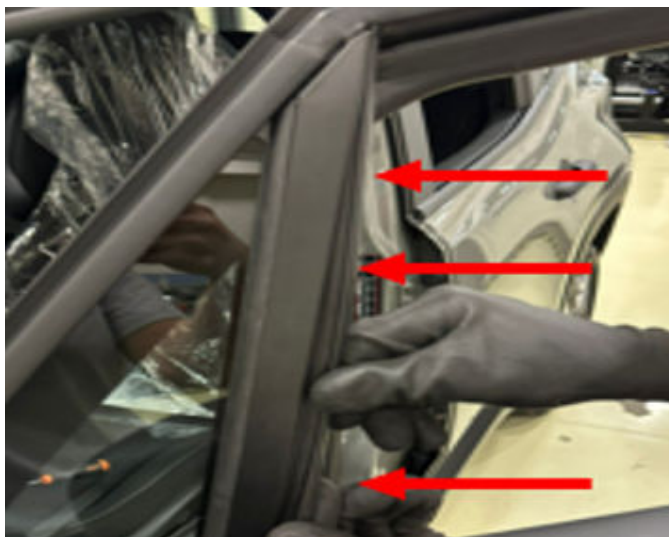
Fig. 6
Install Trim

8. Install and press the trim back in place Fig. 6.

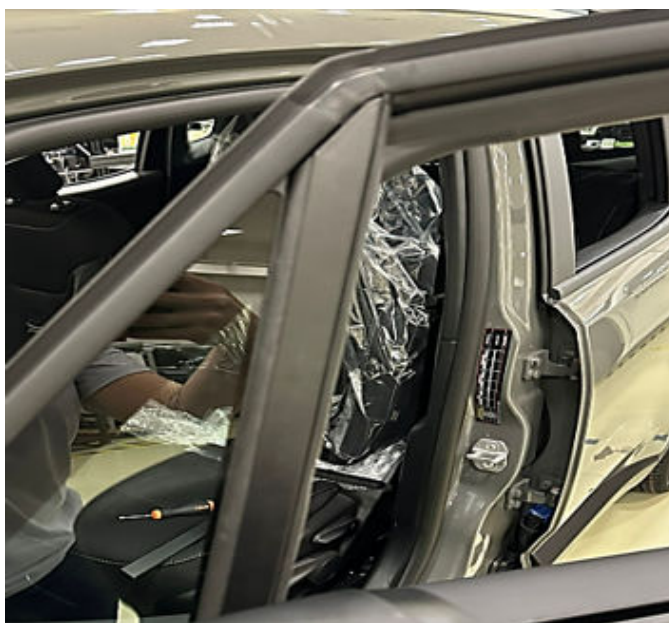
Fig. 7
Properly Installed Door Applique

9. Confirm the door applique is properly installed Fig. 7.
