REFERENCE:	TSB: 09-019-25 GROUP: 09 - Engine	Date:	July 16, 2025	REVISION:	–
VEHICLES AFFECTED:	2025 (WL) Jeep Grand Cherokee/ Grand Cherokee L This bulletin applies to the following vehicles built on or after June 02, 2025 (MDH 0602XX) and on or before June 05, 2025 (MDH 0605XX) equipped with the 3.6L V6 24V VVT UPG 1 W/ESS Engine (Sales Code ERC).	MARKET APPLICABILITY: <input checked="" type="checkbox"/> NA <input type="checkbox"/> MEA <input type="checkbox"/> SA <input type="checkbox"/> IAP <input type="checkbox"/> EE <input type="checkbox"/> CH NOTE: This bulletin applies to the North America market.			
CUSTOMER SYMPTOM:	Customers may experience the following: <ul style="list-style-type: none"> • A deterioration in engine performance. 				
CAUSE:	Disconnected Make Up Air Hose

This bulletin involves inspecting the Make Up Air Hose and, if needed, reconnecting the hose to the resonator.

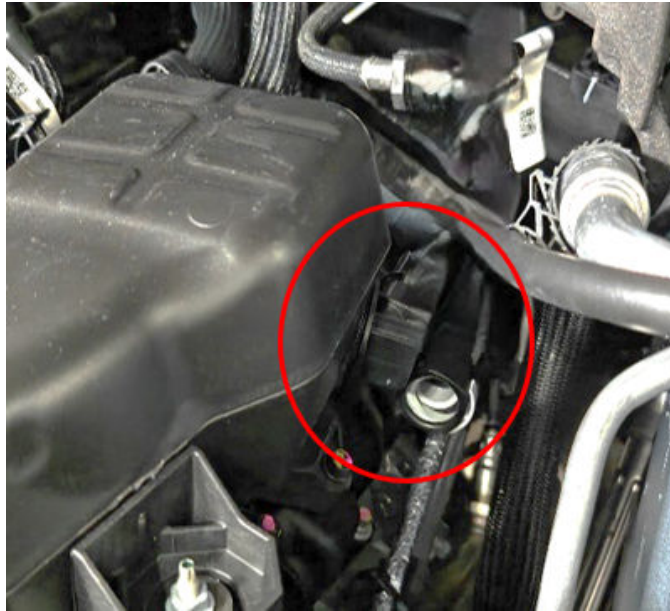
**Fig. 1**

1. Open the hood.
2. Locate the air cleaner duct.
3. Follow the tubing along the left side of the engine.
4. Locate the Make Up Air hose quick connect with the gray tab.
5. Is the Make Up Air Hose disconnected [Fig. 1](#)?

Make Up Air Hose Disconnected

- YES >>> Proceed to [Step 6](#).
 - NO >>> This bulletin does not apply. Use Inspect LOP (09-20-20-95) to close this active RSU. Perform further diagnostics.
6. Reconnect the Make Up Air Hose to the resonator [Fig. 2](#).

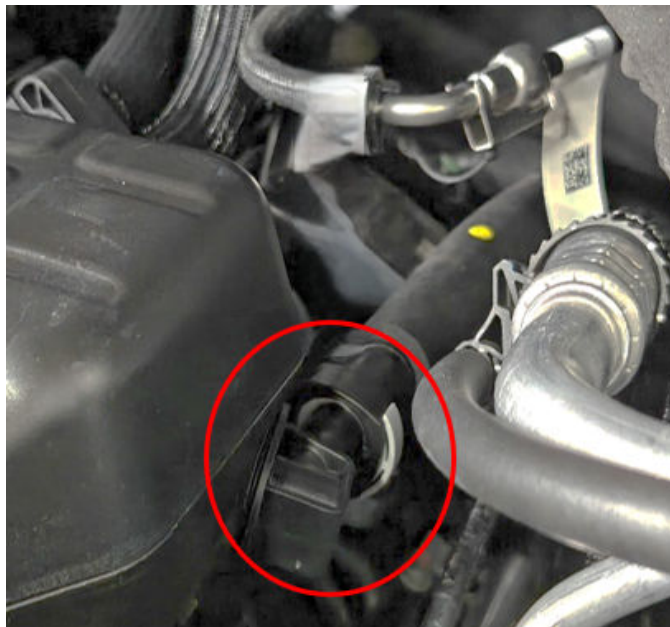
**Fig. 2**

Make Up Air Hose Connected

7. Employ a push - pull method to ensure a solid connection.
