## STAR ONLINE PUBLICATION

**Case Number:** S2523000068

**Symptom/Vehicle Issue:** Buzz Squeak Rattle (BSR) Noise From Headliner Near Sunroof Opening, Passenger Side Visor, Or B-pillar Area.

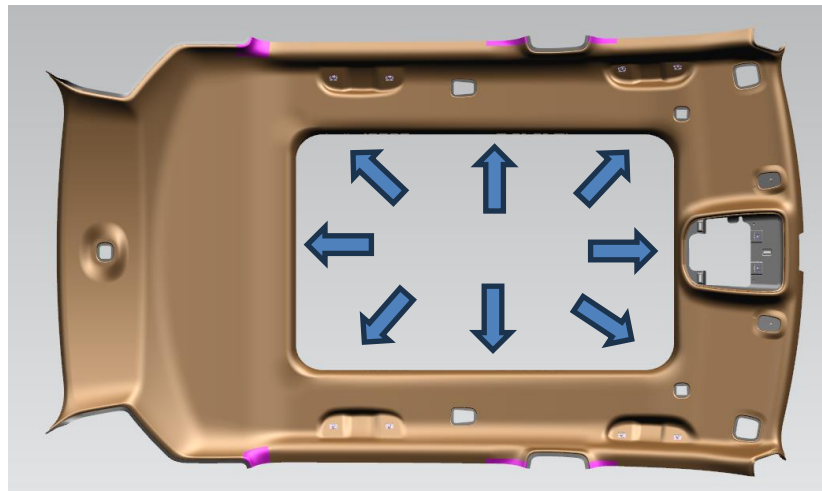
**Discussion:** Drive vehicle on rough road or twisty roads. With an assistant driving and noise duplicating, press upwards on the headliner at the area where the rattle is heard. If the noise is diminished or eliminated while pressing up continue with the below procedure.

Fig 1  
BSR Zone Around Sunroof Opening

Pull down the headliner at the sunroof opening to disengage the Velcro at the zone where the noise is heard. If the plastic retainer appears to have separated from the glue, that might have caused the BSR. If separation is found, continue with the below procedure.

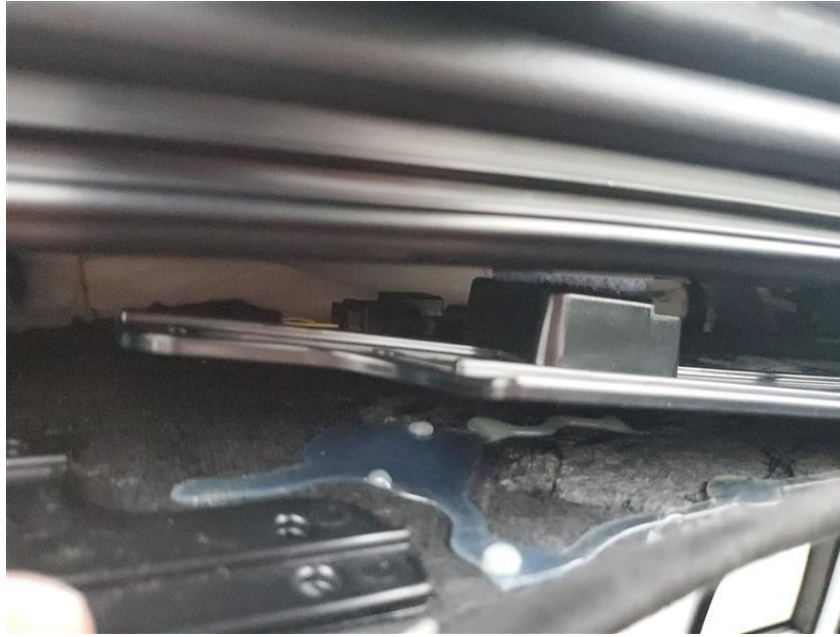
Fig 2  
Adhesive Separation

**Repair Procedure:** Applying adhesive does NOT require the removal of the headliner.

1. Pull down the headliner from the sunroof opening enough to access the top side. Disengage the Velcro from the roof side. Use a hot glue gun (preferably with polyamide type glue stick adhesive) to apply some glue between the plastic retainer and the substrate. Use clamps to ensure adequate bond is achieved until the glue cures. To avoid staining the headliner material a layer of towel or paper between the clamp and the headliner should be used. Also wood blocks or spacers as shown in Fig 3 will help spread the clamp force and avoid headliner damage.

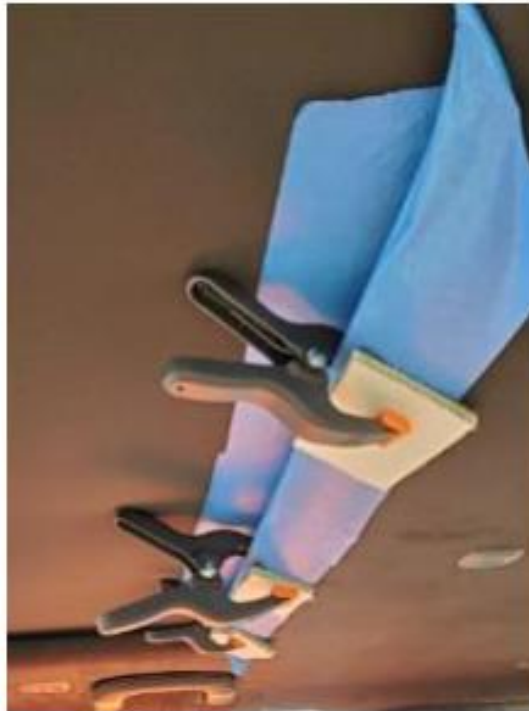
Fig 3  
Adhesive Applied And Clamps Used To Secure

2. Once glue has cured, engage the headliner Velcro. Test drive to verify repair.
