July 9, 2025

Version 2

Warranty Extension: 2014–19 MDX and 2017–19 MDX Sport Hybrid - Moisture in the Inner Taillights

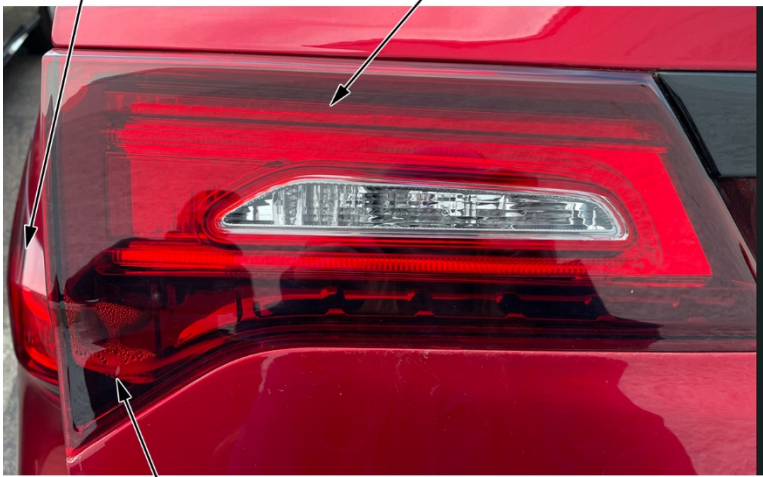
2. Inspect for any signs of water intrusion into the inner taillight assemblies.
 - If water intrusion is found, replace the affected taillight(s). Go to REPAIR PROCEDURE.
 - If no water intrusion is found, no further action is required.

WATER TRAPPED IN INNER TAILLIGHT

Inspect and, if necessary, replace the inner taillight(s).

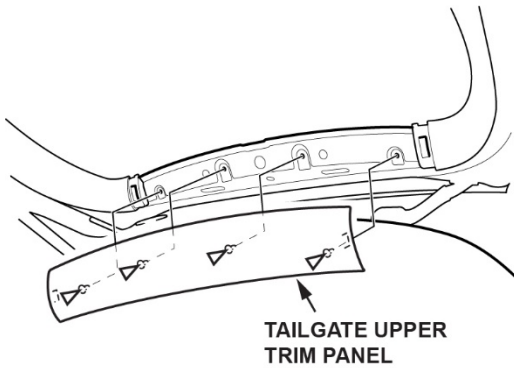
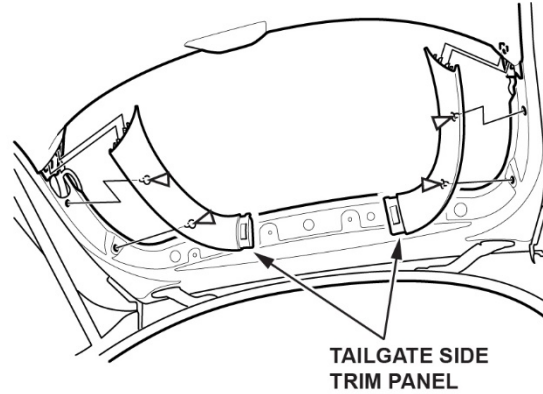
2. Remove the tailgate upper trim panel, then remove the side trim panels.

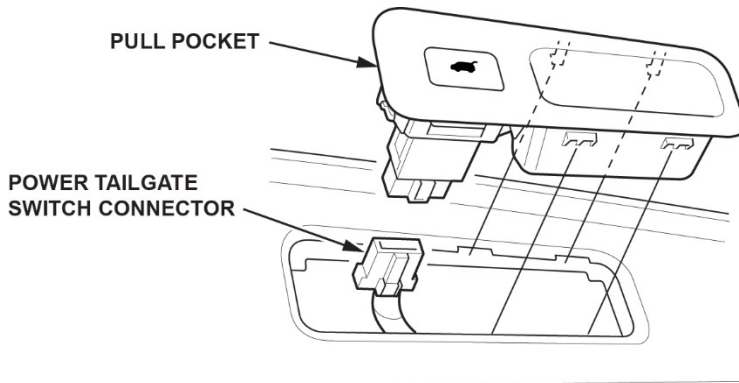
3. Remove the pull pocket, then disconnect the power tailgate switch connector.

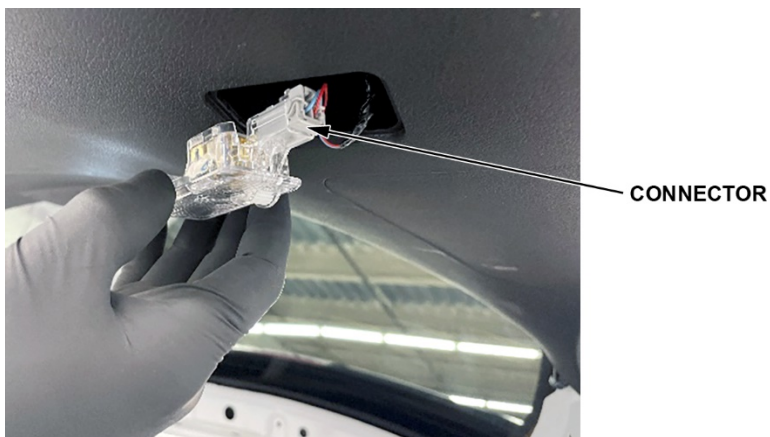
4. Remove and disconnect the tailgate light connectors.

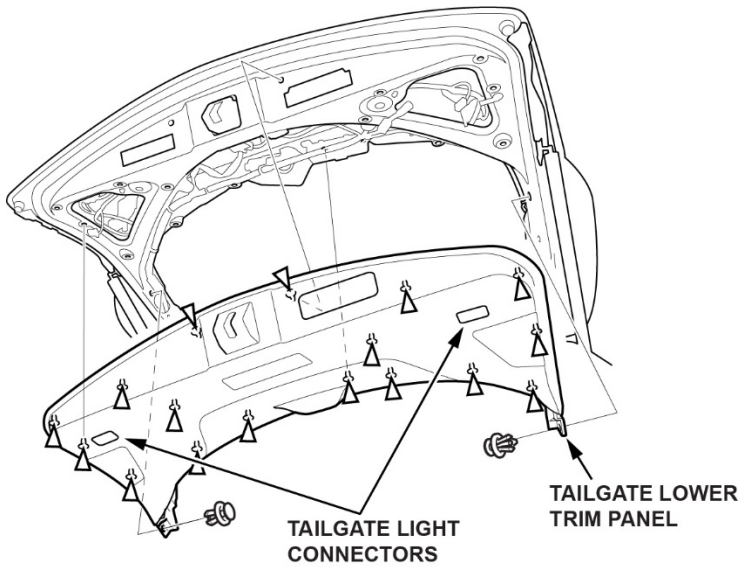
- Remove the tailgate lower trim panel.

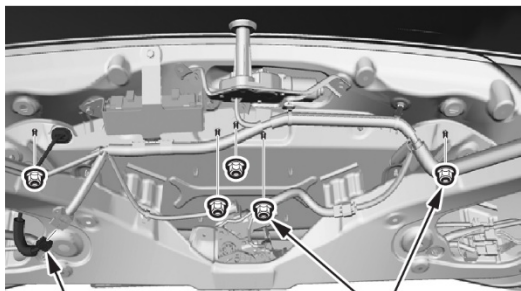
INSIDE THE TAILGATE

- Disconnect the license sub-harness connector, remove the five nuts, release the pins from the clips, then remove the rear license trim.

LICENSE SUBHARNESS CONNECTOR

4.9 N-m (3.6 lb-ft)

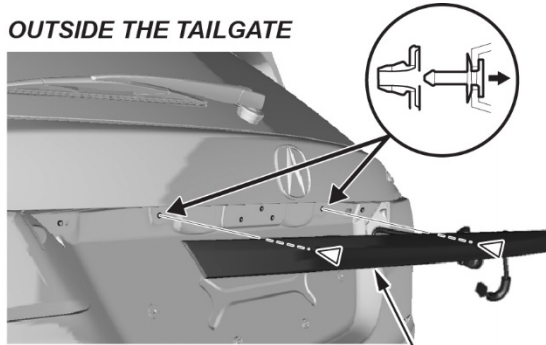
OUTSIDE THE TAILGATE

REAR LICENSE TRIM

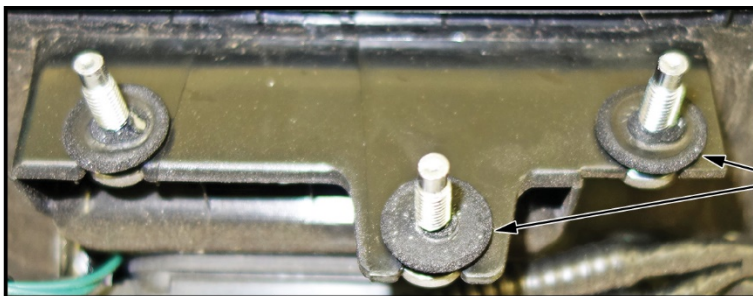
Be sure the grommets stay on the studs and clips.

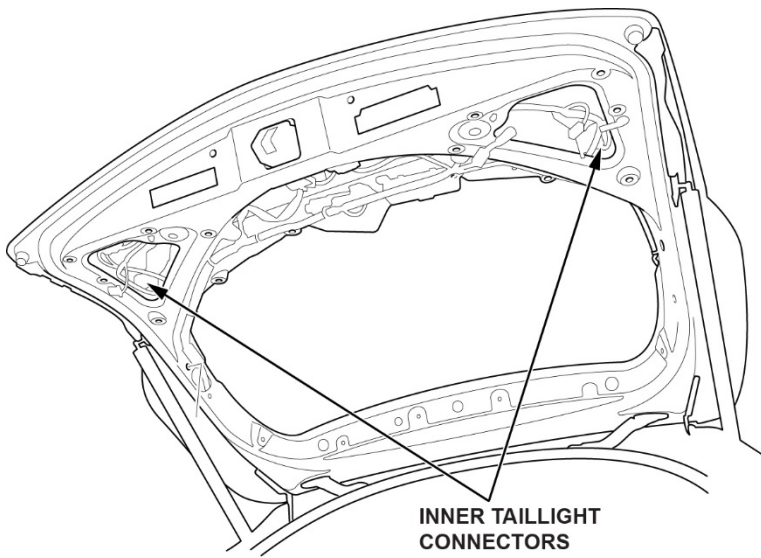
7. Disconnect both inner taillight connectors.

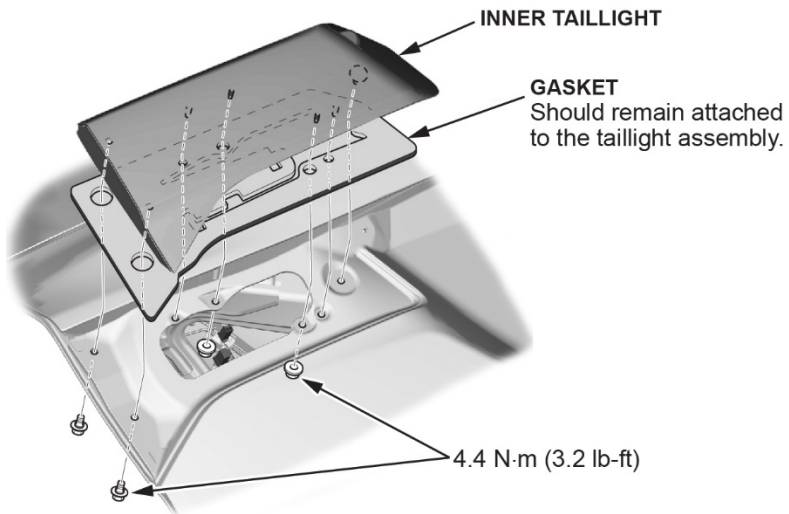
8. Remove the failed inner taillight(s) by removing the two mounting bolts and two mounting nuts.

NOTE: Be sure to completely remove the old inner taillight gasket from the tailgate surface.

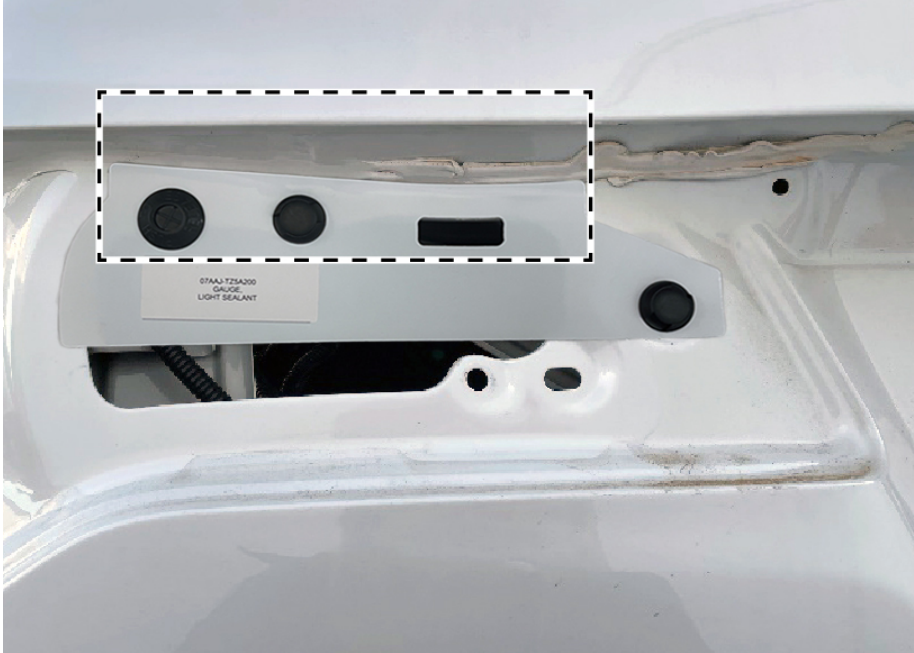
9. Install the template to the inner taillight location on the tailgate using the body clips.
10. Use the top edge of the template to mark the area **with a marker** where the dust sealer needs to be removed. The sealer should be removed from between the vertical lines, and along the edge of the template.

NOTE: There should be no dust sealer remaining inside the marked area.

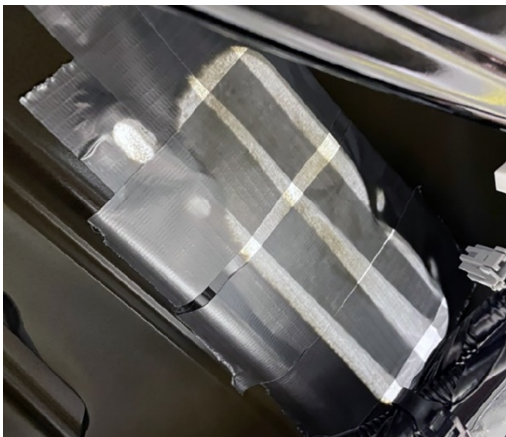
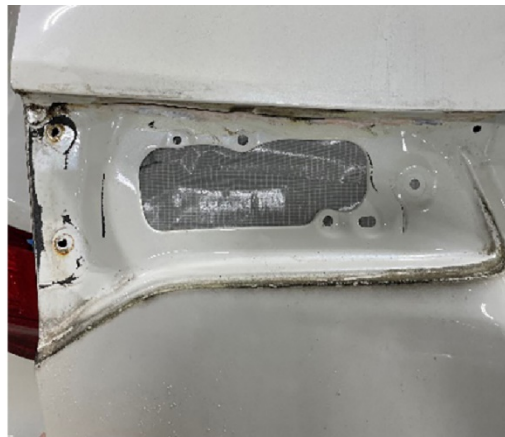
11. Once the dust sealer removal area has been marked, remove the template.
12. Seal the tailgate before doing the dust sealer removal:
 1. Place tape over the opening for the lid light.
 2. From the inside of the tailgate, place tape over the opening for the inner taillight.

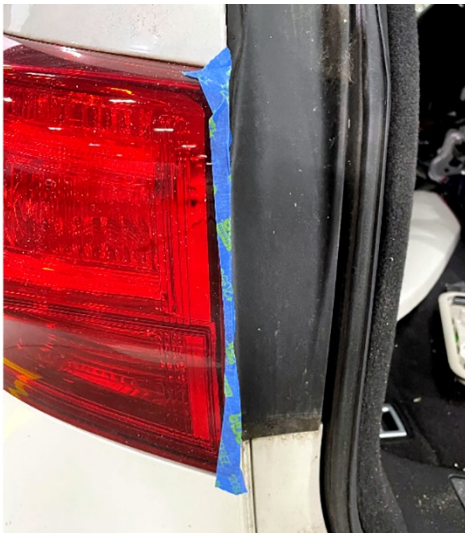
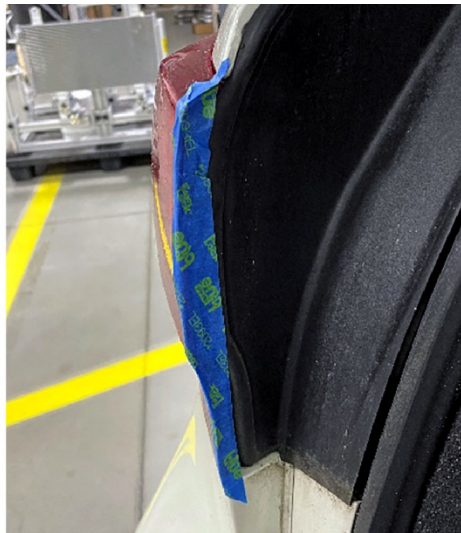
13. Place tape over the edge of the outer taillight to keep debris from getting into the housing.

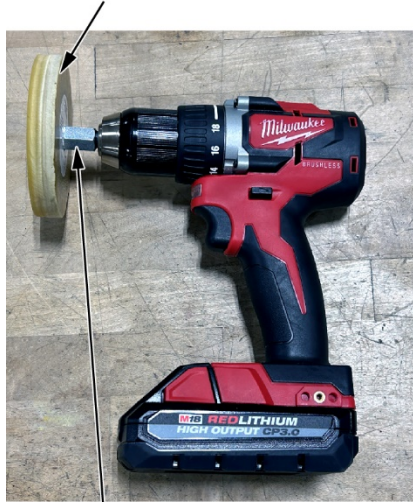
3M STRIPE OFF WHEEL

14. With the tailgate closed, and while wearing proper eye protection, use a drill (or equivalent rotary tool) with the 3M Stripe Off Wheel to remove the dust sealer between the markings.

- Ensure that the power tool being used is appropriate for the type of stripe off wheel being used.
- The maximum RPM for the recommended 3M Stripe Off Wheel is **4,000 RPM**.
- The stripe off wheel will only remove paint where there is sealer underneath the paint.

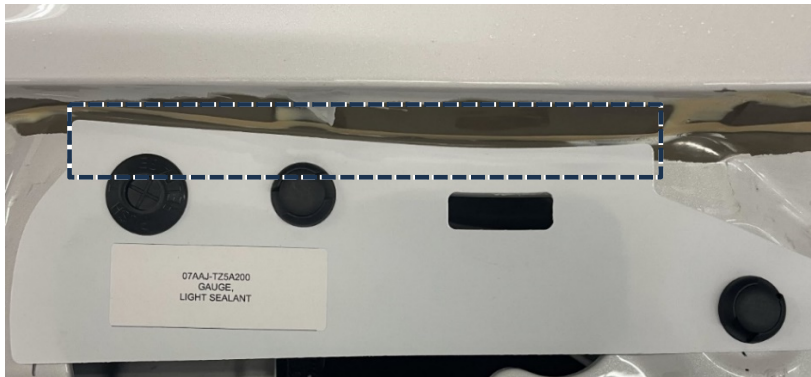
15. Use the template as a guide to ensure enough sealer has been removed.

NOTE: If the template indicates that additional sealer needs to be removed, remove the template, then continue to remove sealer as needed with the stripe off wheel.

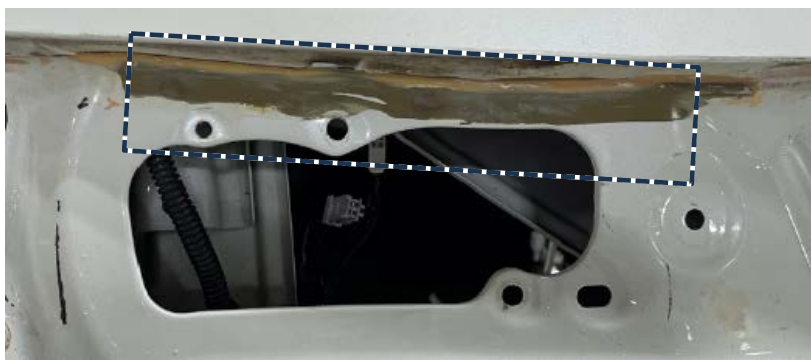
Example of finished sealer removal:

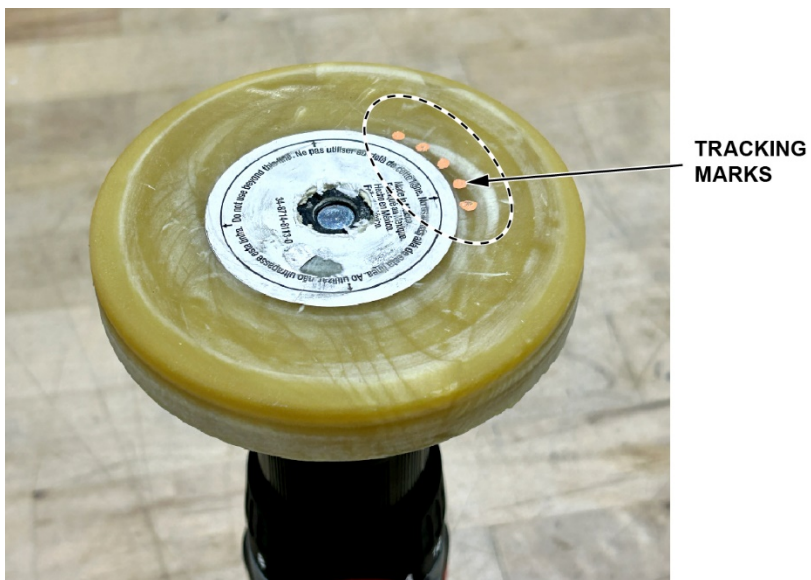
16. Place a tracking mark on the center of the stripe off wheel after each VIN is repaired. When 10 VINs have been completed (10 tracking marks have been added), flip the wheel over and repeat the process for 10 more VINs. After 20 VINs have been completed (10 tracking marks on each side of the wheel), replace the stripe off wheel with a new wheel.

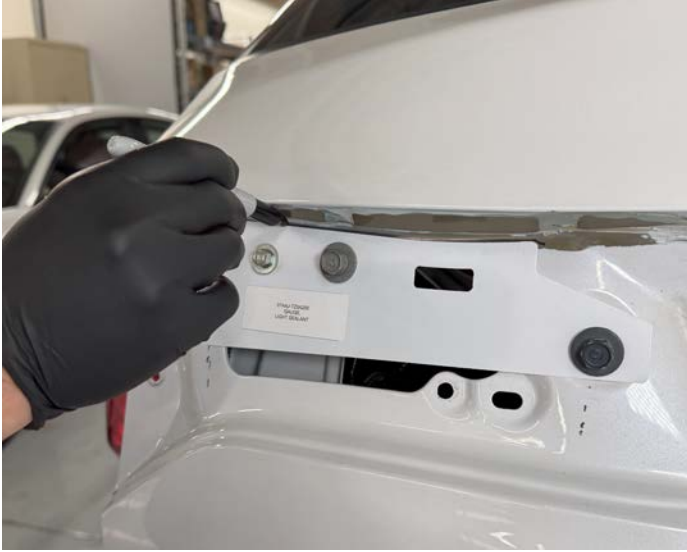
17. With the template installed, use a marker to make a line across the top edge of the template, then remove the template.

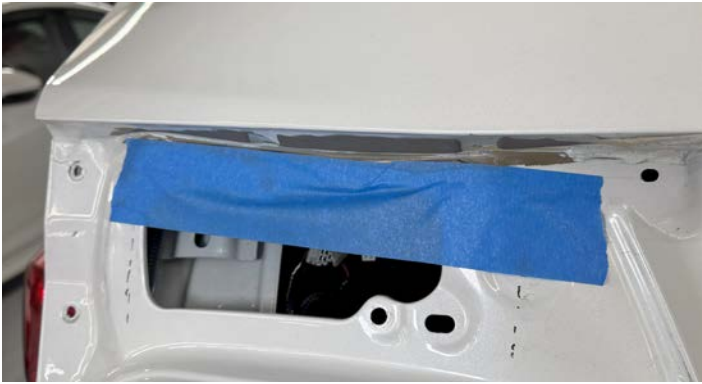
18. Place tape along the underside of the line that was drawn in the previous step.

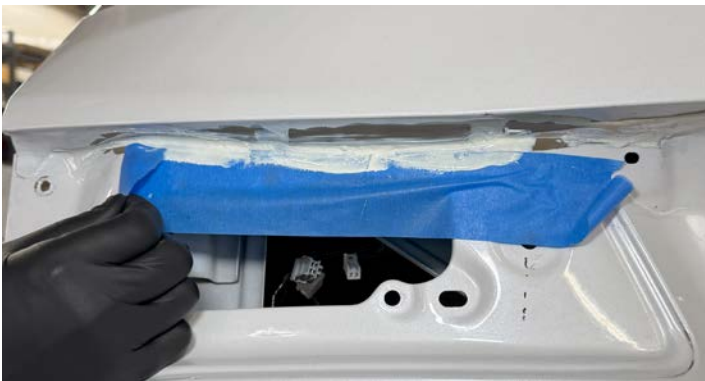
19. Apply a thin bead of Penguin Seal 353 to the area above the tape where the tailgate panels meet. While wearing a glove, run a finger along the new sealer to seal the panel joint and smooth the sealer across the area where the old sealer was removed.

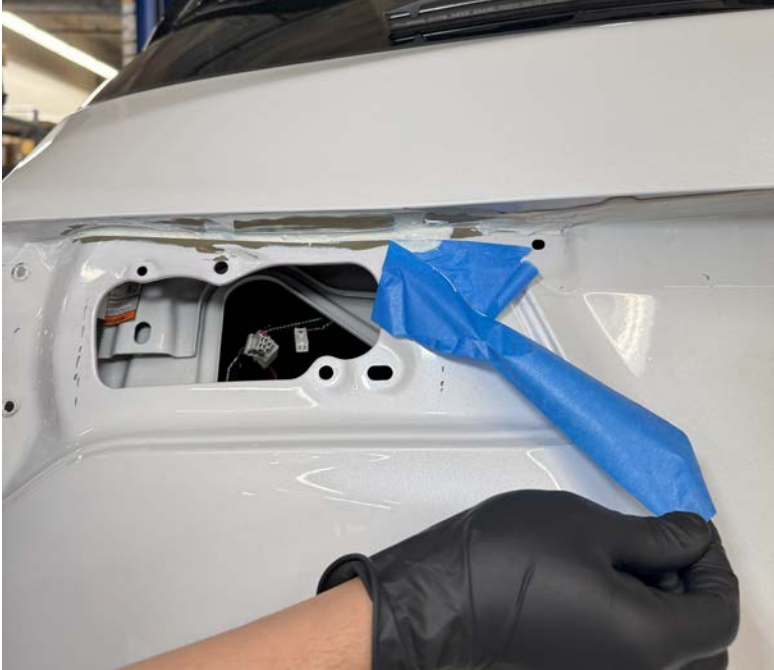
20. Immediately remove the tape below the sealer and allow 15 minutes for the sealer to dry.

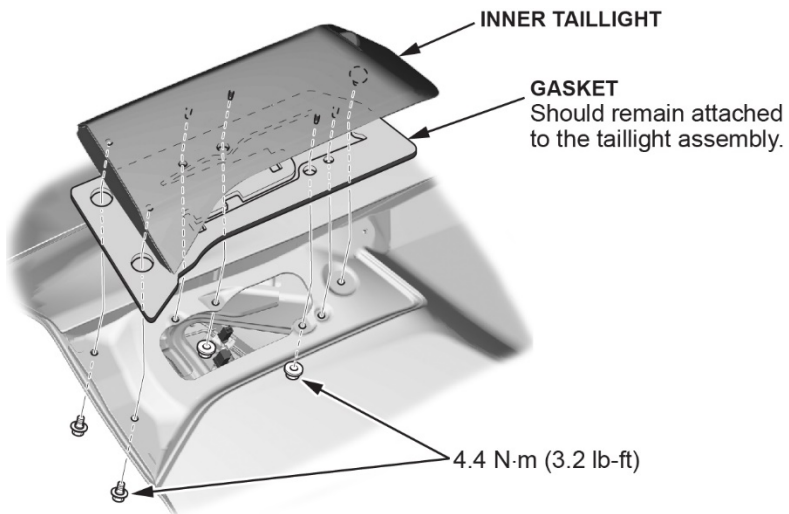
22. Install the new inner taillight(s) and connect them.
