SIB 52 07 25
M5 HEAD RESTRAINT GROANING NOISE

2025-07-17

E-Series	Model Description	Production Date
G90	M5 Sedan	Produced up to August 30, 2024
G99	M5 Touring

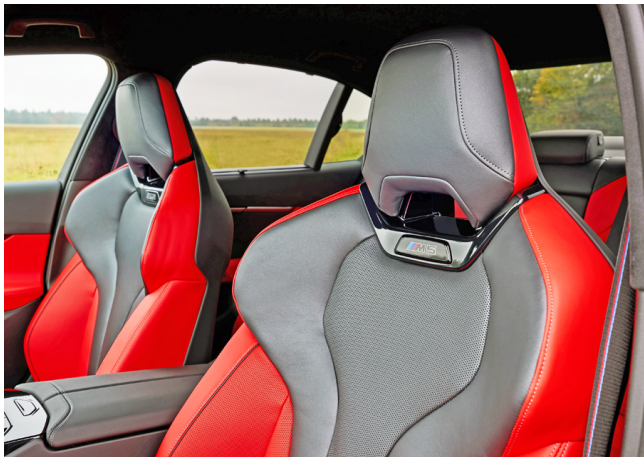
The decorative trims on the head restraints of the driver’s seat and front passenger seat cause groaning noises on any route, at any temperature, even in a slightly reclined position.

The edge of the aperture trim rubs against dry seat leather upholstery at the point of contact.

Apply leather lotion to the seat leather to eliminate the sticking against the aperture trim.

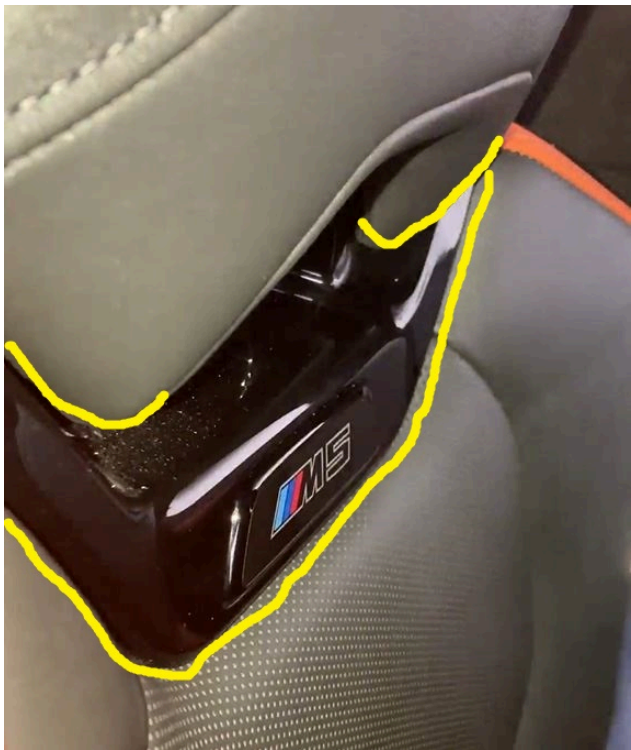
If the decorative trim causes groaning noises, apply leather lotion to the area where the decorative trim comes into contact with the leather (highlighted in yellow).

This can be done without any seat disassembly.

Even if the customer only mentions that the noise comes from one seat, apply the leather lotion to both the passenger and driver's seat leather.
