Technical Service Bulletin

GROUP CAMPAIGN	NUMBER 25-01-050H
DATE JULY 2025	MODEL(S) IONIQ 9 (ME1A EV)

SUBJECT: WALK-IN SWITCH INSPECTION & REPLACEMENT
(SERVICE CAMPAIGN TEC)

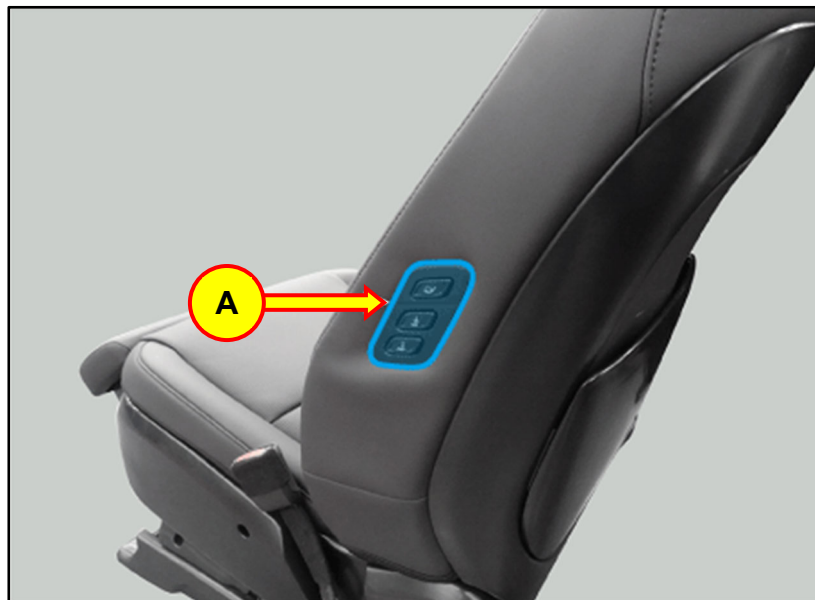
Description: Certain IONIQ 9 (ME1A EV) vehicles may have Walk-in switches (A) that are not fully secured. This bulletin provides instructions to inspect and, if necessary, replace the Walk-in switch (A).

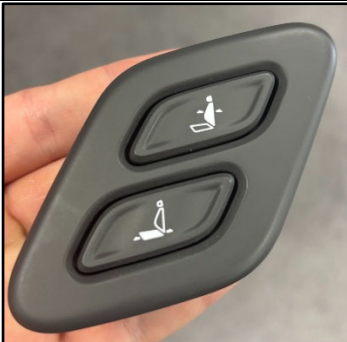
Model	Part Name	Part Number	Figure	Remarks
IONIQ 9 (ME1A EV)	Switch Assembly – Walk in, RH	88085-DO000YGN

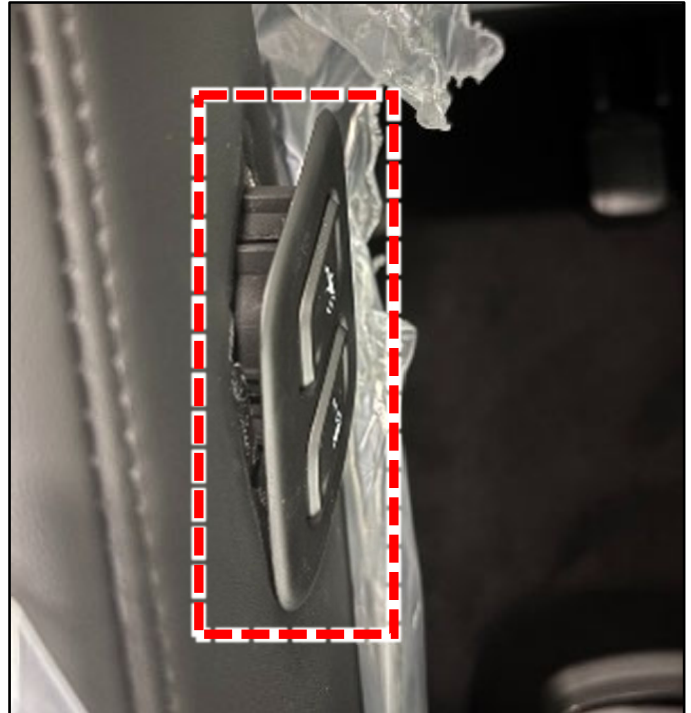
1. Visually inspect the Walk-in switch located on the inner side of the seat back on the front passenger seat.

Gently pull on the Walk-in switch assembly to ensure the Walk-in switch assembly is securely mounted.

2. If the switch is **NOT** fully secured, proceed to **step 1** of the **Walk-in Switch Replacement** procedure.

If the switch is fully secured, proceed to Digital Documentation **step 4** of the **Walk-in Switch Replacement** procedure.

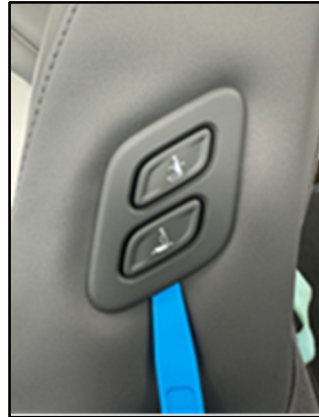
1. Use a plastic trim removal tool to pry off the Walk-in switch from the bottom and disconnect the connector (A).

Use a plastic trim removal tool to prevent damage to parts.

2. Install the supplied Walk-in switch assembly, and firmly press until all clips are engaged.
3. Gently pull on the supplied Walk-in switch assembly to confirm the Walk-in switch assembly is securely installed.
