Technical Service Bulletin

GROUP	NUMBER
HVAC	25-HA-002G
DATE	MODEL(S)
JULY 2025	SEE BELOW

SUBJECT: EVAPORATOR CORE LEAK INSPECTION AND REPLACEMENT

Description: Certain Genesis vehicles may experience insufficient cooling in the cabin due to leakage at the evaporator core. This bulletin provides instructions to inspect the A/C system for leaks and replace the evaporator core, if necessary.

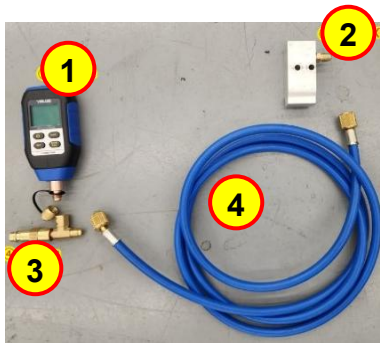
<ol style="list-style-type: none"> 1. Gauge 2. SST TXV 3. Fitting 4. Hose <p>The Evaporator Core Inspection SST Kit will be shipped to all Genesis Dealers.</p> <p>If additional tools are needed, they may be ordered via WebDCS through the normal ordering process.</p>
R-1234YF PAG Oil Injector Syringe	ROB18465

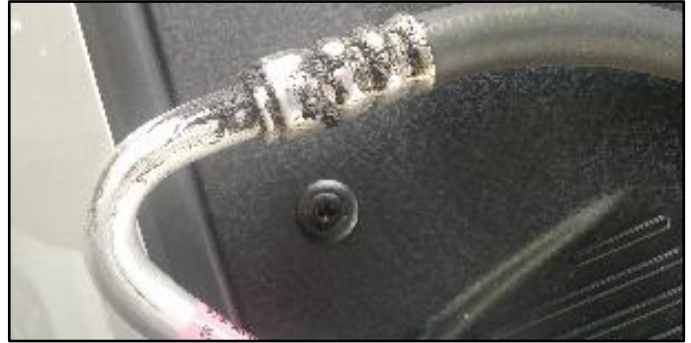
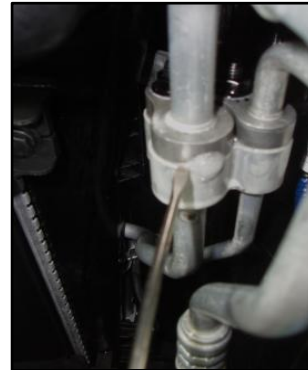
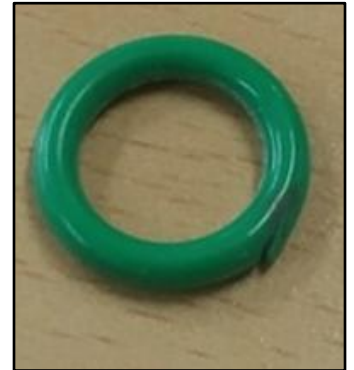
4. Visually inspect the discharge hose and condenser joint for frost oil leak trails.

If **NO** frost oil leak trails are visible, apply a soap and water solution to the outside of the discharge hose and condenser joint to confirm leakage.

If a leak is visible after applying a solution, the O-Ring may be damaged and must be replaced.

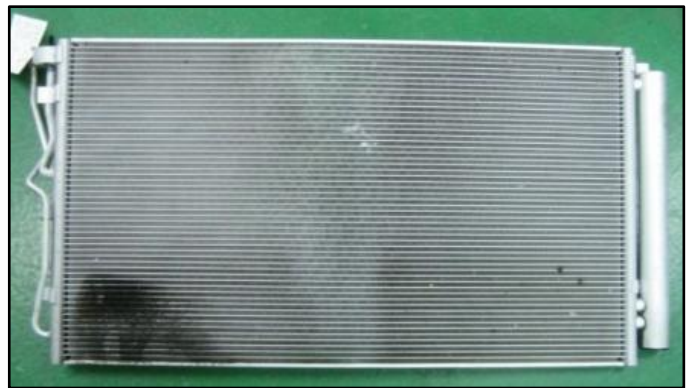
5. Inspect the A/C Condenser for frost oil leaks.

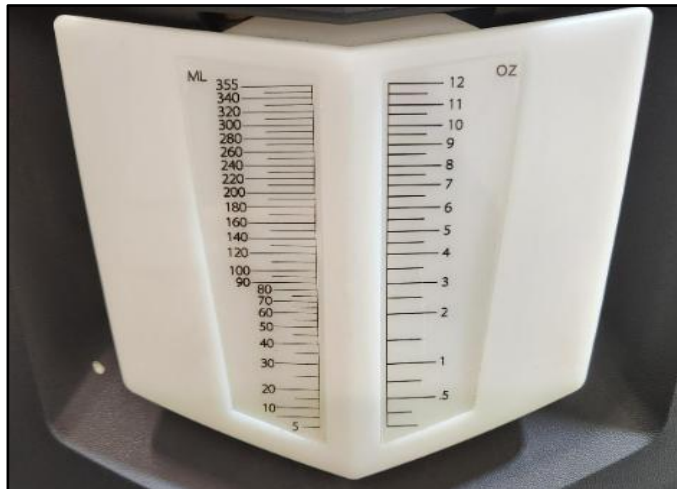
3. Measure the amount of PAG oil drained during recovery and record it so that amount can be injected later during the recharging process.

- If the refrigerant level is at specification, this TSB does **NOT** apply.
- If refrigerant level is found to be below specification, proceed to **step 4**.

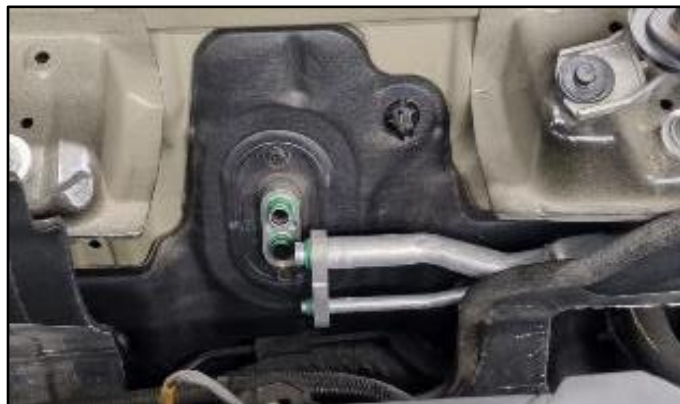
4. Refer to the Shop Manual to remove the Thermostatic Expansion Valve (TXV):

Draining the engine coolant is **NOT** necessary at this step, remove the TXV without doing so.

- Disconnect the expansion valve block from the suction & liquid pipe.

lb-ft	7.3
lb-in	87
N.m	9.8

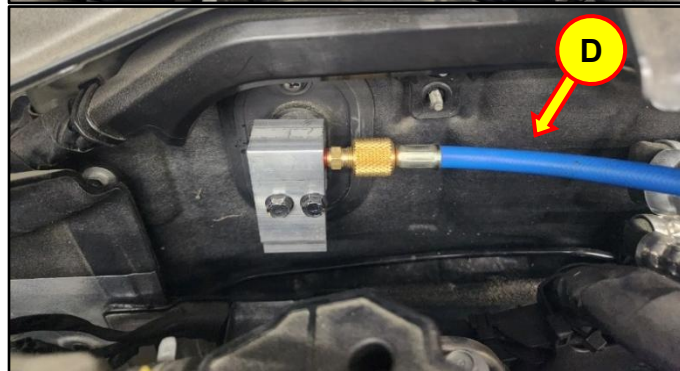
5. Install the SST TXV (C) to the evaporator core pipe.

- In tight areas, connecting the supplied refrigerant hose (D) to the SST before tightening may be beneficial.

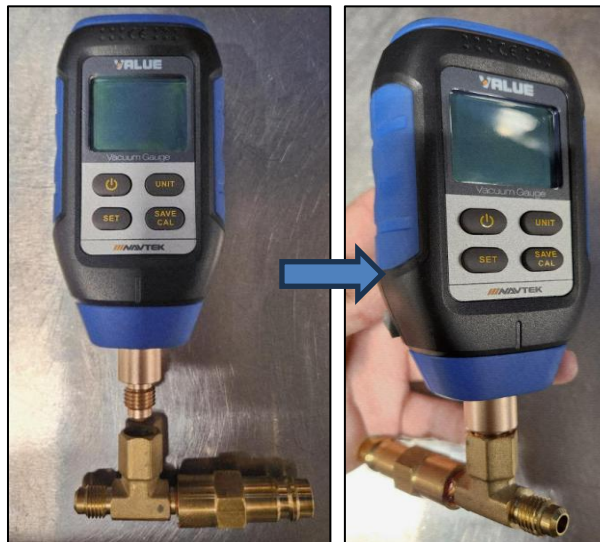
6. Assemble the fitting to the supplied pressure gauge.

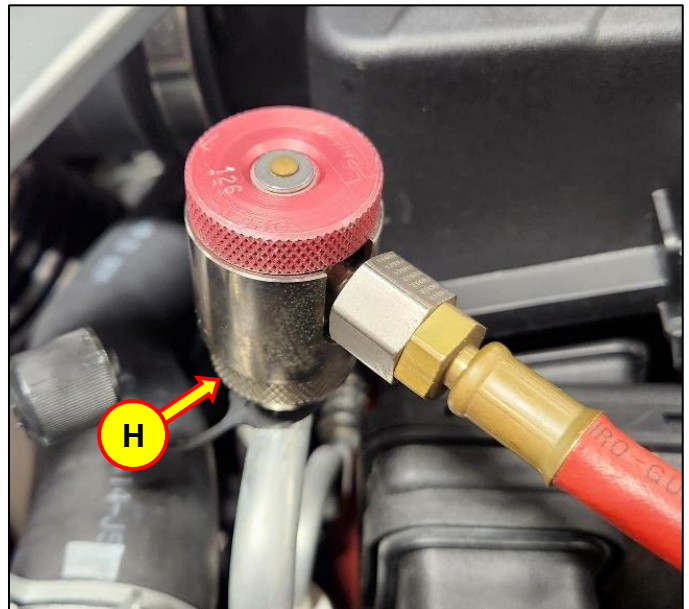
9. Close the high-pressure service port (H) and remove the coupler from the vehicle.

If the high-pressure service port is left closed and connected to the vehicle, it may skew the results.

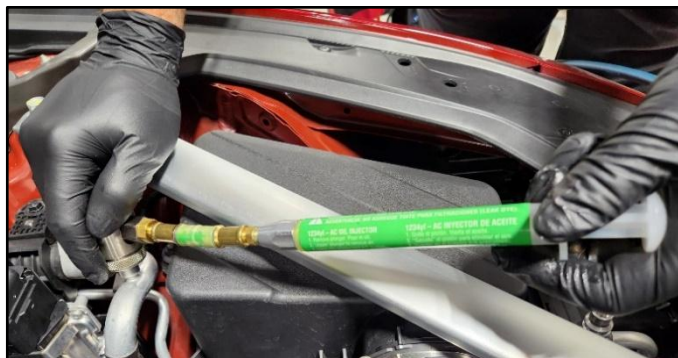
20. Use the R-1234YF PAG Oil Syringe Injection tool and add PAG Oil with UV Dye.

Place the measured amount during recovery back into the vehicle; approx. **3~10 mL**.

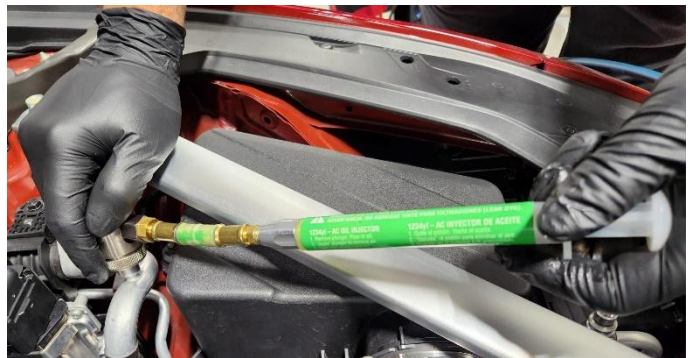
11. Use the R-1234YF PAG Oil Syringe Injection tool and add PAG Oil with UV Dye.

Place the measured amount during recovery back into the vehicle; approx. **3~10 mL**.
