# Technical Service Bulletin

<b>Topic</b>	Front or rear door(s) - Soft close function failure - DTC B122D29   Bentayga   22MY - 25MY
<b>Market area</b>	Australia E04 Bentley rest Asia and Australia (6E04), China 796 VW Import Comp. Ltd (Vico), Beijing (6796), Germany E02 Bentley rest Europe (6E02), Japan E03 Bentley Japan (6E03), Korea, (South) E08 Bentley South Korea (6E08), United Arab Emirates E06 Bentley Middle East and Africa (6E06), United Kingdom E01 Bentley UK (6E01), United States E05 Bentley USA and rest America (6E05)
<b>Brand</b>	Bentley
<b>Transaction No.</b>	2072938/4
<b>Level</b>	EH
<b>Status</b>	Released for publishing
<b>Release date</b>	Jul 29, 2025

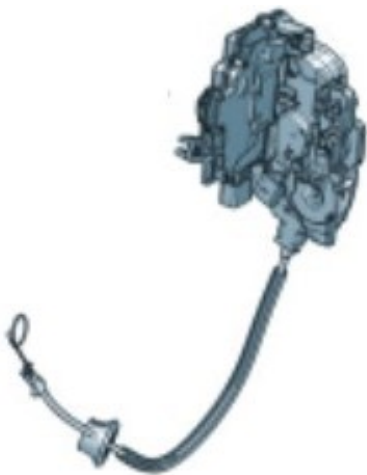
**Note:** For reference purposes Figure 1 shows an example of a door latch

**Step 2 - Door latch replacement**

Referring to Rep.Gr 57 (front) or Rep.Gr 58 (rear) replace the applicable door latch
