Field campaign

Topic	Oil Cap Specification Verification 25-26MY (SC25/38)
Market area	Bentley: worldwide (2WBE),China 796 VW Import Comp. Ltd (Vico), Beijing (6796)
Brand	Bentley
Transaction No.	2078780/1
Campaign number	ED66
Note	
Type	
US code

25-26MY | All Models

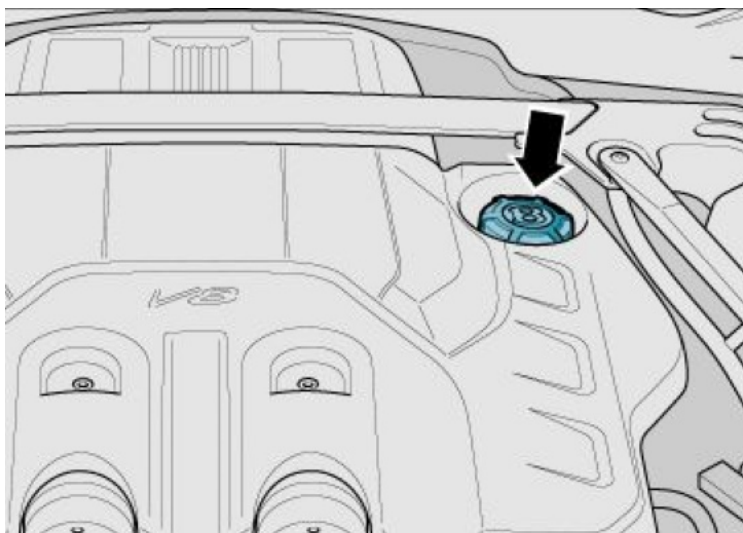
Figure 1 Oil Filler Cap part check

1. Open the bonnet and inspect the oil filler cap to confirm it matches the correct specification for the vehicle model.

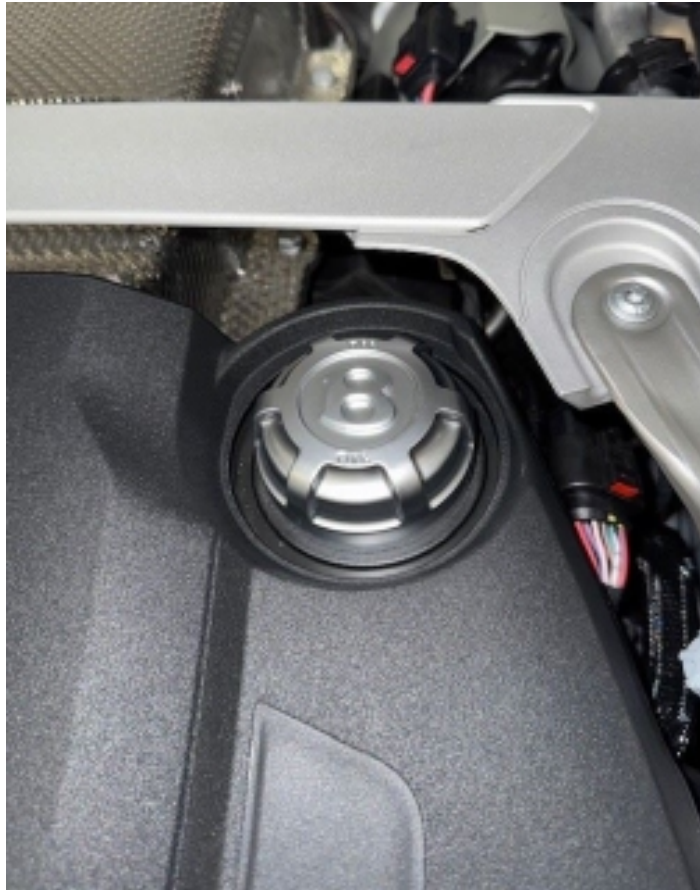
Figure 2 OK Oil Filler cap part specification

2. Perform a check of the Oil filler cap. If the specification is correct, as per figure 2. Refer to the identification section to confirm campaign completion.

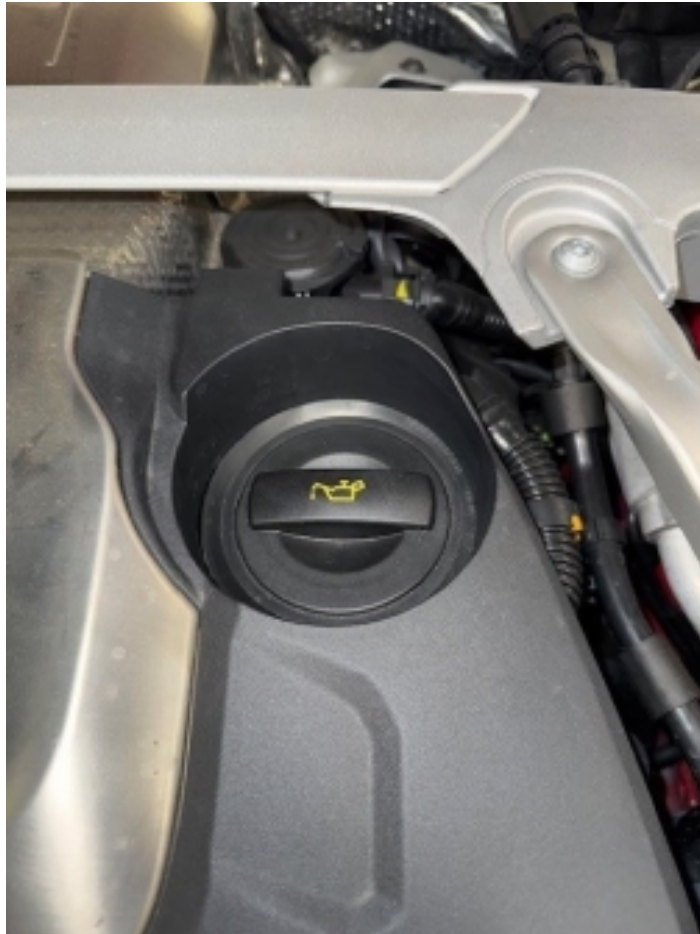
Figure 3 NOK Oil filler cap part specification

Due to an unforeseen supply quality issue from the component provider, certain vehicles have been delivered without the optional Jewel Oil Filler Cap. This part is a customer-paid option, and in order to avoid further delays and inconvenience to our customers, these vehicles were supplied with the standard Oil Filler Cap in place of the Jewel version.

3. If the oil filler cap does not match the specified part, as per figure 3. Replace it with the correct specification part listed in the genuine parts section.

Ensure the replacement is securely fitted and meets all visual and functional standards.

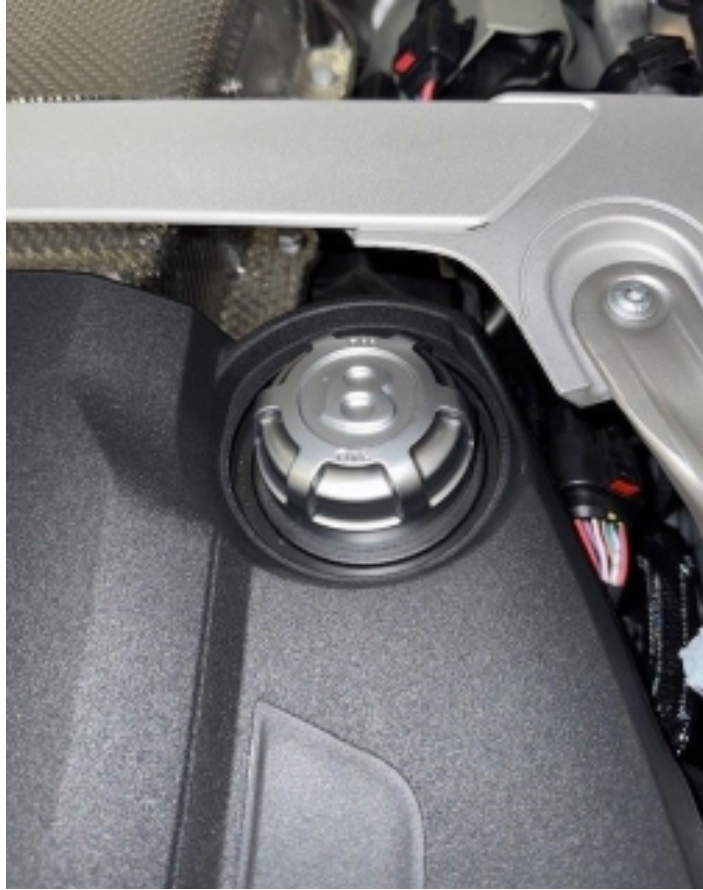
Figure 4 OK Oil filler cap part specification

Fitment of the correct specification oil filler cap as per Figure 4 confirms campaign completion.
