## **Manufacturer's Communication to Dealer**

On certain Tiffin Convoy, GH1 and GT1 motorhomes, the Sirius XM antenna signal may be blocked intermittently by the solar panels. Tiffin Motorhomes has instructions and parts for relocating the antenna to a different location on the roof for owners having issues with their radio reception.

**Purpose:** To relocate the Sirius XM radio antenna on a Tiffin GH1 RV for improved signal reception.

**Models Involved:** 2023, 2024, 2025 & 2026 Tiffin GH1, GT1 & Convoy Motorhomes

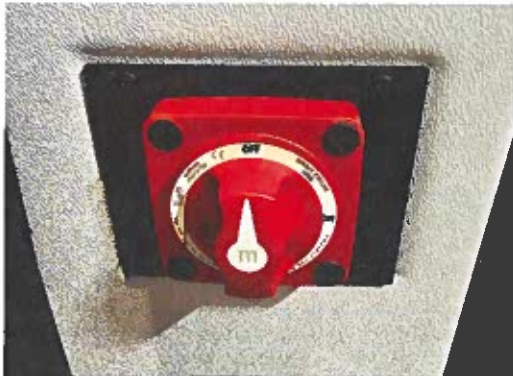
Figure 1A

1. Disconnect all power from the 30-amp shore cord.
2. Turn main battery disconnect "OFF". The disconnect is located at the rear of the coach on the driver's side. See Figures 1A & 1B below.

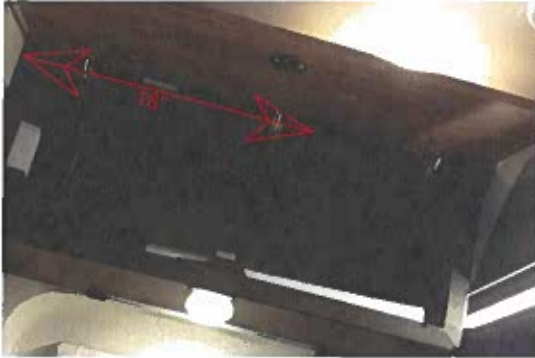
Figure 2

6. Measure 18" from the shower wall to the left of the cabinet, see figure 2, and cut a 2"x2" hole directly behind the metal face frame using an oscillating saw to access the existing Sirius antenna cable.

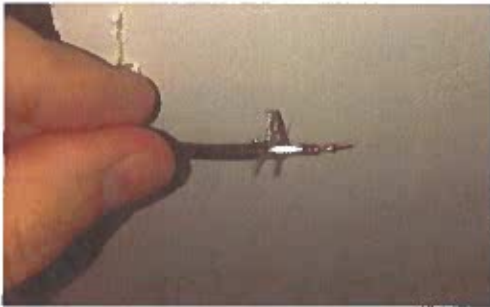
Figure 3

7. Use wire cutters to cleanly cut the coax cable. Strip the jacket and shielding to expose the center conductor, see figure 3, of the antenna wire that is connected to the radio.

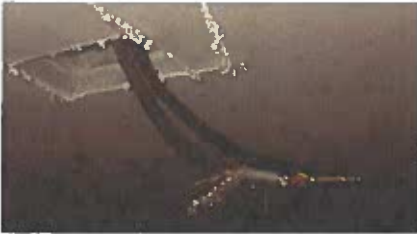
Figure 4a

8. Install part number 5176254 Adapter SMBZ male crimp conn XM radio to the wire using a coax crimping tool. See figure 4a & 4b.

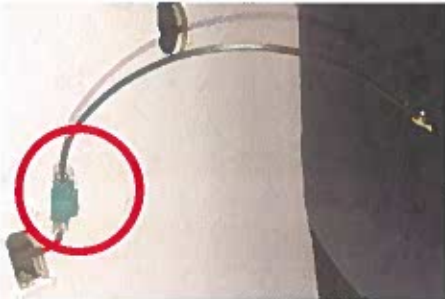
Figure 5

9. Install part number 5176253 Adapter F to SMB M Conn XM ant 8in, see figure 5.

14. Inside the motorhome, connect the new antenna connector to the connector on the radio antenna wire, see step 9, figure 5. Ensure the connector clicks securely and the cable is not under stress or strain.
15. Test the system by powering on the motorhome and turning on the Sirius SM radio system. Confirm signal lock and verify audio playback on satellite channels. Inspect connections and routing if signal is not acquired.
16. Apply self-leveling sealant to seal roof access port cover to prevent water intrusion.
17. Secure solar panel(s) back to roof.
18. Reinstall the felt cabinet panels inside the overhead cabinet of the motorhome.

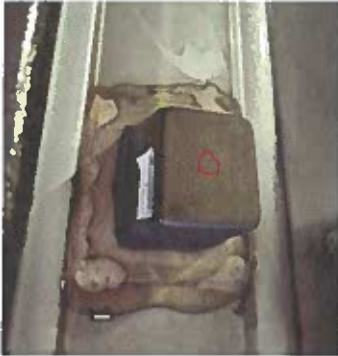
Figure 6

10. Remove bolts securing the solar panel(s) to the roof rack and carefully set the solar panel aside.
11. Drill a hole in the roof access port, see figure 6, and feed the antenna cable of part number 5176251 Antenna Sirius XM Radio 23ft, through to inside the motorhome.

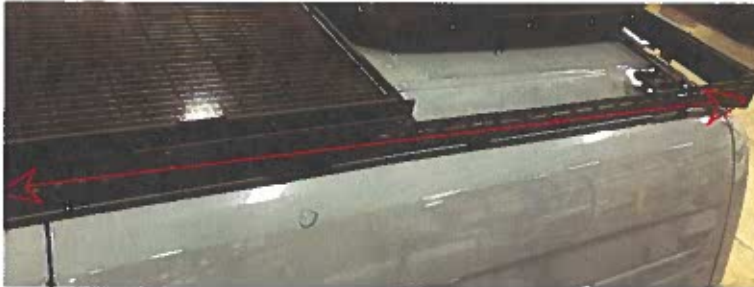
Figure 7

12. Route the cable along the inside edge of the roof rack, see figure 7, to the rear driver side corner, securing the cable as needed with the UV-rated zip ties.
