**ID #** CBR-2482

PTO Malfunction Pop Up - VN (4) - PR (4)

Purpose of this CBR is to address Pop up message for PTO Malfunction when there is not PTO Installed.

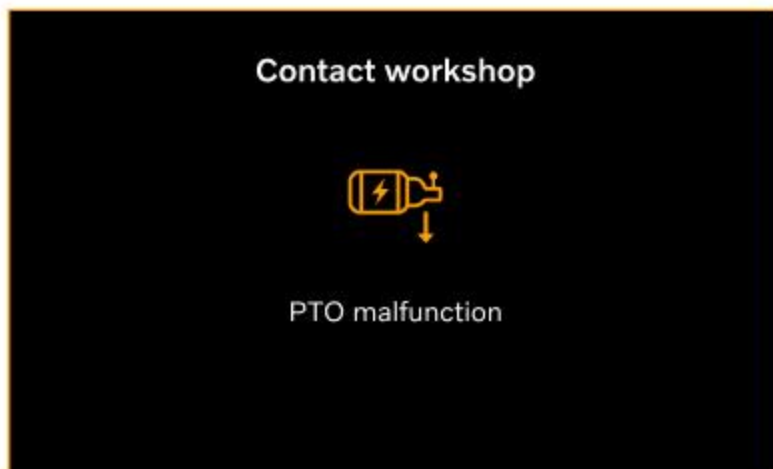
Purpose of this CBR is to address Pop up message for PTO Malfunction when there is no PTO Installed.

When encountering a unit with a pop-up message for PTO malfunction and fault code P100A15, follow steps below:

1. Check to see if unit has a PTO switch installed in dash. If there is a switch, check to see if there is a PTO solenoid installed on transmission.
2. If there is no solenoid installed on transmission please order parts below and install solenoid.

**NOTE:** If solenoid bracket is not installed please order: 24262391

3. Once solenoid is installed, please clear faults and release unit to service.
