Technical Service Bulletin

GROUP CAMPAIGN	NUMBER 25-01-037H-1
DATE JULY 2025	MODEL(S) IONIQ 5 (NEA EV)

SUBJECT: REAR BUMPER MISSING LICENSE PLATE MOUNTING HOLES INSPECTION & REPLACEMENT (SERVICE CAMPAIGN TCY)

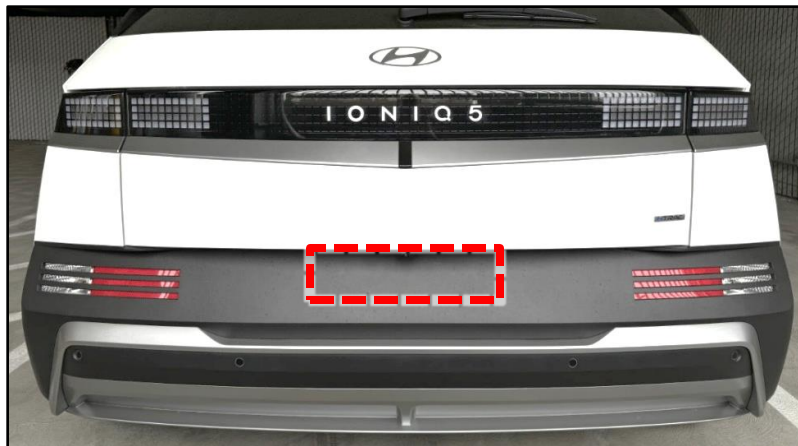
Description: Certain 2025MY IONIQ 5 vehicles (NEA EV) may be missing the license plate bracket mounting holes in the rear bumper cover. This bulletin provides instructions to inspect, and if needed replace the rear bumper cover with the mounting holes to accommodate the installation of the license plate bracket.

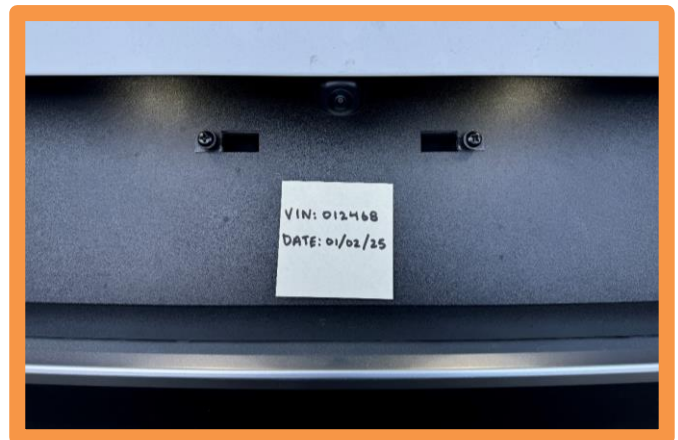
Using STUI, take a photo of the rear bumper lower cover license plate mounting holes with the last 6 digits of the VIN and the date of repair on a piece of paper.

Upload the photo to STUI.

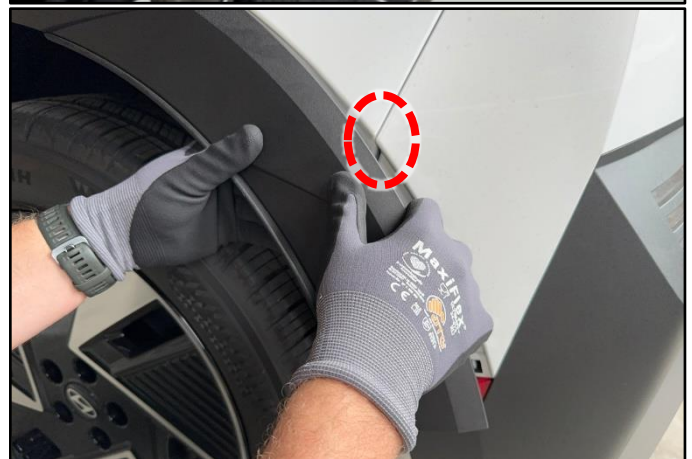
2. Remove the lower section of both rear quarter garnishes (A) so that the rear bumper can be removed from the vehicle (first **3-4 clips** from the rear edge **ONLY**).

If clips are broken, reference the parts table for applicable clips/part numbers.

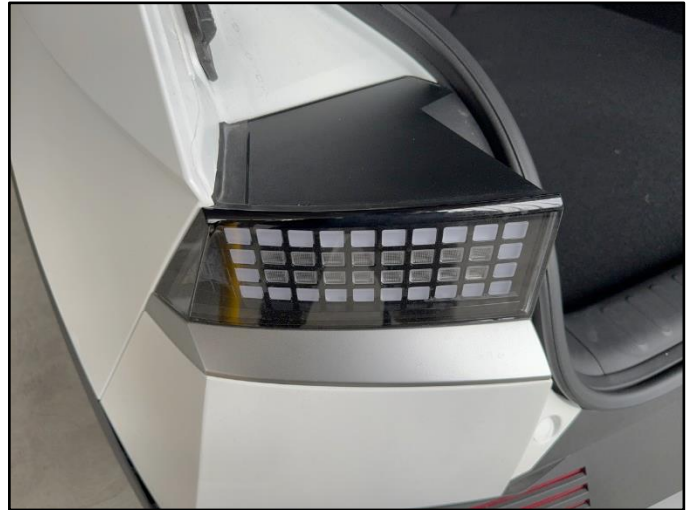
3. Remove both rear combination lamps.

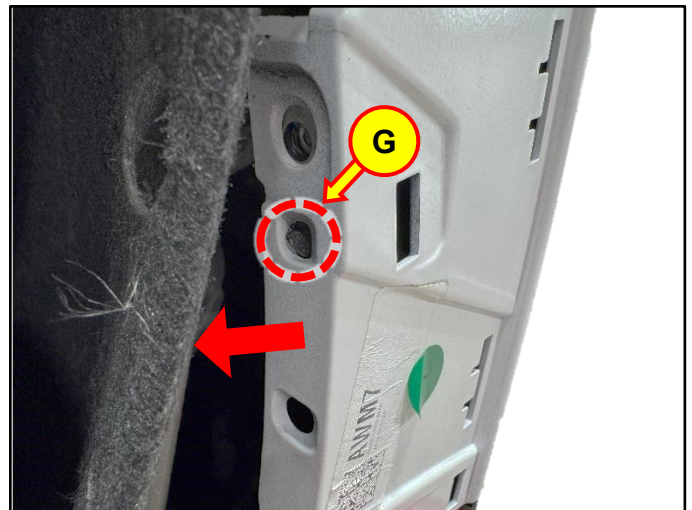
7. Remove the rear bumper from the vehicle.

To assist in removal of the rear bumper, first unseat the bumper from the area (G). Then push from the bottom of the bumper in the area (H) upward as pictured. Repeat on other side of the bumper.

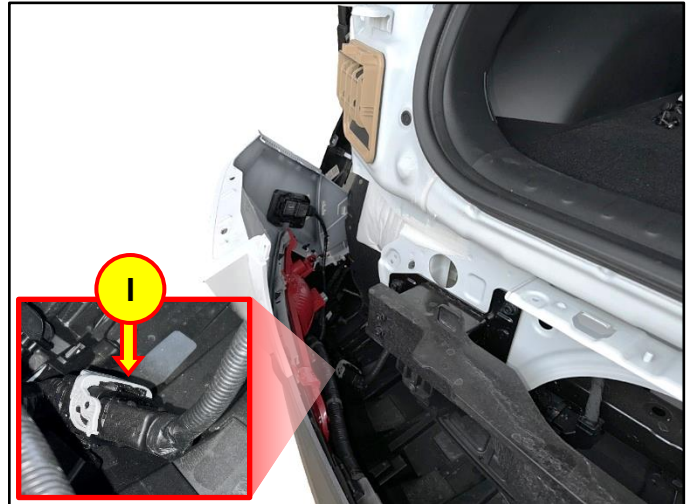
8. Disconnect the harness (I) and remove the bumper from the vehicle.

Once the bumper has been removed from the vehicle, ensure it is placed on a clean, non-marring surface to prevent damage to the paint/finish before working.

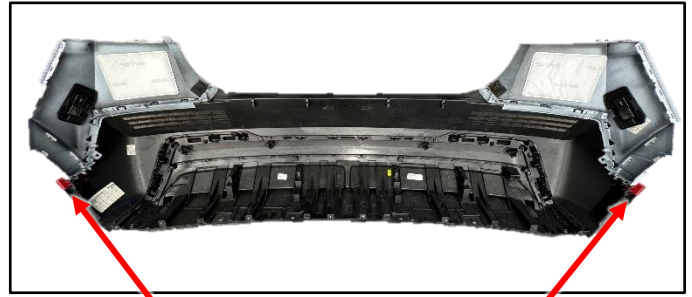
6. Unscrew and remove the side reflectors.

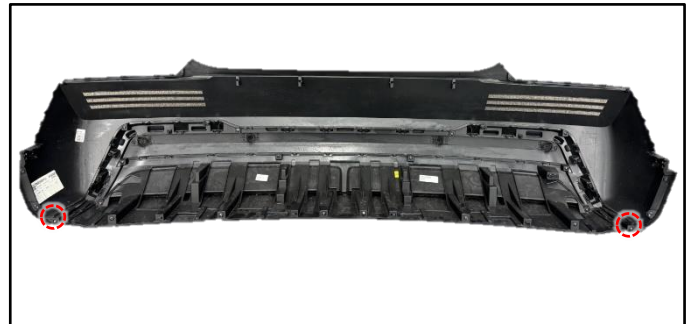
10. Remove the clips from the rear bumper.

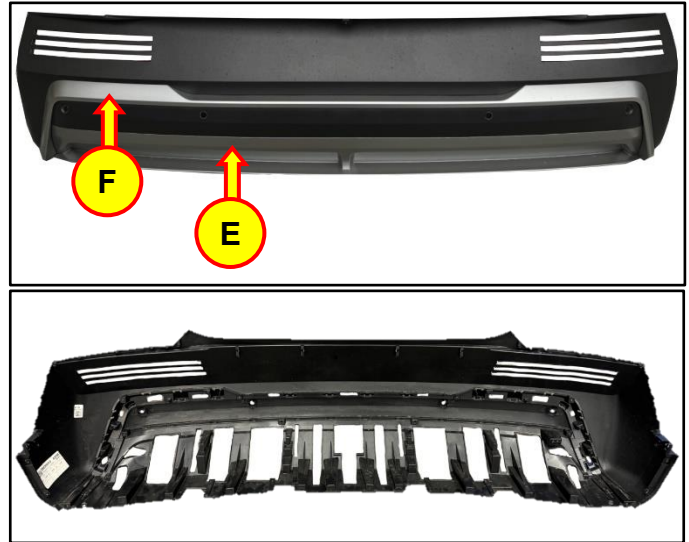
- Carefully detaching the clips, remove the attached bumper skid plate (E) and center molding assembly (F) from the bumper cover assembly.

Ensure no other parts, sensors, screws, clips, etc. are attached to the original rear bumper lower assembly.

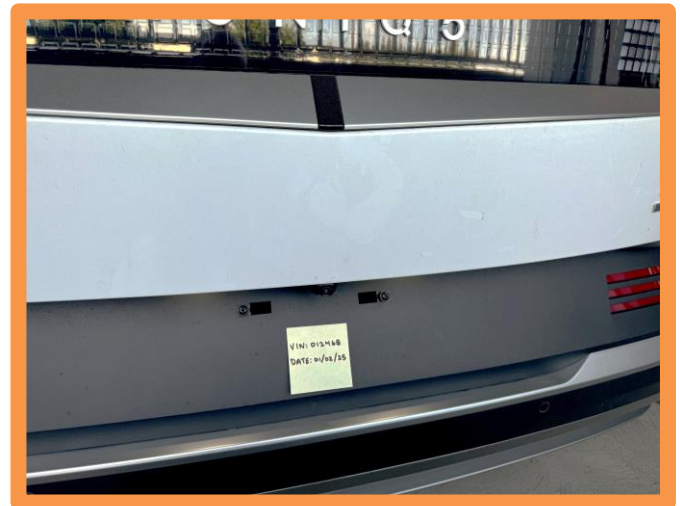
Using STUI, take a photo of the replacement rear bumper lower cover installed on the vehicle with the last 6 digits of the VIN and the date of repair on a piece of paper.

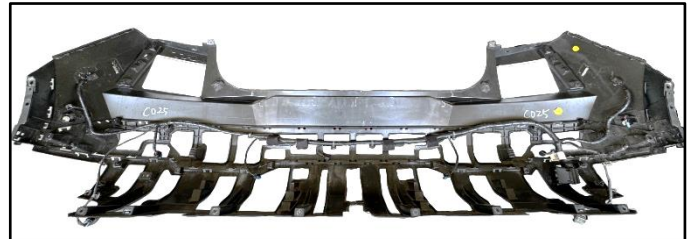
12. With the last 4 arrowhead mount cable ties exposed, detach them from the bumper and remove the harness.

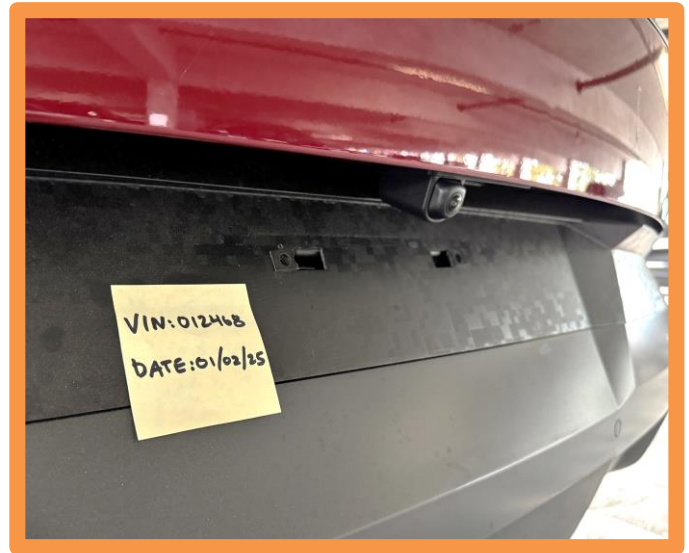
Using STUI, take a photo of the replacement rear bumper upper cover installed on the vehicle with the last 6 digits of the VIN and the date of repair on a piece of paper.

Upload the photo to STUI.
