REFERENCE:	TSB: 03-003-25 REV. A GROUP: 03 - Differential and Driveline	Date:	July 30, 2025	REVISION:	03-003-25
VEHICLES AFFECTED:	2024 - 2025 (JL) Jeep Wrangler This bulletin applies to vehicles built on or after **July 28, 2023 (MDH 0728XX) and built on or before December 05, 2024 (MDH 1205XX)** equipped with the Dana M220 Wide Full Floating RR Axle (Sales Code DRN).			MARKET APPLICABILITY: <input type="checkbox"/> NA <input type="checkbox"/> MEA <input type="checkbox"/> SA <input checked="" type="checkbox"/> IAP <input type="checkbox"/> EE <input type="checkbox"/> CH NOTE: **This bulletin applies to the India & Asia Pacific market.**	
CUSTOMER SYMPTOM:	Customers may experience the following: <ul style="list-style-type: none"> Intermittent grinding, screeching, ratcheting noise coming from the right hand side of vehicle on the rear axle. 				
CAUSE:	Lack of lubrication

This bulletin involves cleaning and lubricating the axle shaft and hub splines.

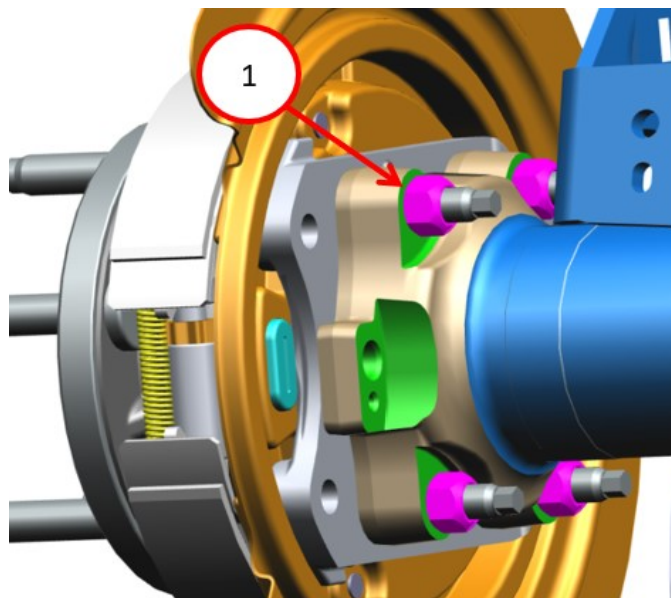
Fig. 1
Hub Nuts

1. Remove the brake caliper and rotor. Refer to the detailed service procedures available in DealerCONNECT/Service Library under: Service Info> Refer to 05 - Brakes, Base/Hydraulic/Mechanical/Rotor, Brake/Removal.
2. Remove the wheel speed sensor from the tube assembly. Refer to the detailed service procedures available in DealerCONNECT/Service Library under: Service Info> Refer to 05 - Brakes, ABS/Electrical/Sensor, Wheel Speed, Rear/Removal.
3. Disconnect the parking brake cable from the parking brake actuator at the backing plate.
4. Remove and **DISCARD** the four nuts [Fig. 1](#) from the hub assembly.

1 - Axle Housing

12. Install the axle shaft, hub and bearing assembly with backing plate onto the shaft then into the tube aligning the four hub studs ensuring the wheel speed sensor hole in the backing plate aligns with the wheel speed sensor hole/pad on the tube assembly.
13. Install four **NEW** hub nuts [Fig. 1](#) on the hub assembly.
14. Connect the parking brake cable from the parking brake actuator at the backing plate.
15. Install the wheel speed sensor from the hub. Refer to the detailed service procedures available in DealerCONNECT/Service Library under: Service Info> Refer to 05 - Brakes, ABS/Electrical/Sensor, Wheel Speed, Rear/Installation.
16. Install the brake caliper and rotor. Refer to the detailed service procedures available in DealerCONNECT/Service Library under: Service Info> Refer to 05 - Brakes, Base/Hydraulic/Mechanical/Rotor, Brake/Installation.

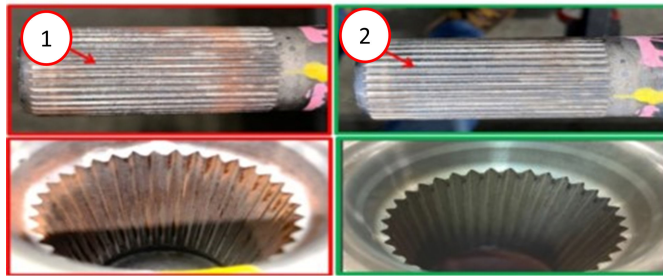
Fig. 2
Axle Shaft Splines/Hub Splines

- Using brake cleaner and a wire brush, clean both the interface of the shaft splines and hub splines to remove any of the “fretting/corrosion” seen on those splines [Fig. 2](#).

1 - Axle Shaft/Hub Splines Prior To Cleaning
2 - Axle Shaft/Hub Splines After Cleaning

NOTE: After cleaning the interface use forced air to remove any remaining debris on interface.

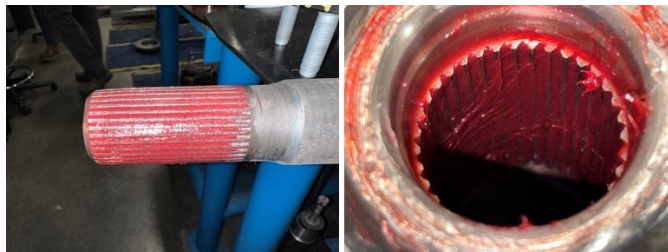
Fig. 3
Lubricated Axle Shaft/Hub splines

- Use wheel bearing grease to lubricate both the hub splines and the axle shaft splines. Ensure to coat the whole surface of the spline interface on the shaft and hub [Fig. 3](#).

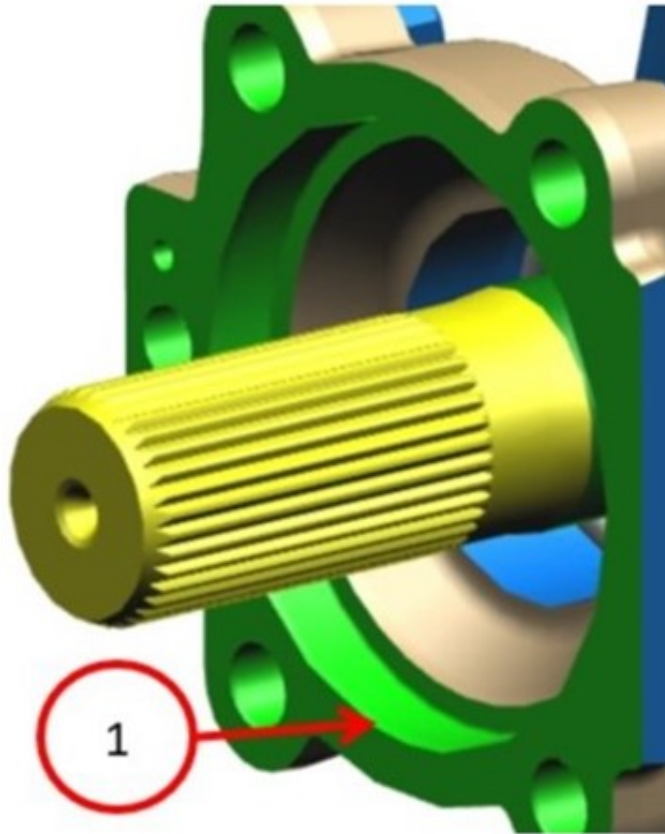
Fig. 4
Tube Flange Diameter To Lubricate

11. Lubricate the tube flange inside diameter with 75-85W sump lube as this aids in O-ring guidance [Fig. 4](#).

1 - Area To Apply Lubricant To The Tube Flange Surface
