WRN4 – Rework Drain Hose on Heating/Fresh-Air Unit (Workshop Campaign)

Model Line: **Taycan (Y1A / Y1B / Y1C)**

Model Year: **2025**

Concerns: **Water drain hose**

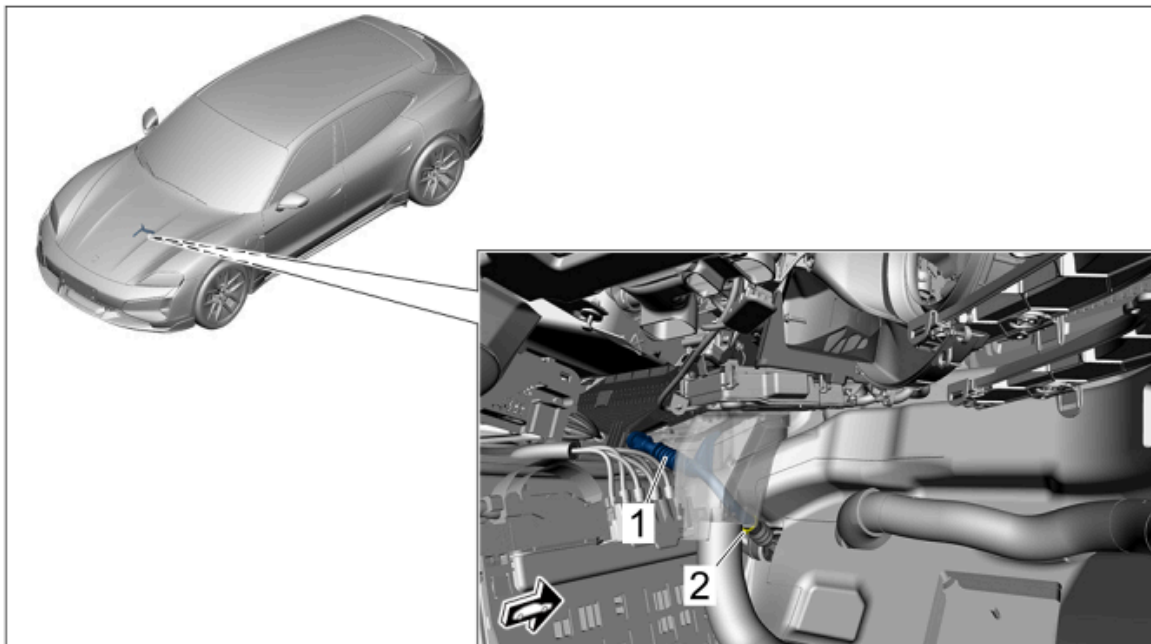
Water drain hose in the passenger compartment

- 1 – Water drain hose (**replace**)
- 2 – Hose clamp (**retrofit**)

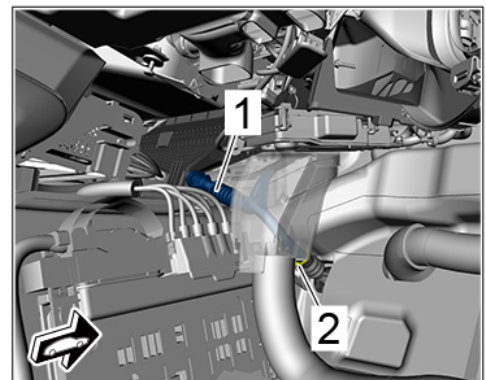
Exposed water drain hose

- Work Procedure: 1 Expose water drain hose ⇒ *Exposed water drain hose -1-* inside passenger compartment.
For procedure, see: ⇒ *Workshop Manual '852119 Remove and install water drain hose'*

The **removal of the anti-roll bar** is **not necessary** for the reworking of the water drain hose in the passenger compartment described in this technical information.

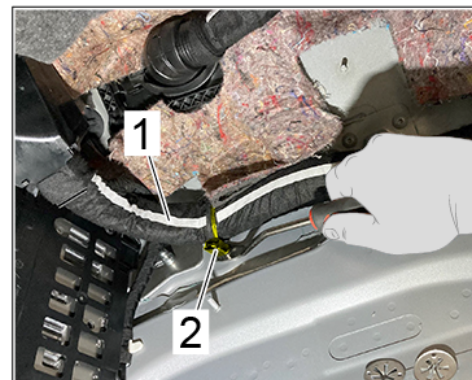
Disconnecting Wiring Harness

- 2 Wiring harness ⇒ *Disconnecting wiring harness -1-*
Carefully detach wiring harness duct ⇒ *Disconnect wiring harness -2-* . from retaining pin.

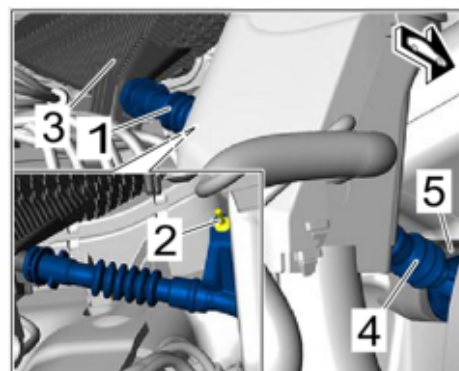
Water drain hose

- 3 Detach the drain hose on heating/fresh-air unit connection piece.
 - 3.1 Unclip ⇒ *Water drain hose -2-*.
 - 3.2 Pull water drain hose ⇒ *Water drain hose -1-* off connection piece for heating/fresh-air unit ⇒ *Water drain hose -3-*.

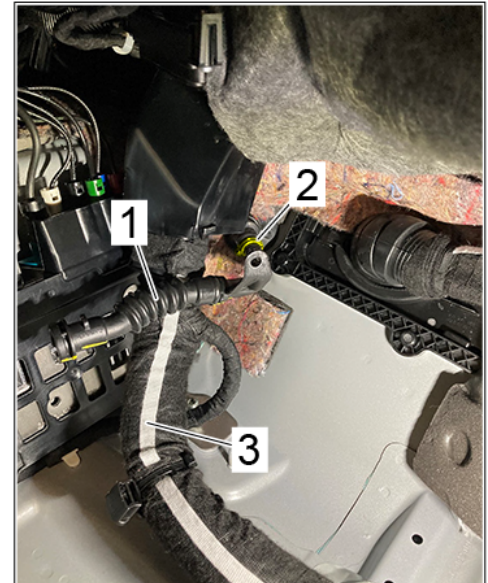
Exposed cable tie

- 4 Direct water drain hose ⇒ *Exposed cable tie -1-* under previously loosened wiring harness duct ⇒ *Exposed cable tie -3-* outside to gain access to the cable tie ⇒ *Exposed cable tie -2-*.
To do this, carefully lift the wiring harness duct upwards.

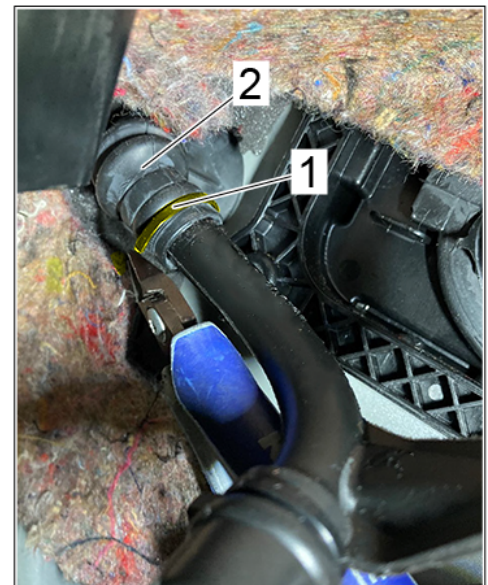
Water drain hose cable tie

- 5 Remove cable ties ⇒ *Water drain hose cable tie -1-* using a suitable tool and pull out water drain hose from rubber sleeve on bulkhead, ⇒ *Exposed cable tie -2-* dispose of the old water drain hose.
When pulling out, make sure that the rubber sleeve on the bulkhead is ⇒ *Water drain hose cable tie -2-* not pulled out of the bulkhead or damaged.

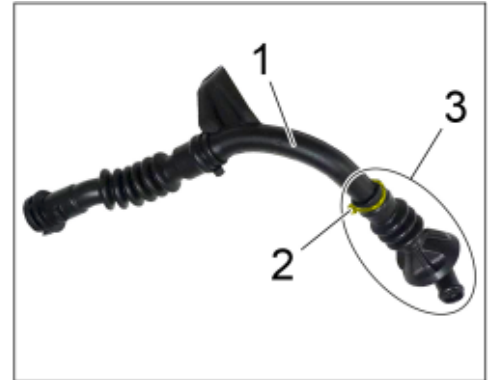
New water drain hose

- 6 Prepare **new** water drain hose ⇒ *New water drain hose -1-*.

- 6.1 Remove cable ties ⇒ *New water drain hose -2-* using a suitable tool and pull the bulkhead rubber sleeve ⇒ *New water drain hose -3-* off the water drain hose. Dispose of the rubber sleeve of the new water drain hose.

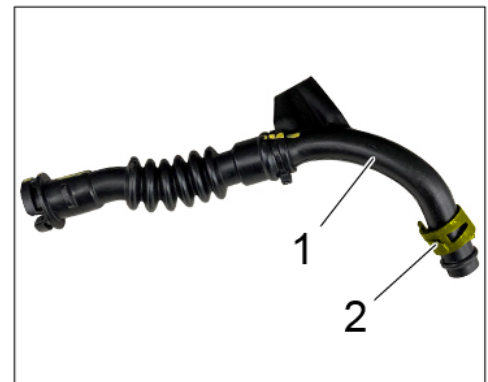
Hose clamp installed

- 6.2 Install the water drain hose ⇒ *Hose clamp installed -1-* with a **new** hose clamp ⇒ *Hose clamp installed -2-*.

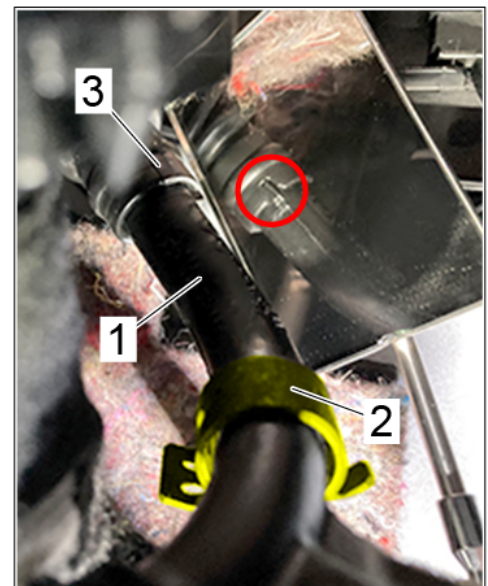
Position of water hose in rubber sleeve

- 7 Insert and position water drain hose ⇒ *Position of water hose in rubber sleeve -1-* with a new hose clamp ⇒ *Position of water hose in rubber sleeve -2-* in bulkhead rubber sleeve remaining in the vehicle ⇒ *Position of water hose in rubber sleeve -3-*. Using a mirror, check that the guide nose of the water drain hose is in the hole in the rubber sleeve on the bulkhead. ⇒ *Position of water hose in rubber sleeve -Circle-*

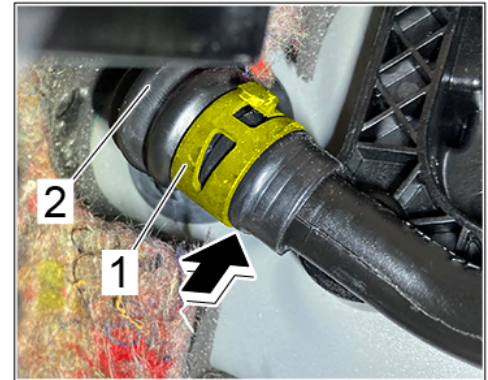
Hose clamp installed

- 8 Attach hose clamp ⇒ *Hose clamp installed -1-* with **spring band clamp plier** to the rubber sleeve on the bulkhead ⇒ *Hose clamp installed -2-*.
Make sure that the hose clamp is positioned behind the first raised section in the rubber sleeve. ⇒ *Hose clamp installed -Arrow-*

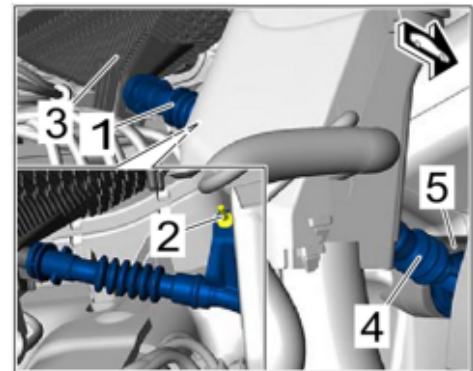
Water drain hose

- 9 Install the drain hose on heating/fresh-air unit connection piece.
- 9.1 Push the drain hose ⇒ *Water drain hose -1-* on heating/fresh-air unit connection piece ⇒ *Water drain hose -3-*.
- 9.2 Clip in clip ⇒ *Water drain hose -2-*.

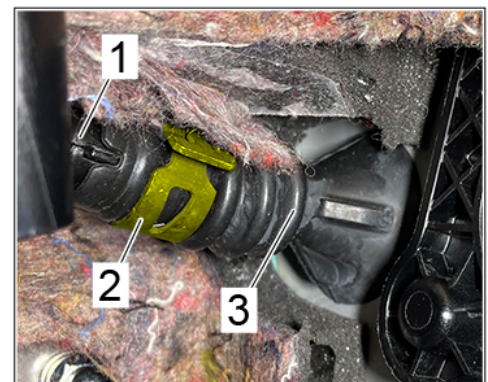
Correct installation of hose clamp

- 10 Check that the spring band clamp ⇒ *Correct installation of hose clamp -1-*, water drain hose ⇒ *Correct installation of hose clamp -2-* and rubber sleeve on the bulkhead ⇒ *Correct installation of hose clamp -3-* are installed correctly.
- 11 Check reworked hose connection for tightness.
- 11.1 Run air-conditioning system at full load (AC-MAX) for at least 15 minutes.
- 11.2 Check reworked hose connection for tightness.
- 12 Assemble passenger compartment.
For procedure, see: ⇒ *Workshop Manual '852119 Remove and install water drain hose'*
- 13 Connect and switch on the battery charger.
⇒ *Workshop Manual '270689 Charging battery/vehicle electrical system'*
