# Door Mirror Foot Light Projects Distorted Logo

| YEAR(S) | MODEL(S) | ADDITIONAL INFORMATION |
| 2018 - 2019 | C-HR | |

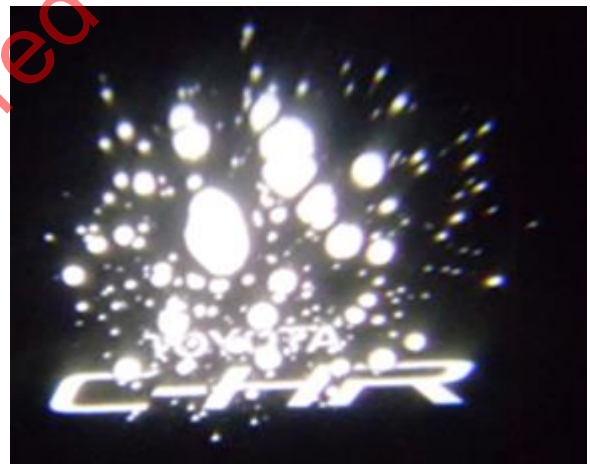
Figure 2. Not Good Condition

Some 2018 – 2019 model year C-HR vehicles may exhibit a condition where the door mirror foot light projects a distorted image of the C-HR logo onto the ground. Follow the Repair Procedure in this bulletin to address this condition.

ANY type of distortion in the image of the Toyota C-HR logo is NOT acceptable.

2. Remove the outer mirror lamp assembly.

3. Install the NEW outer mirror lamp assembly.

4. Confirm the C-HR logo projects correctly.
