SIB 01 11 25

N57T EGR COOLER / AUX EGR COOLER EXT LTD WTY (ELW) 25
YRS/NO MILEAGE LIMIT

Component-Specific Limited Emission Warranty Extension (ELW)

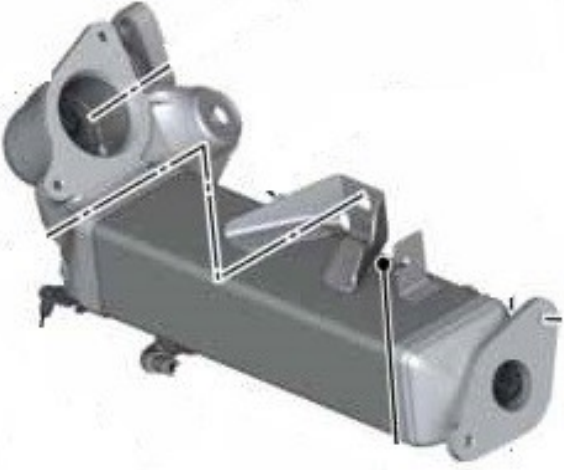
<p>For the eligible N57T diesel engine vehicles models, BMW of North America, LLC (BMW NA) is extending the limited warranty for these vehicle's Exhaust Gas Recirculation (EGR) Cooler together with the Intake Manifold replacement (Shown below) to:</p> <ul style="list-style-type: none"> • 25 years without mileage limit as determined by the vehicle's original in-service date.

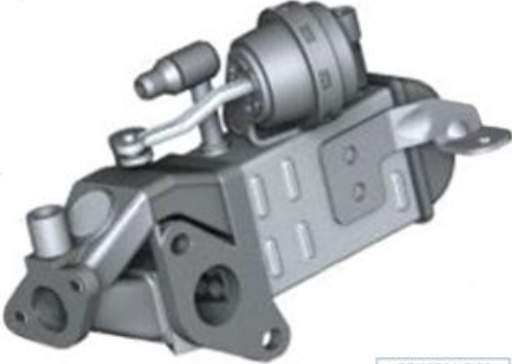
<p style="text-align: right; font-size: small;">GRUSB0117-30</p>	<p>Additionally, for the N57T, BMW NA is also extending the limited warranty for these vehicle's Auxiliary Exhaust Gas Recirculation (EGR) Cooler to:</p> <ul style="list-style-type: none"> • 25 years without mileage limit as determined by the vehicle's original in-service date. <p>Replacing the Auxiliary EGR Cooler, the EGR Cooler together with the Intake Manifold (Shown below).</p>
