## Technical Journal

**Wind Noise from Side Window**

<b>REF NO:</b> TJ 37421.1.0	<b>ISSUING DEPARTMENT:</b> Technical Service	<b>CAR MARKET:</b> United States and Canada	
<b>PARTNER:</b> 3 US 7515 Polestar		<b>ISSUE DATE:</b> 2025-07-03	<b>STATUS DATE:</b> 2025-07-18
<b>FUNC GROUP:</b> 8455	<b>FUNC DESC:</b> Guide moulding for door glass; sealing	Page 1 of 3

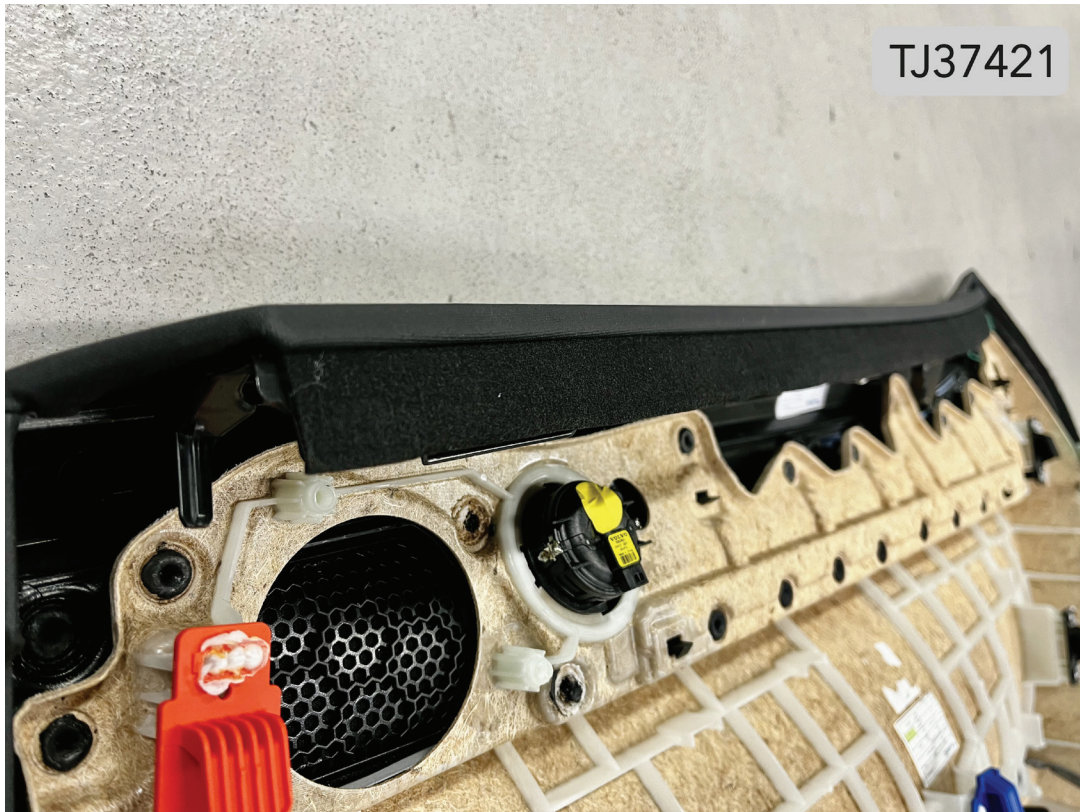
1. Apply tape to door panel (see attachment TJ37421\_1.JPG). Cut the tape to following dimensions: 25 mm wide and 690 mm long, ensuring it covers the entire panel lip.
2. Apply tape to the outer waist moulding against the glass (see attachment TJ37421\_2.JPG). Cut the tape to: 10 mm wide and 300 mm long. Apply with 2 layers. The tape should start approximately 300 mm from rear end (B pillar) and only cover the middle portion of the seal, not the entire moulding.
