## Technical Journal

Technical Journal Title Vehicle Fails to Charge on All AC and DC Chargers		Ref. No. TJ 37436.1.0	
Issuer (Dept.) Technical Service		Issue Date 7/10/25	Status Date 7/15/25
Car Market United States and Canada	Partner 3 US 7510 Volvo Car USA	Function Group 3234	
Function Description Onboard charger, high voltage		Page Page 1 of 3

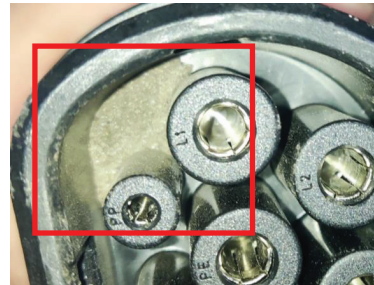
TJ 37436

1. The condition of the EVI for damage and/or foreign objects.
  - Sample images can be found on page 1 of the attached PDF file.
2. The connectors at the CDD: unplug, then plug them in again.
  - Relevant connectors are numbers 1, 2, 6, and 9 on the drawing on page 2 of the attached PDF file.

If no deviations are found at the EVI or the connectors at the CDD, continue fault tracing in VIDA.
