TECHNICAL SERVICE BULLETIN

Air Register Broken

25-2325

Ford 2021-2025 Bronco

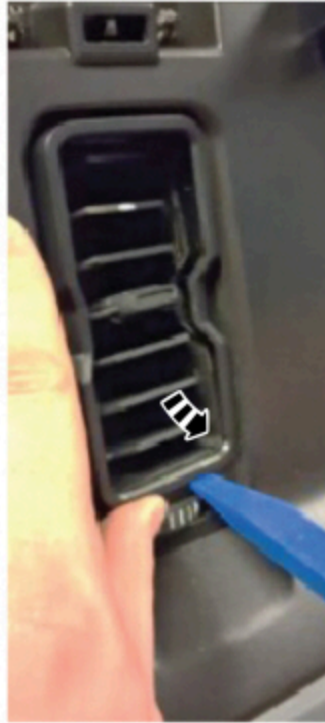
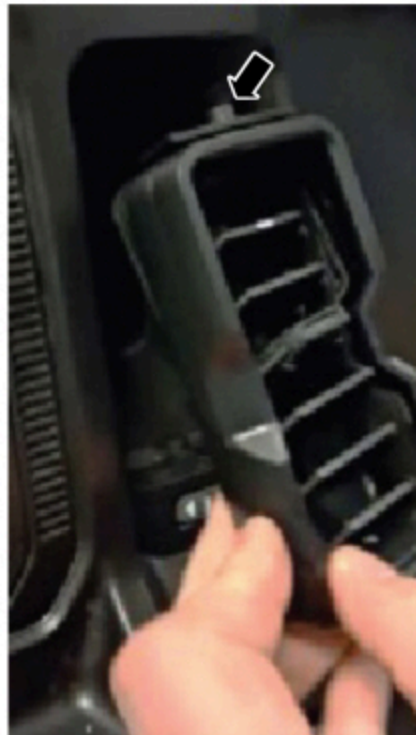
Figure 1

Issue: Some of the vehicles listed in the Model statement above may exhibit an air register that is broken or loose. This may be due to the register barrel detaching from the register assembly. Removal of the instrument panel is no longer required.

1. Use the interior trim remover tool to release the lower air register barrel clip and separate the existing air register barrel from the air register housing. (Figures 1-2)
