August 19, 2025

Misfire No. 4 Cylinder (DTC P0304)

Year	Model	Trim Level	VIN Range
2017-21	Civic	TYPE R	ALL

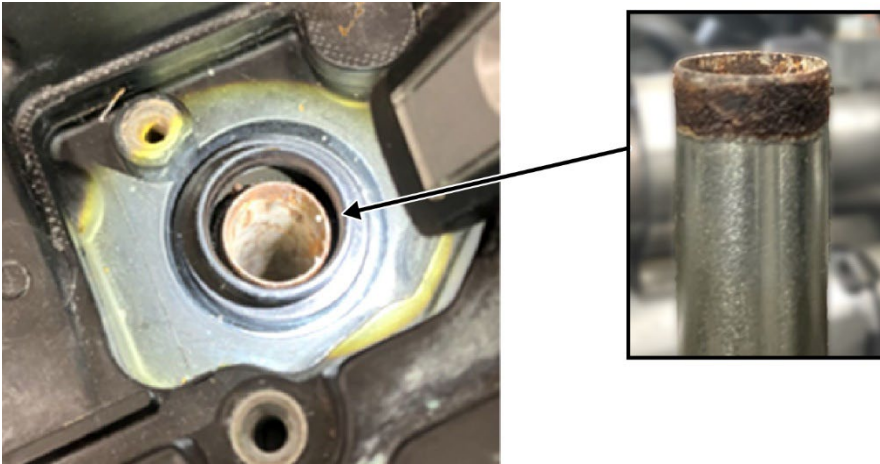
1. Connect HDS to the DLC. ([Click HERE](#))
2. Verify DTC P0304 is stored.
3. Remove the engine cover and remove the no. 4 ignition coil. ([Click HERE](#))
4. Inspect cylinder no. 4 spark plug tube, remove any residual water from the plug tube area.
5. Remove cylinder no. 4 spark plug and inspect for any corrosion on the plug.
6. Remove the remaining ignition coils.
7. Remove the cylinder head cover. ([Click HERE](#))
8. Inspect cylinder no. 4 ignition coil, plug tube, and spark plug of residual water and corrosion.

Are there any signs of water and/or corrosion on the ignition coil, plug tube, or spark plug?

Yes – Go to step 9.

No – This bulletin **does not apply**, continue with normal troubleshooting.

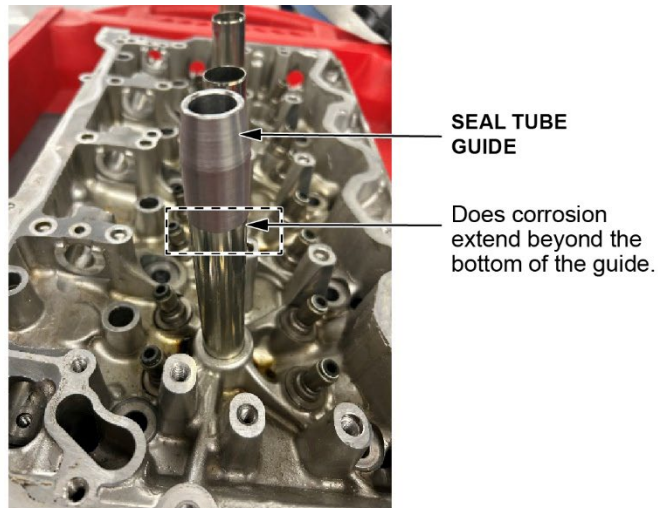
9. Place a clean shop towel around the bottom of the no. 4 spark plug tube, then clean the excessive rust and corrosion from the spark plug tube using a burgundy colored abrasive pad.
10. After cleaning the rust and corrosion:
 - Check the spark plug tube for small holes and/or cracks
 - Place the seal guide on to the no. 4 spark plug tube

Does the corrosion on the no. 4 spark plug tube exceed 12 mm or extend beyond the bottom of the seal tube guide?
Are there small holes and/or cracking in the tube?

Yes – Take a photo of the spark plug tube corrosion/hole(s)/crack(s), then proceed to **Repair Procedure B**.

No – Go to **Repair Procedure A**.

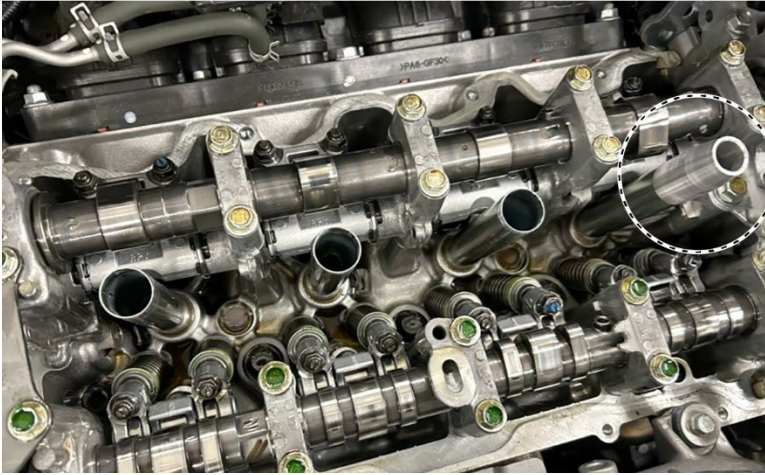
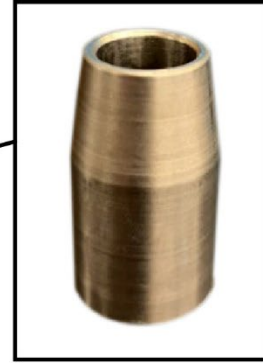
1. Install the seal tube guide tool on top of the clean no. 4 cylinder plug tube.

NOTE: Make sure the tapered end of the seal tube guide tool is pointing up.

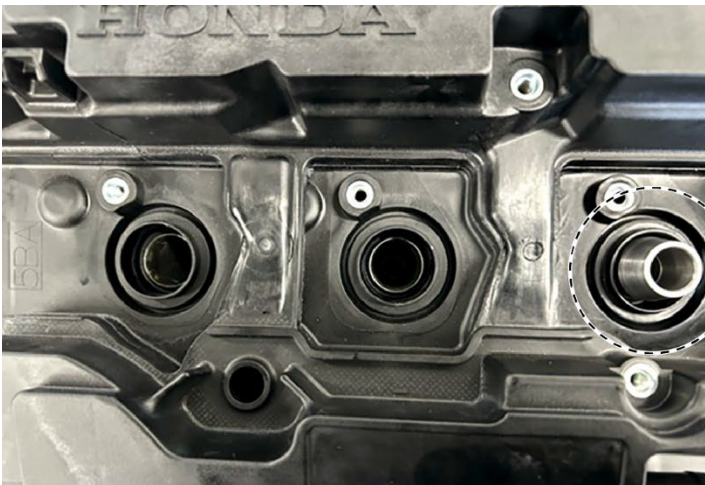
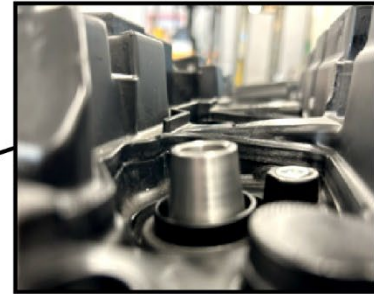
2. Apply a light coat of fresh engine oil to the new head cover plug seal, then carefully slide the head cover over the seal tube guide and onto the cylinder head.

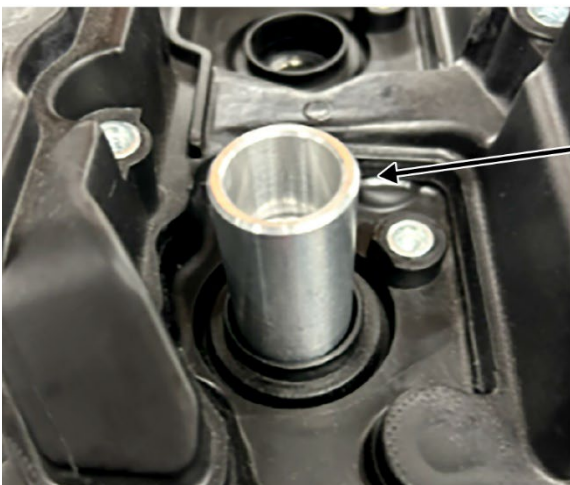
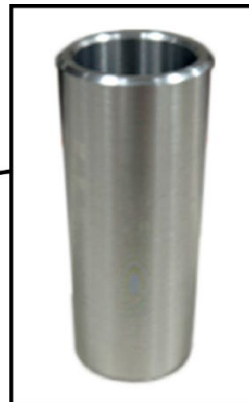
3. Set the seal tube setter tool in the head cover and on top of the seal tube guide. Make sure the plug tube is properly set in the cylinder head cover.
