| TSB # | TSB 25-03 | | |
| Description/Title: | Floor Model 17D Ceiling Light Dimmer Switch | | |
| Affected Product Line(s): | MY 2025-26 Coleman Van & Freedom Elite Van | | |

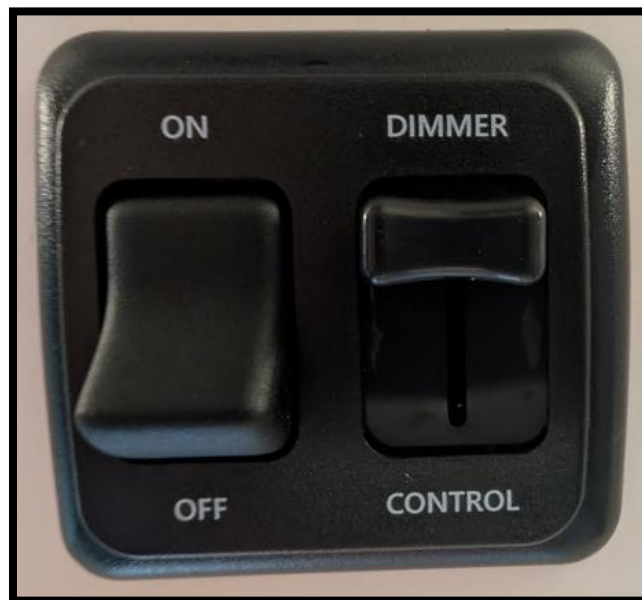
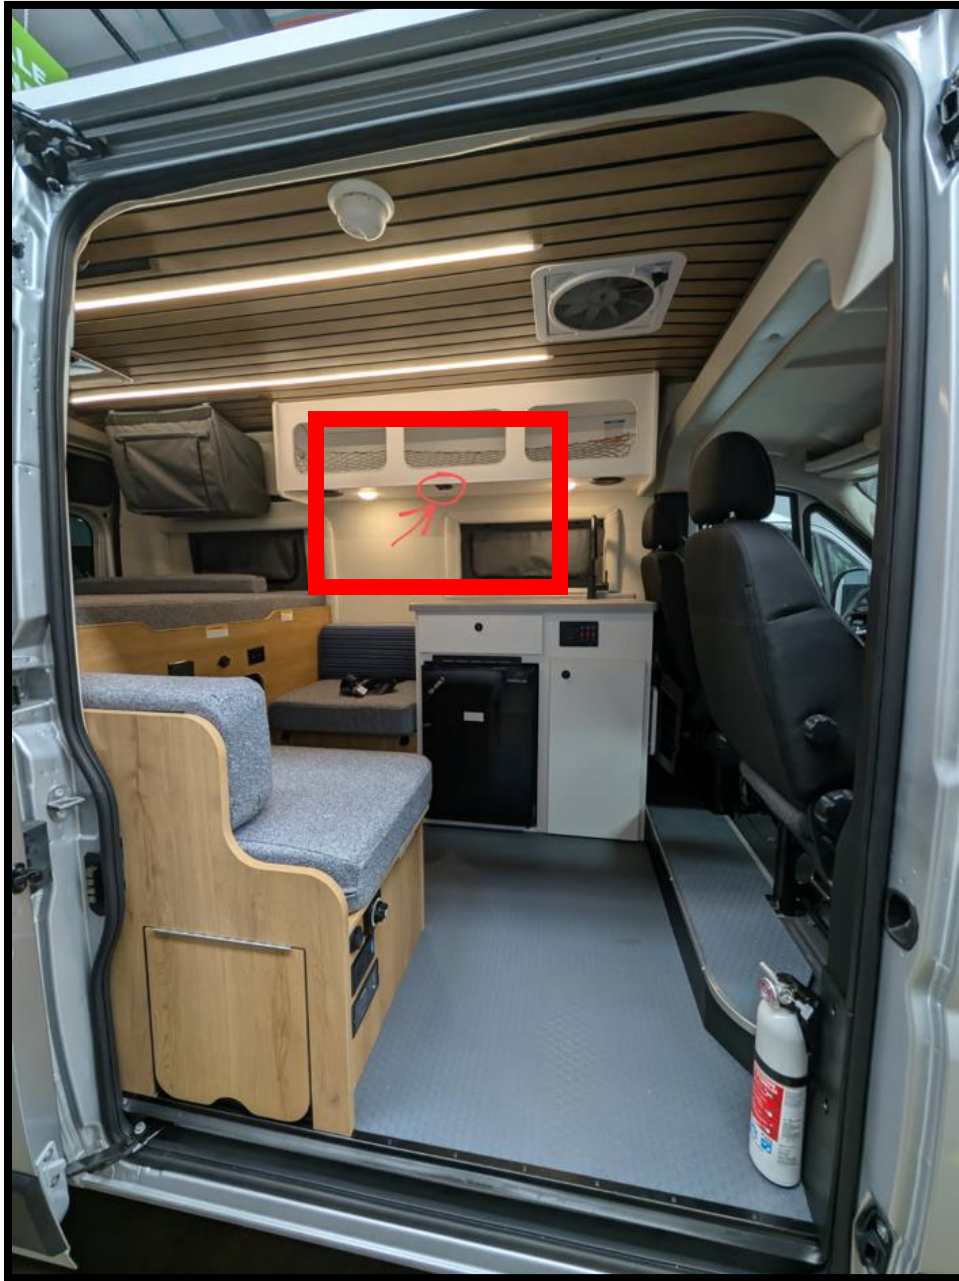
1. Locate the ceiling light switch with dimmer under the cabinet.

2. Remove the trim cover around the switch/dimmer and unscrew from the cabinet.
3. Expose the wiring behind the switch locating the butt-connectors.

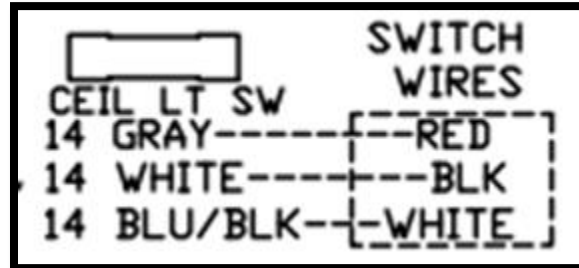
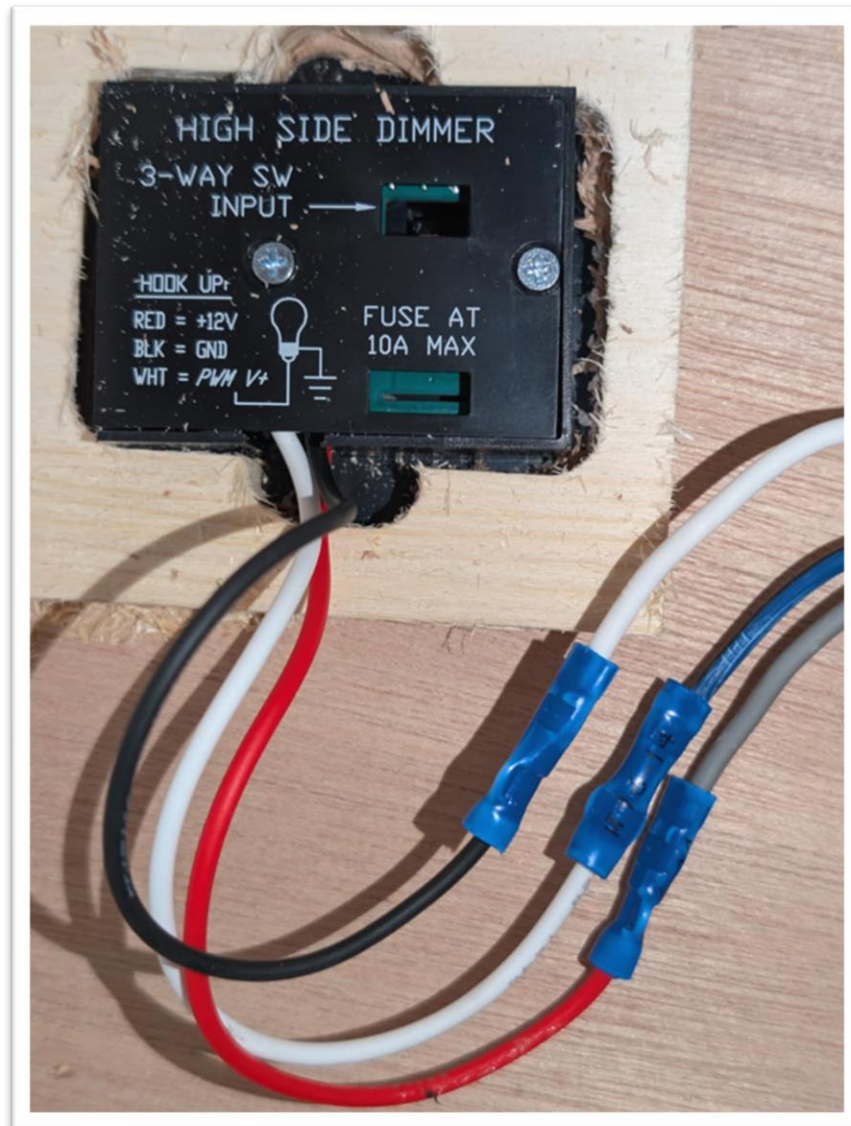
It has been discovered the dimmer switch for the ceiling light is wired incorrectly. The light will turn on/off, but the dimming feature does not operate.

4. The Red and White wires on the dimmer switch will need to be cut and swapped so the colors match up to the diagram. Use new butt-connectors to secure the wiring.
