Field campaign

Topic	Front Airspring - Retaining ring check Continental GT/GTC/Flying Spur 25MY (SC25 /35)
Market area	Bentley: worldwide (2WBE),China 796 VW Import Comp. Ltd (Vico), Beijing (6796)
Brand	Bentley
Transaction No.	2078462/1
Campaign number	ED63
Note	
Type	
US code

25MY Continental GT/GTC and Flying Spur

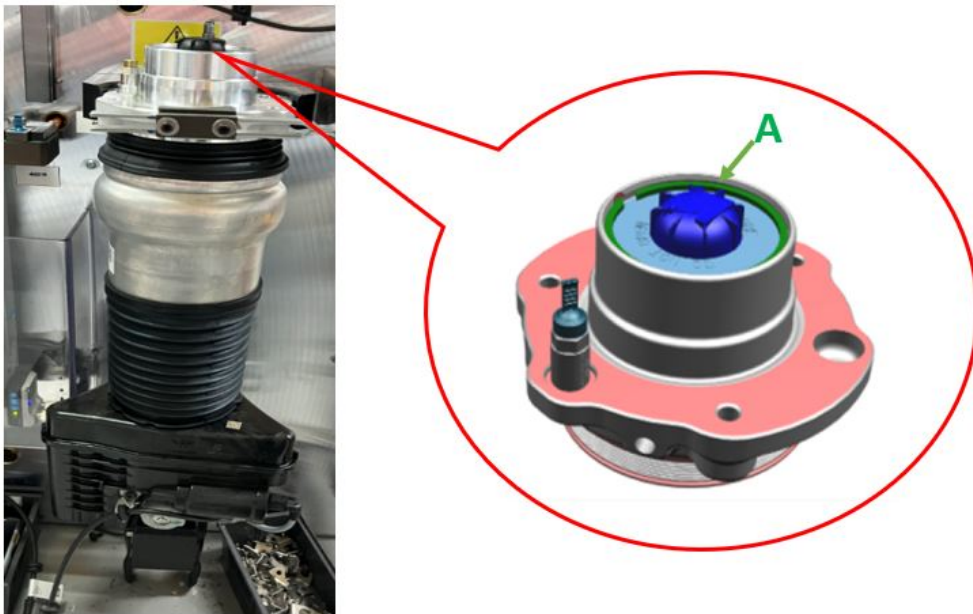
Figure 1. Front Air spring damper Retaining Ring location

The retaining ring on the front air spring dampers may not be correctly seated on select vehicles. If incorrectly seated, it can cause the retaining ring on the top of the air spring damper to come loose and release the air in the air spring. As a result the driving characteristics of the vehicle can be adversely affected but full and stable handling of the vehicle is retained in such a situation.

This campaign requires the inspection of the retaining ring 'A' shown below, and if it is not correctly fitted, the affected air spring damper must be replaced to ensure correct operation of the vehicle.

Inspect the retaining ring on the top mount of the front air spring dampers on both sides of the vehicle using the designated check tool.

If the tool fits inside the retaining ring it is correctly seated, no further action is required.

If the tool does not fit inside the retaining ring it is not correctly seated, replace the air spring damper assembly on the affected side(s).

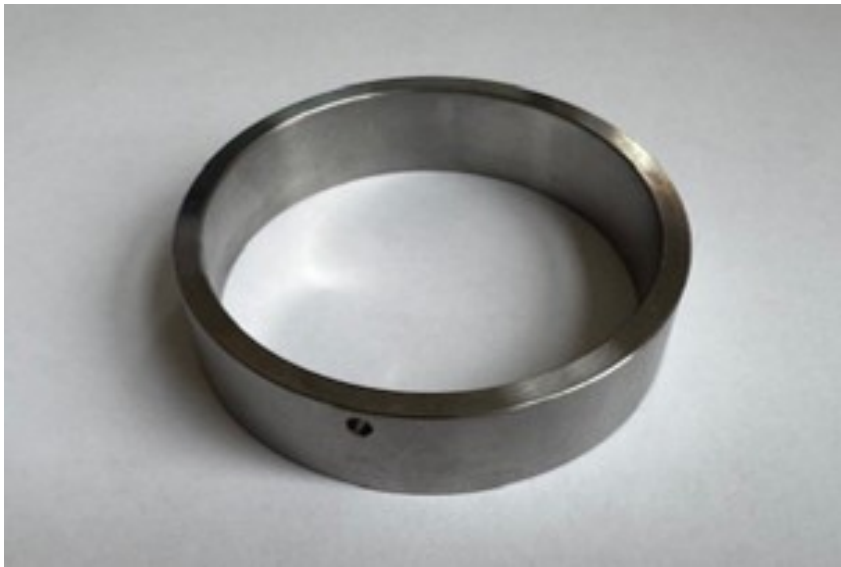
Figure 2. Specialist check tool (WT10711)

A specialist check tool (WT10711) will be automatically issued and supplied directly to retailers. All retailers will receive 1x WT10711. This tool will be used in accordance with the procedure outlined in the measure section.

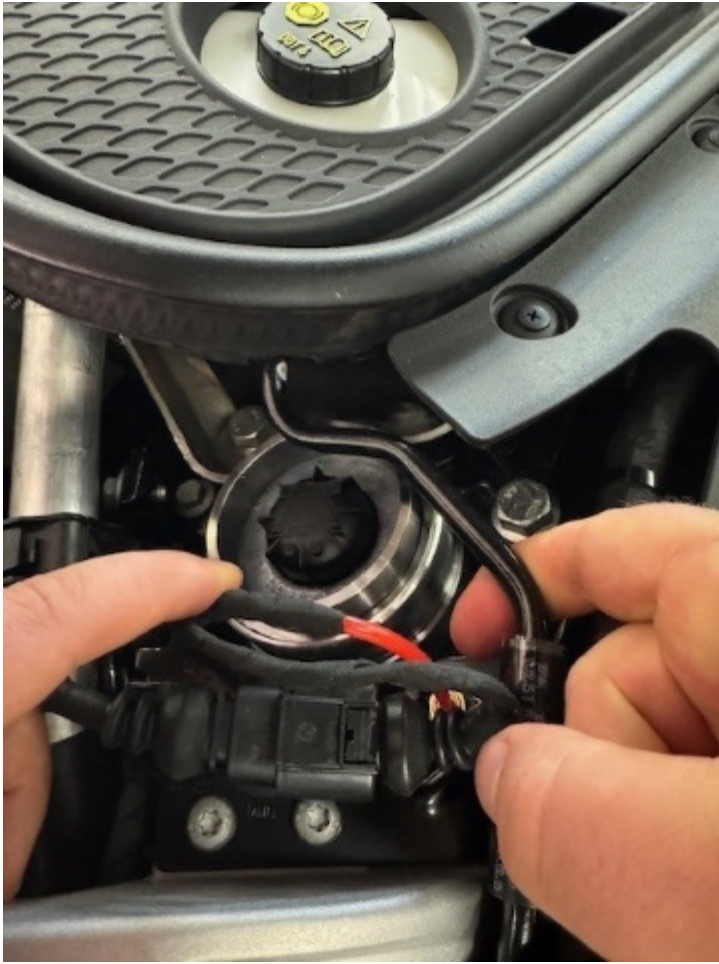
Figure 3. Check tool to air spring damper top mount fitment example

3. Carefully insert the check tool onto the air spring damper top mount as shown in figure 3.

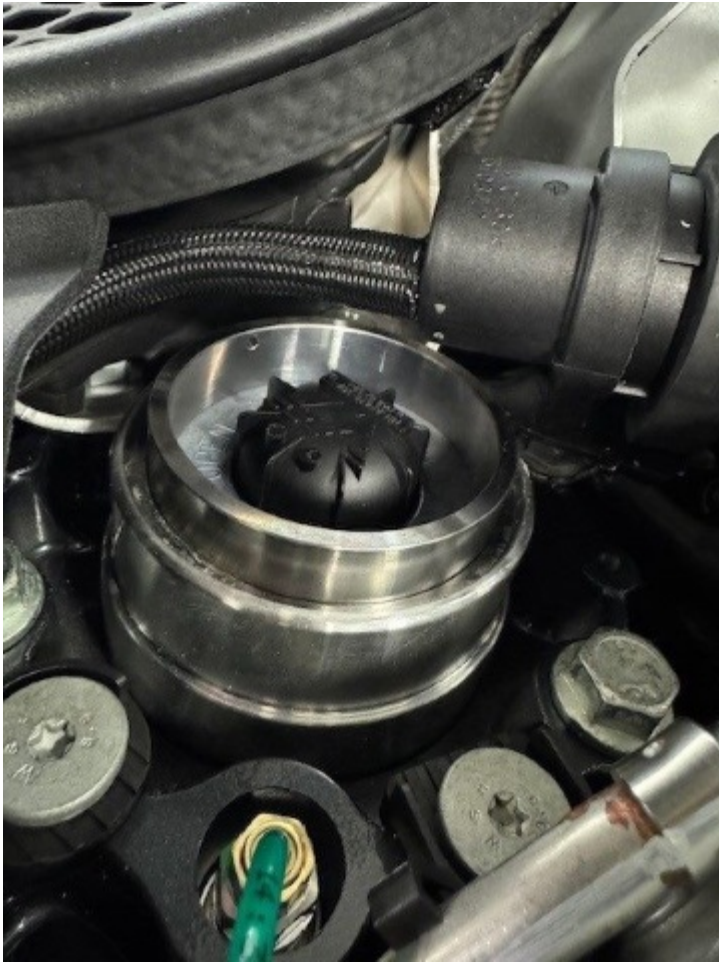
Figure 4. *OK check tool fitment*

4. Verify the check tool is fully seating inside the retaining ring as shown in figure 4.

5. If the check tool sits flush without obstruction, the retaining ring is correctly installed. No further Action is necessary. Reinstall any removed trim and refer to the Identification section.

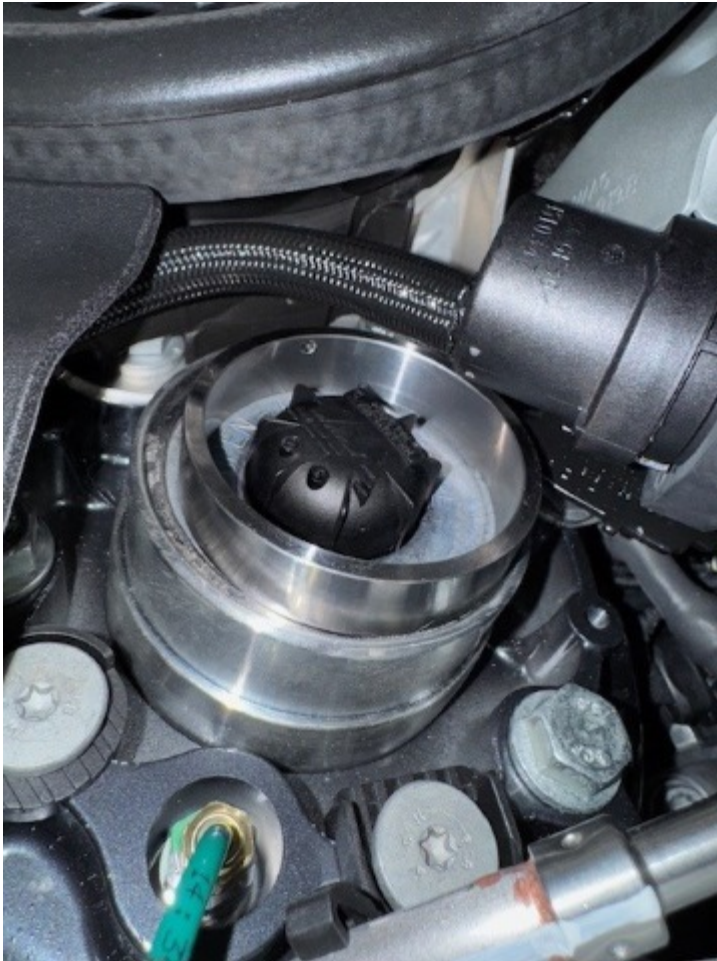
Figure 5. NOK check tool fitment

6. If the check tool is obstructed and does not fit inside the retaining ring as shown in figure 5.

If retaining ring condition is confirmed as NOT OK as per figure 5, a Technical DISS query must be raised, including photographic evidence clearly showing the failure. Once the DISS query is validated, the supply of replacement parts will be authorised.

- Position the vehicle on a ramp and set to "JACK" mode. Refer to "Raising and supporting the car" ElsaPro → Booklet 404
- Discharge the air suspension system. Refer to ElsaPro Repair Group 43 "Air suspension system - To discharge and charge"
- Replace the affected front air spring damper. Refer to ElsaPro, Repair Group 40 'Front air spring damper – To remove and fit'.

If the fault is on a vehicle with a mileage/km of more than 6,214 mls/ 10,000 km on the affected side, both air spring dampers must be replaced.

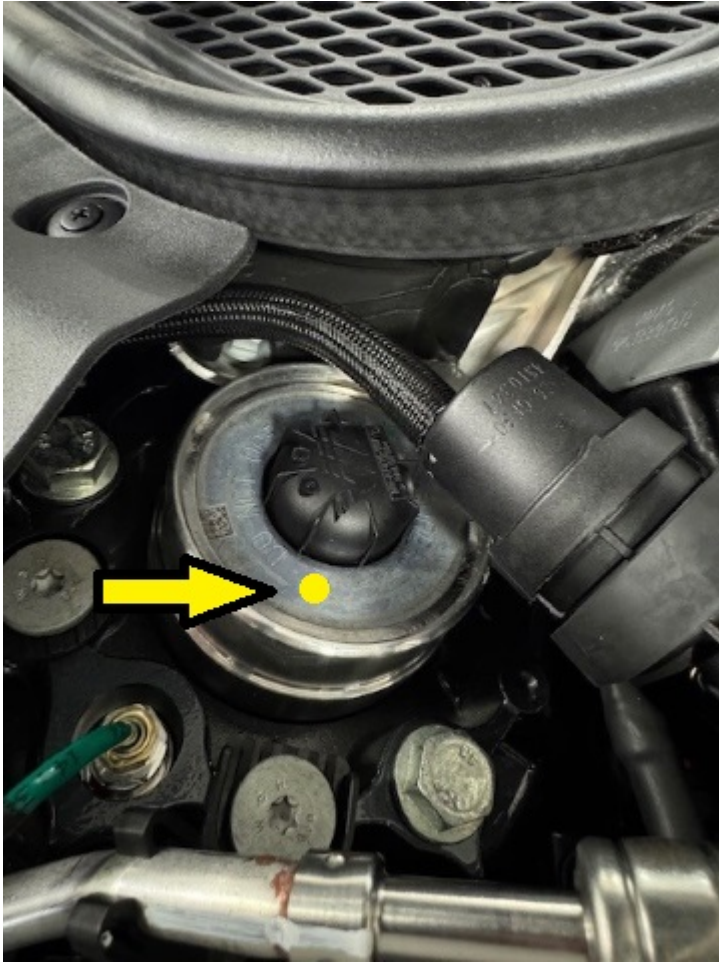
You must also add a yellow paint mark to both checked air spring dampers as per the image below.
