Preview Solution CBR-2487-1

## Volvo Chassis - Hood Crack Near Headlamp - Model VN (4)

Published 5 August 2025

Purpose of this CBR is to address the issue with hoods cracking at the headlight.

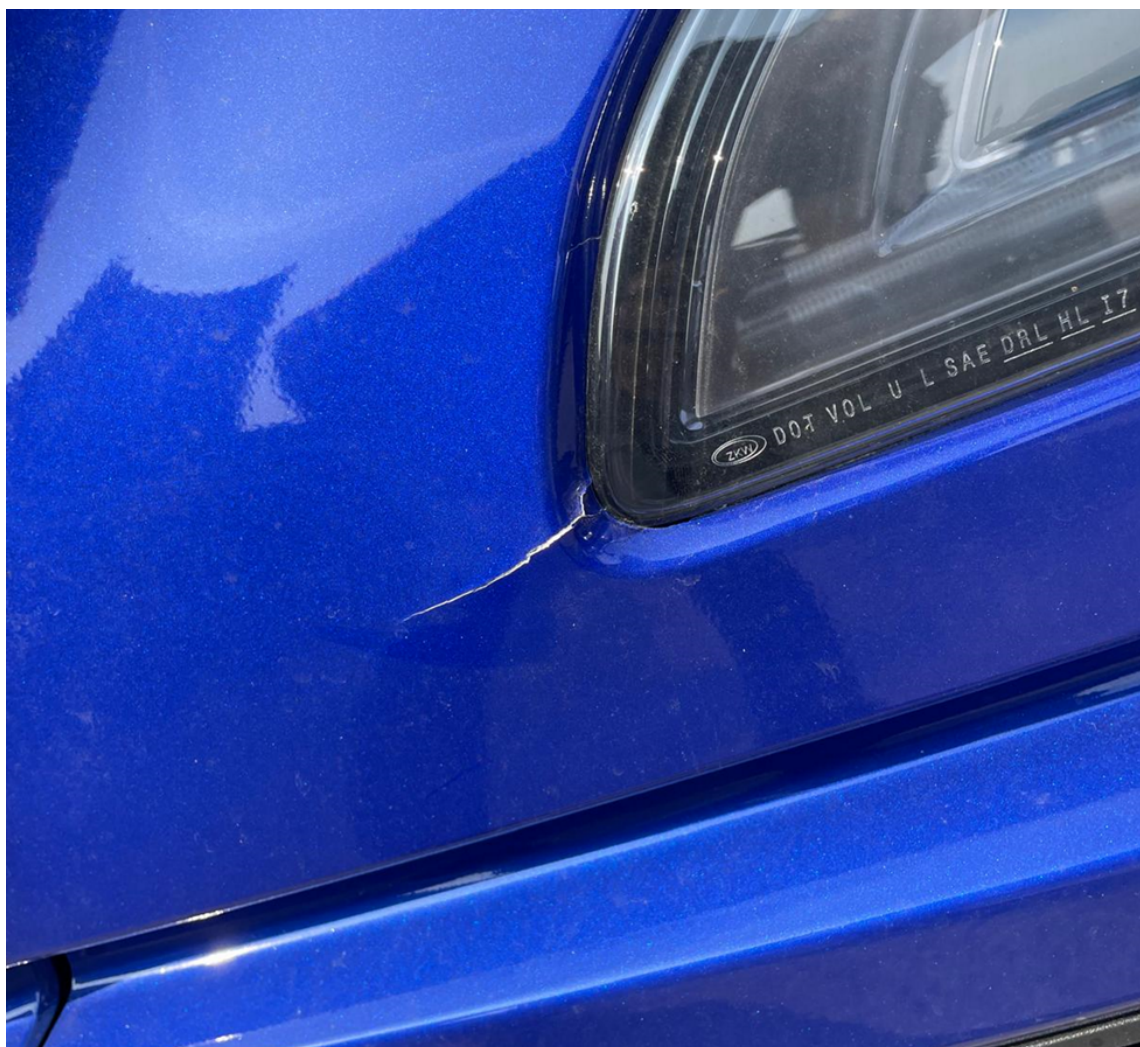
Headlight mounting is causing too much pressure on the inner corner on the driver side, causing hood to crack.

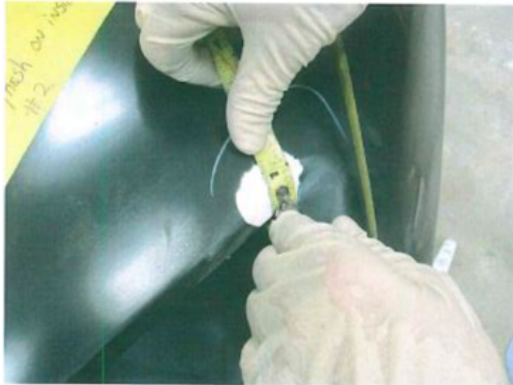
Measure crack

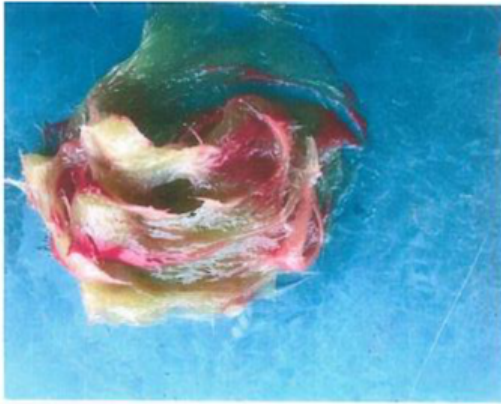
Appearance of incorrect Fibral mix

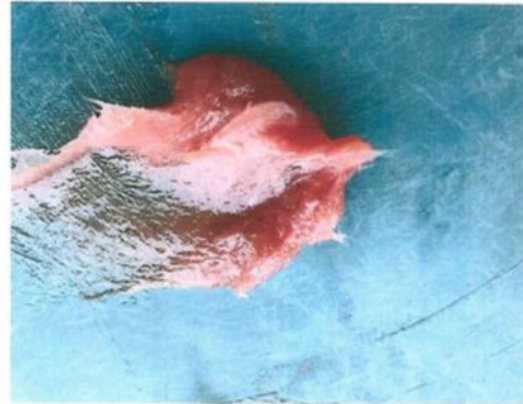
Appearance of correct Fibral mix

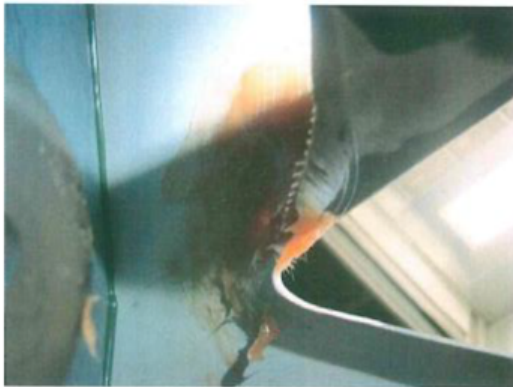
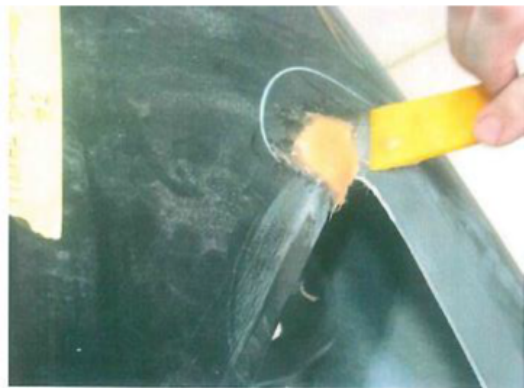
Fibril applied
