Preview Solution CBR-2489-1

## Volvo Chassis - Water found near the top of the engine tunnel and/or the floor board - VN (4)

Volvo Chassis - VN (4)

Model Year - 2025 to Current.

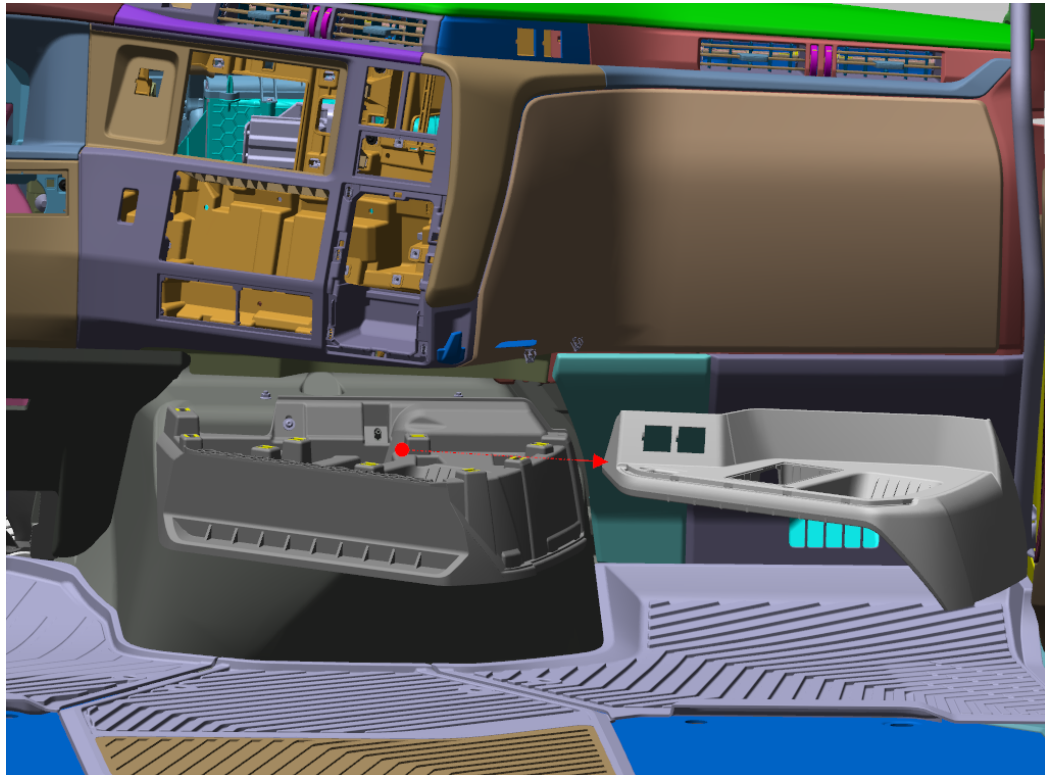
1. Remove Kick panels next to dog box.
2. Remove rubber pad on top of cup holder.
3. Remove top trim cover on cup holder. This cover is just held with clips.

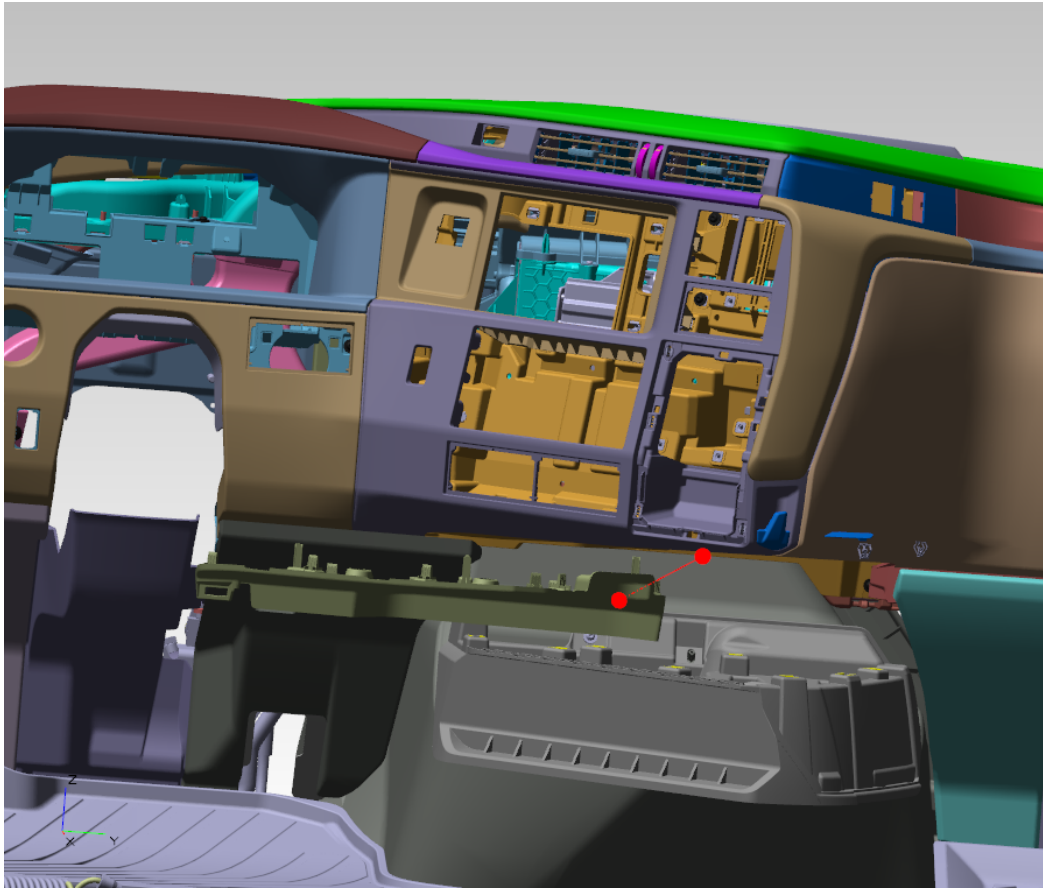
4. Remove trim panel under dash that is above cup holder. This trim panel is held by clips.

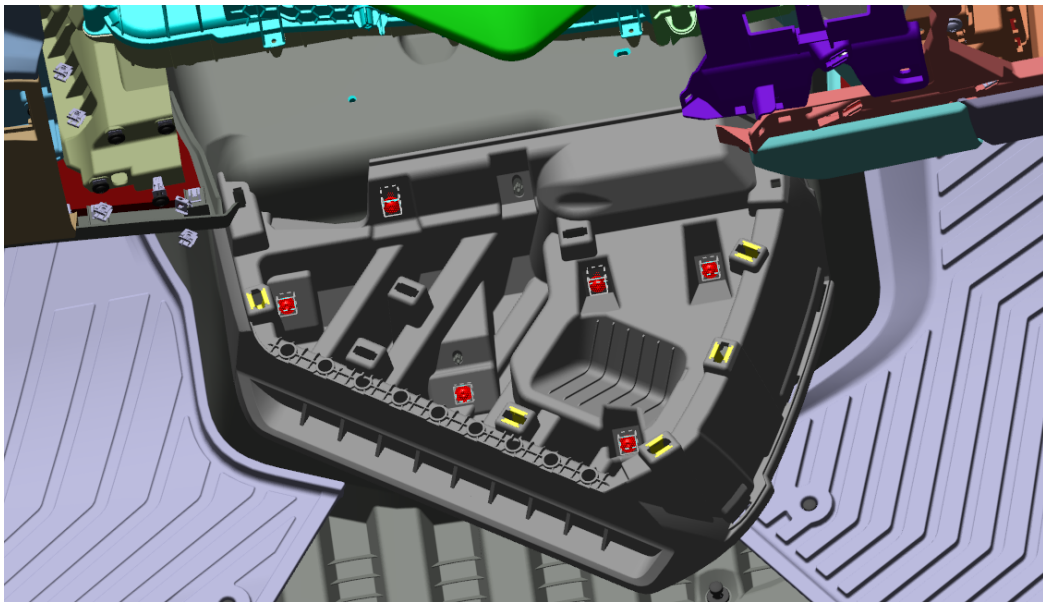
5. Remove the 6 T25 screws in lower cup holder assembly

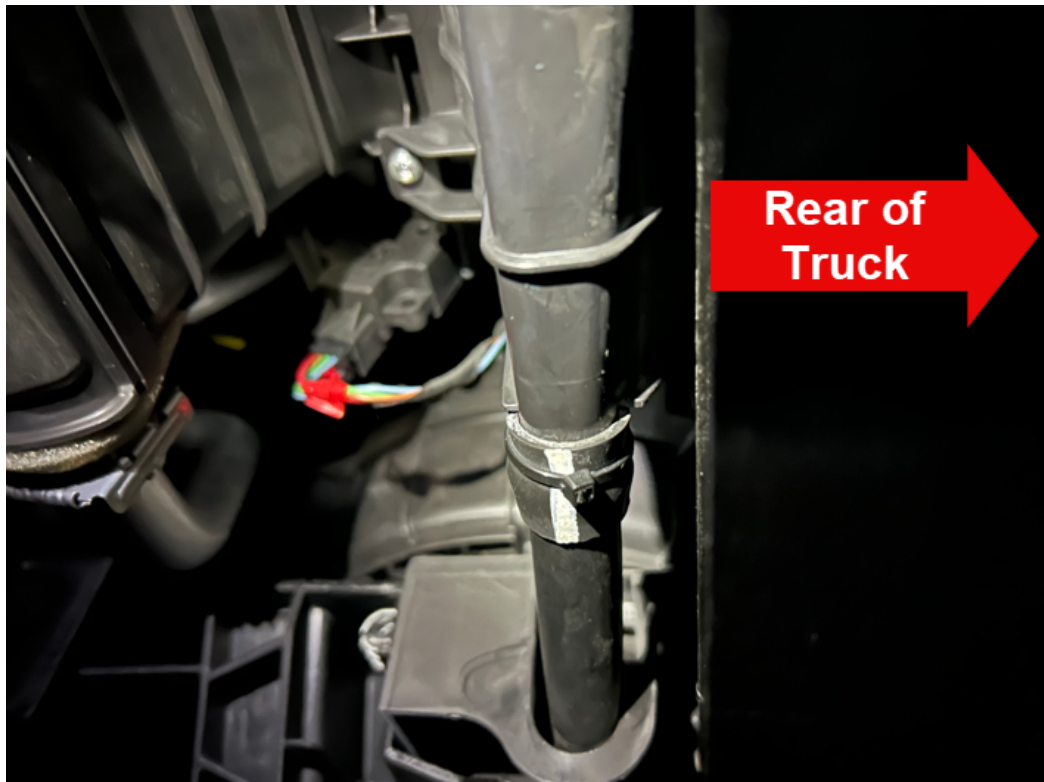
The purpose of this CBR is to address reports of water pooling on top of engine tunnel and/or the floor board of the cab. Volvo trucks has identified a issue with the drain pipe from **Heating, Ventilation and Air Conditioning (HVAC) box**.

6. Remove lower cup holder.
7. Locate HVAC box with drain hose.

8. Cut zip tie and remove hose from HVAC box.
  9. Apply a thin layer of RTV silicone to the HVAC drain outlet.
  10. Reinstall HVAC hose and zip tie behind barb.
- Note: Please follow instructions on drying time with RTV you use.
11. Reinstall all trim parts removed.
  12. Return truck to service
