GROUP	MODEL
<b>Voluntary Service Campaign</b>	<b>2014-2019MY Soul (PS)</b>
NUMBER	DATE
<b>SC334 (Rev 1, 08/20/2025)</b>	<b>June 2025</b>

# UNDERBODY INSPECTION & ANTI-CORROSION MATERIAL APPLICATION (SC334)

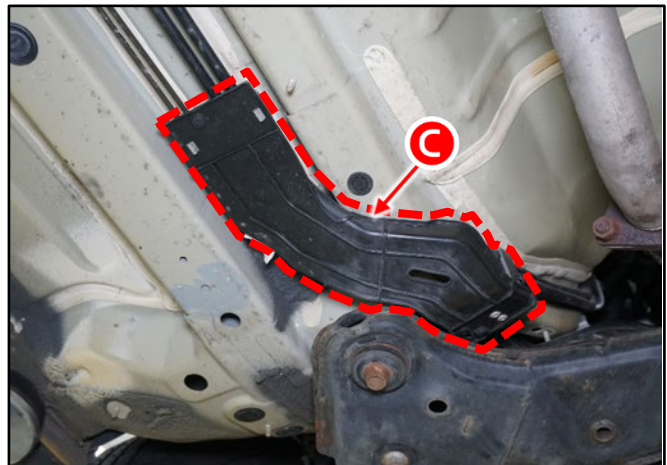
3. Remove the protection cover (C).

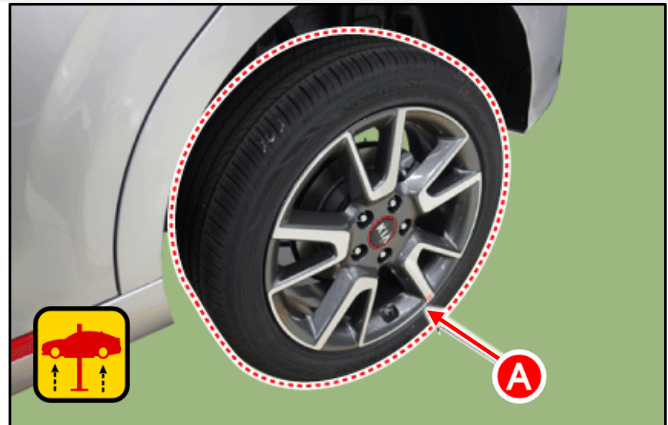
1. Remove both left and right rear wheels (A).

Tightening torque for lug nuts:  
65.1 - 79.6 lb.ft (88.3 - 107.9 N.m)

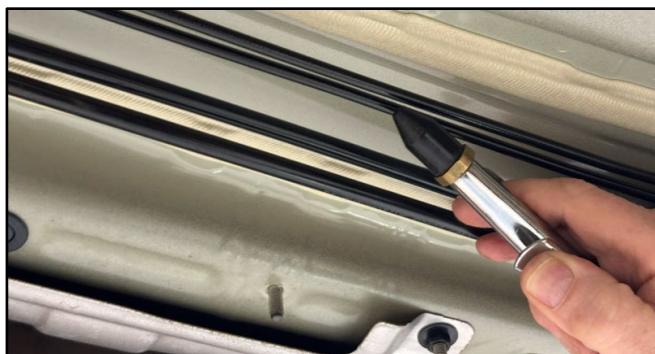
- 1a.
  - If the brake lines are NOT being replaced, remove any rust scales or contaminants from the brake lines then proceed to step 1c.

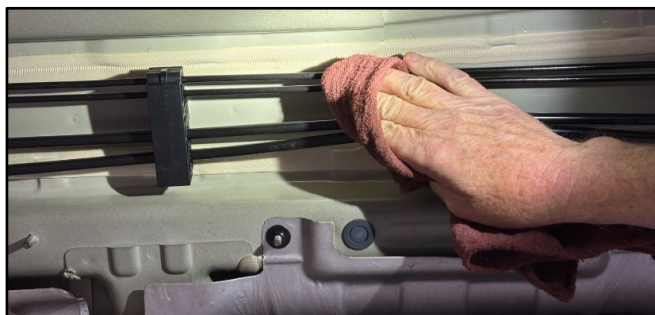
- 1c. Use an air gun to blow compressed air over the brake lines and thoroughly wipe clean with a clean rag/cloth.

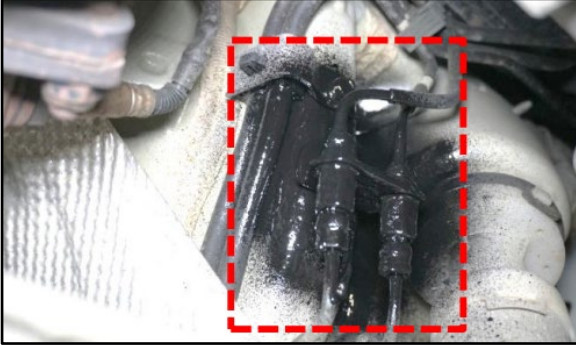
Two-Way Brake Tube Connector

3. Spray a heavy coat of the undercoating spray (PN UM010 CH044) on the Two-Way Brake Tube Connectors, Flexible Brake Hoses, and the entire length of the Brake Lines.
