## SERVICE ACTION

Global Service Action  
Number: N935

<b>Subject:</b>  <b>Incorrect Emissions Label Installed</b>	Publication No.: N935
	Model: Discovery (LR)
	Model Year: 2025
	Date of Issue: 26 August 2025

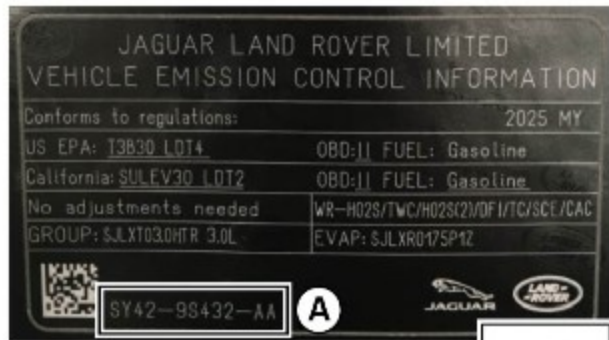
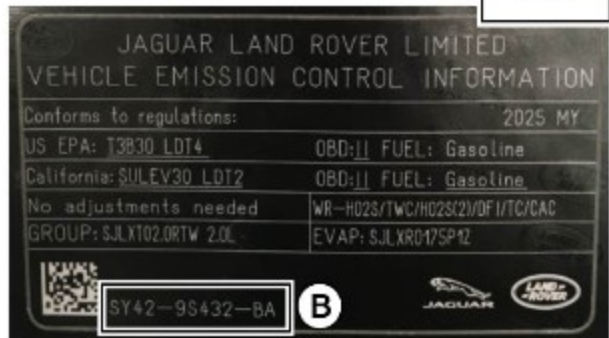
E350137

1. The image shows the location of the emissions label part number.

2. The table below shows the new emissions label part number that must be installed according to the vehicle engine derivative and original label part number.

Engine Derivative	Illustrated Label Part Number Location	Original Label Part Number	New Label Part Number
INGENIUM I6 3.0L Petrol	A	SY42-9S432-AA	SY42-9S432-AB
INGENIUM I4 2.0L Petrol	B	SY42-9S432-BA	SY42-9S432-BB

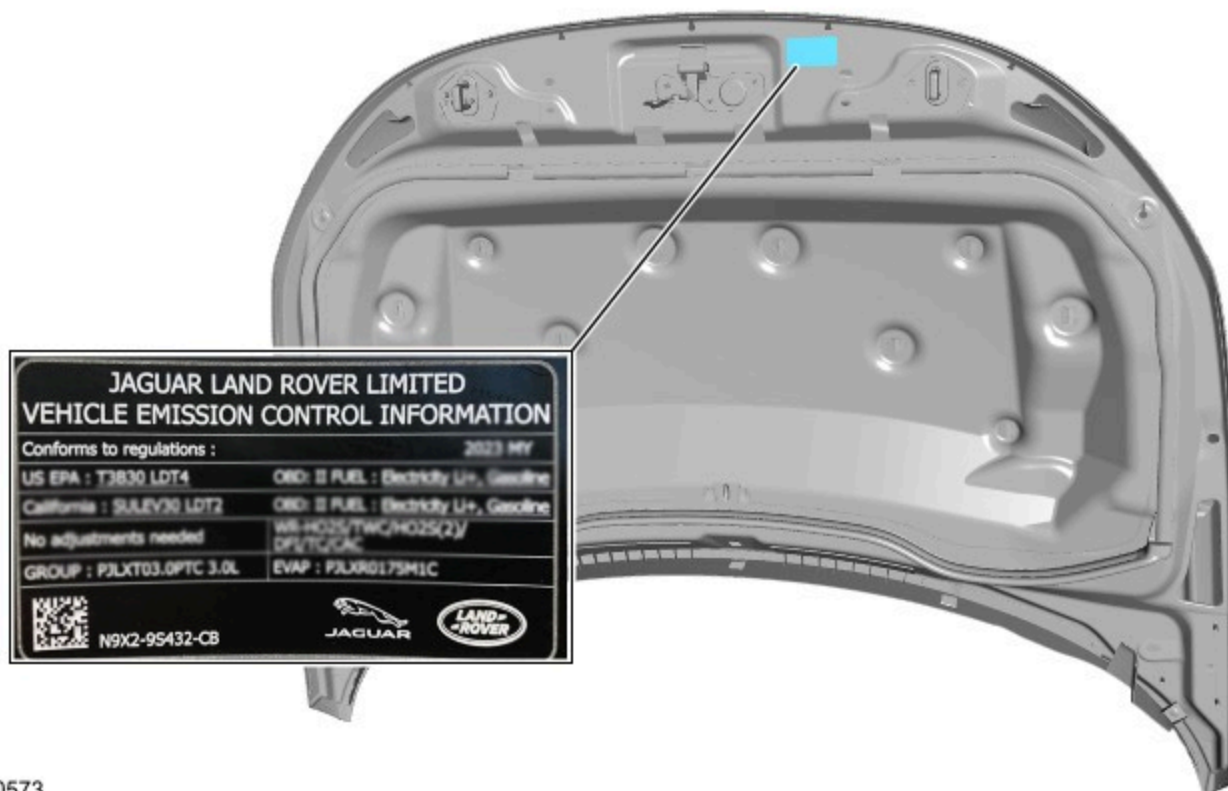
E370573

- The emissions label part number differs dependant on the vehicle engine derivative.
- The new emissions label must be installed in the same position as the previous emissions label.
- Apply a small amount of heat to the emissions label to aid the removal of the label.

Remove and discard the emissions label.

- Clean the surrounding area.
- Remove the adhesive backing from the new emissions label
- Install the new emissions label.
  - Refer to the table in the Service Information section to identify the correct label to be installed.
