Title: Electric Vehicle Air Dryer Operation

Applies To: IC Bus® Electric CE Series, International® eMV™ Series

This document will guide the user through proper operation of the air dryer and known concerns with the system.

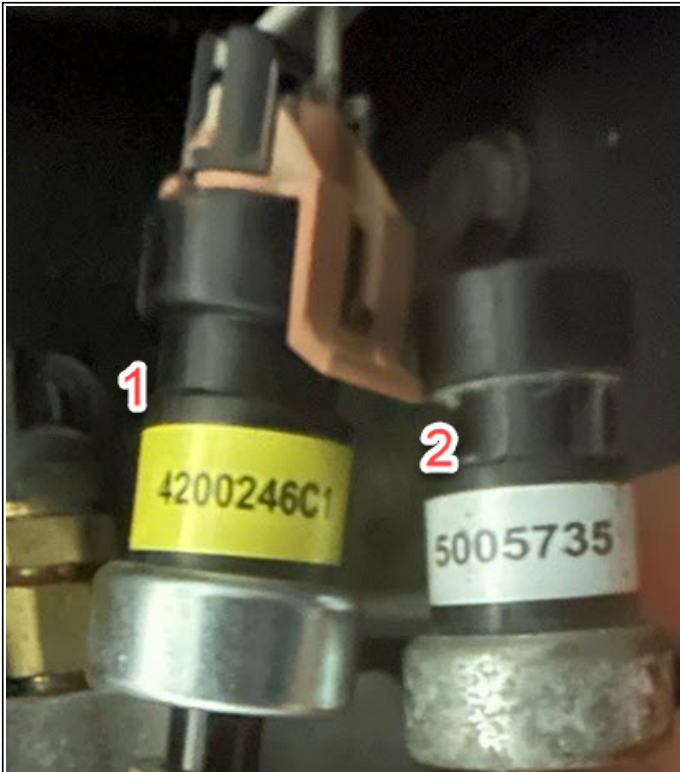
**Figure 1: Air Dryer Switch Comparison**

Item 1: Correct Sensor, Yellow Label  
Item 2: Incorrect Sensor, White Label

| Kit Description | Part Number | Quantity Required | Notes |
|---|---|---|---|
| Switch, sensor, pressure switch | 4200246C1 | 1 | Yellow label, normally closed |

| Step | Action | Decision |
|---|---|---|
| 2 | <p><b>DIAGNOSTIC:</b></p> <p>Does the air dryer purge, but develops a constant air leak at the purge valve.</p> | <p><b>Yes.</b> Inspect the governor pressure switch and verify the correct sensor is installed.</p> <p>Incorrect sensor will have a white label, with PN 5005735 printed on it.</p> <p>Correct sensor will have a yellow label, with PN4200246C1 printed on it.</p> <p>Install correct sensor and retest. (refer to <b>Figure 1</b> below)</p> <p>If constant air leak is still present please proceed to step 3.</p> <p><b>No.</b> No further action is needed, return vehicle back to service.</p> |
