## PHEV GEN4 INVERTER MISSING COVER SERIAL NUMBER INSPECTION AND HANDLING GUIDANCE

SSM 76373

- 24-25MY Range Rover -PHEV
- 24-25MY RR Sport - PHEV

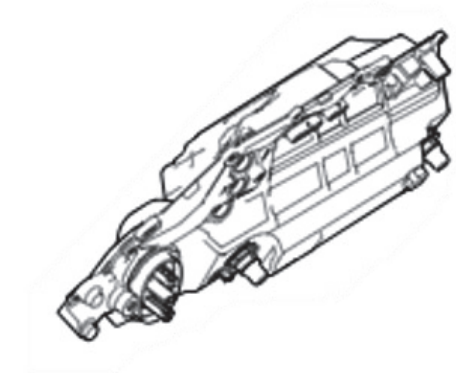
- Plastic protective dust cover is missing on the replacement part.

- JLR Engineering has confirmed units without the cover are still suitable for use.
- Proper handling during installation is critical to avoid damage or contamination.

- Inspect the EPIC unit before installation
- If the plastic cover is missing, check the unit's serial number with the list on the SSM.
- If the serial number matches the approved list below, proceed with installation using the following precautions:
  - Handle only by the outer casing.
  - Avoid direct contact with the exposed Printed Circuit Board.

**Note:** If retailer has an inverter without the dust cover and serial number is not on the chart attached to the SSM, please raise an EPQR.
