# Technical Service Bulletin

<b>Subject:</b>  SUNVISOR(S) DO NOT STAY IN FULLY RETRACTED POSITION	<b>Bulletin No.:</b> 09-012/25
	<b>Last Issued :</b> 08/01/2025

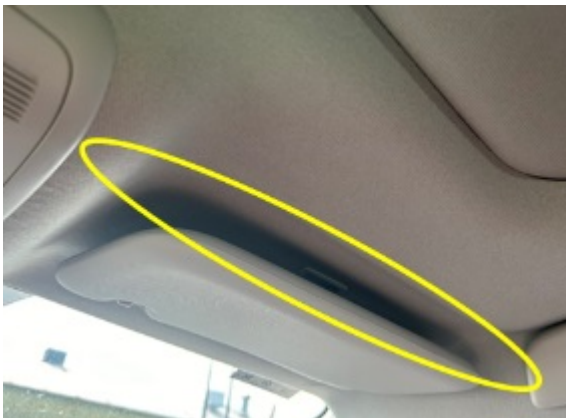
Some vehicles may experience a sunvisor that does not stay in the fully retracted position (as shown below). The left and/or right side sunvisor may lower slightly due to its own weight. The part where the sunvisor connects is broken, so the spring cannot hold the sunvisor in the fully retracted position.

To eliminate this concern, the stay holder and spring holder have been reinforced.

1. Verify customer concern.
2. Replace the affected side sunvisor with the modified part according to the instructions on MGSS.
  - Mazda3: SUNVISOR REMOVAL/INSTALLATION
  - CX-30: SUNVISOR REMOVAL/INSTALLATION
3. Verify the repair.
