Technical Service Bulletin

Subject: SAGGING FRONT SIDE OF REAR SUNSHADE	Bulletin No.: 09-014/25
	Last Issued : 08/05/2025

2024-2026 CX-90

2025-2026 CX-70

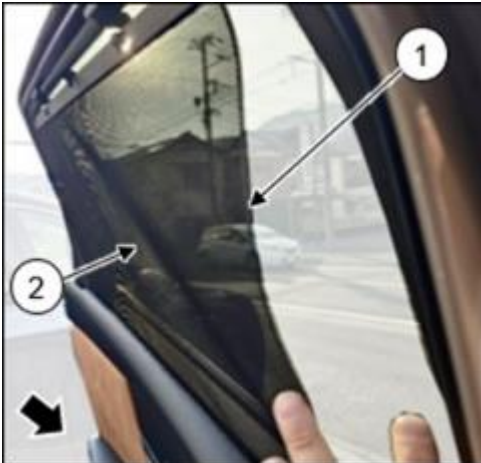
Some vehicles may exhibit sagging (1) at the front side of the rear sunshade(s) (2) or a difference in tension between the front and rear of the sunshade(s). When the rear sunshade is fully pulled up and then hooked up, the front hook's position may be lower, causing sagging on the front side of the rear sunshade.

NOTE: The figure shows left side (same as right side).

Customers having this concern should have their vehicle repaired using the following repair procedure.
