Technical Service Bulletin

Subject: REAR CONSOLE LID MAY COME OFF	Bulletin No.: 09-035/25
	Last Issued : 08/25/2025

2020-2025 CX-30 (Mexico built) vehicles with VINs lower than 3MV DM**** ** 862787 (Produced before Jul. 1, 2025)

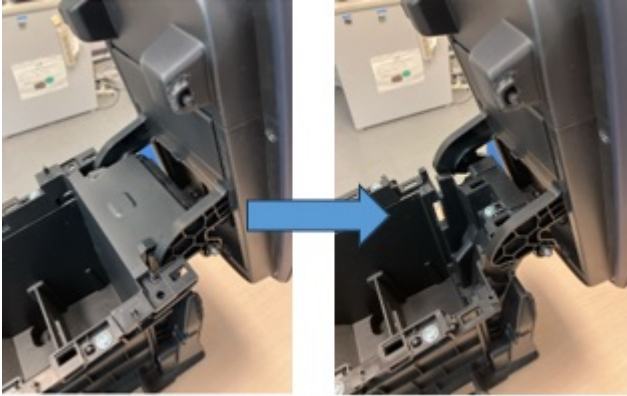
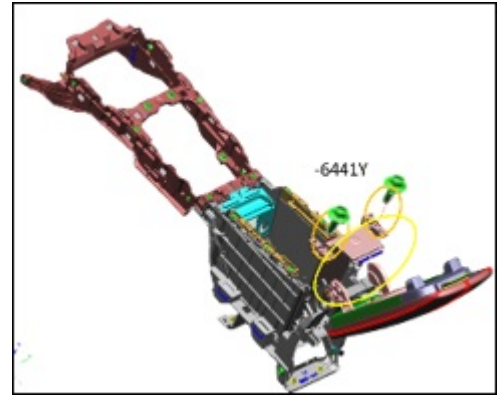
NOTE: The photos below show a new part without defects.

d. Remove the (2) two fastening screws for rear console panel (-6441Y), then remove the bracket cover.

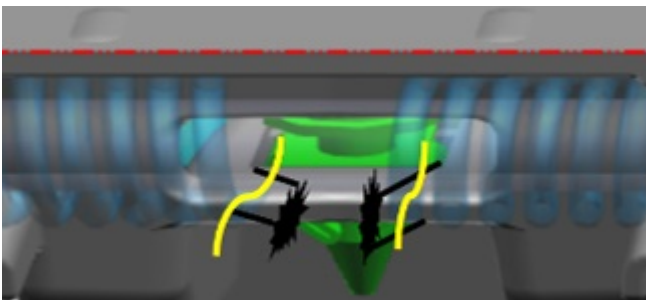
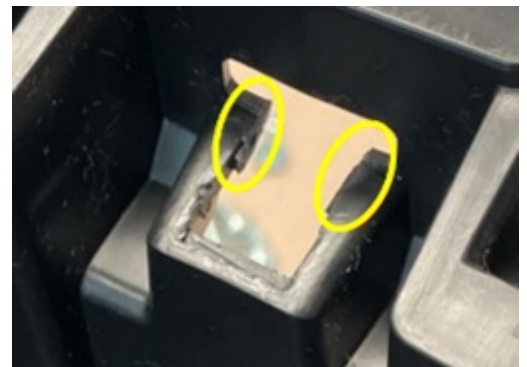
Some customers may complain the rear console lid comes off. This is caused when the spring mounting surface of the rear console lid breaks, causing the free spring mounting part to pop out and interfere with the console panel. The fastening surface of the spring is small, and under high temperatures the rigidity of the rear console PP material decreases, leading to fastening surface damage.

NOTE: The yellow-circled area is where the washer needs to be placed during the repair. When removing it, try to leave as much of the protruding part as possible.

f. Use snips or similar tools to minimally cut and remove the damaged part of the spring seat. Cut along the yellow wavy line shown below.
