## Can-Am Canyon MY25 Saddlebag Handle May Rust - 144235

The MY25 Canyon saddlebag handle could exhibit signs of corrosion

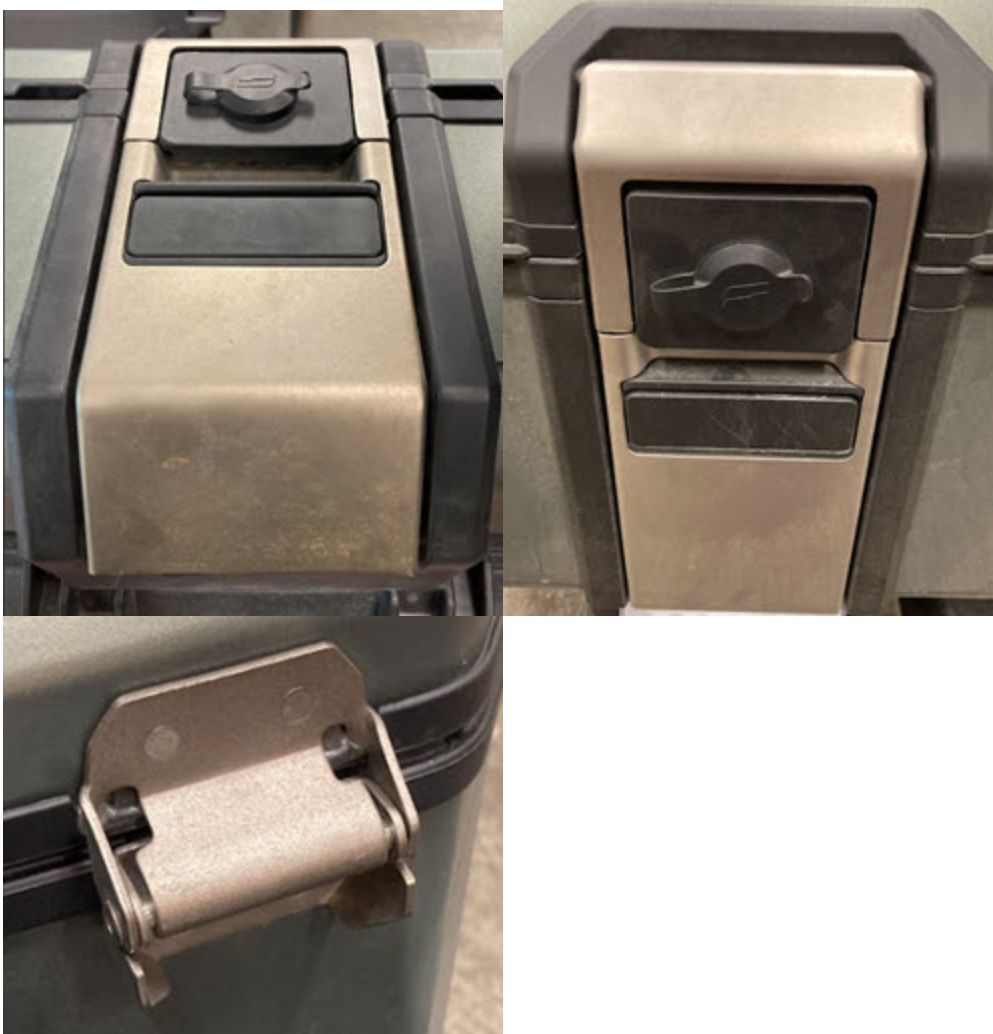
The Canyon saddlebag handle could exhibit signs of corrosion

The affected areas are, side case handles, top case handles, top case hinges

Clean the affected handles and hinges with Ferronet p/n 219800633 that should be available soon
