**SIB 01 11 25**

**N57T EGR COOLER / AUX EGR COOLER EXT LTD WTY (ELW) 25 YRS/NO MILEAGE LIMIT**

This Service Information bulletin (Revision 02) supersedes SI B01 11 25 **dated August 2025**

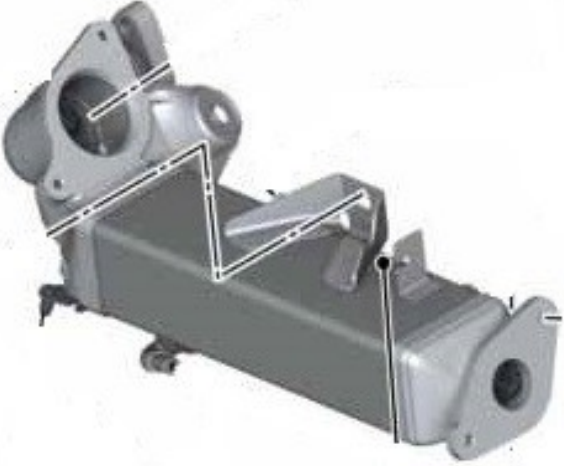
<p>For the eligible N57T diesel engine vehicles models, BMW of North America, LLC (BMW NA) is extending the limited warranty for these vehicle's <b>Exhaust Gas Recirculation (EGR) Cooler together with the Intake Manifold replacement (Shown below)</b> to:</p> <ul style="list-style-type: none"> <li>• <b>25 years without mileage limit as determined by the vehicle's original in-service date.</b></li> </ul>

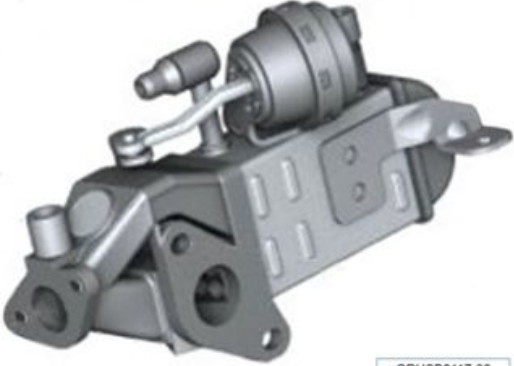
<p>Additionally, for the N57T, BMW NA is also extending the limited warranty for these vehicle's <b>Auxiliary Exhaust Gas Recirculation (EGR) Cooler</b> to:</p> <ul style="list-style-type: none"> <li>• <b>25 years without mileage limit as determined by the vehicle's original in-service date.</b></li> </ul> <p>Replacing the Auxiliary EGR Cooler, the EGR Cooler together with the Intake Manifold (Shown below).</p>

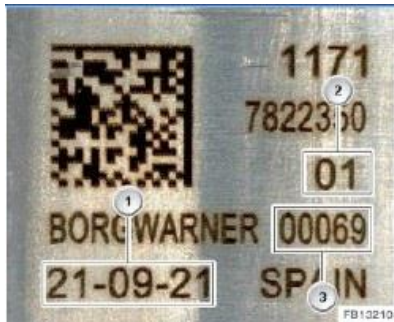
WarrantyApp: Under B01 11 25 EGR Label Vac Bleed Intake Ports

After the diagnosis confirms that an EGR Cooler/Intake Manifold replacement repair is required to be performed, use the WarrantyApp (B01 01 23) to take a photo of the information shown to the left on the "new replacement EGR Cooler" before it is installed.

1. Production date [YY-MM-DD]
2. Revision index
3. Serial number

These numbers will be required to be used later to register the vehicle's new EGR Cooler in ISTA (See below).
