**SIB 64 05 25**

HVAC FLAP LINKAGE NOT FULLY CONNECTED

E-Series	Model Description
G45	X3 Sports Activity Vehicle

Right front warm
air mixing flap 5B
linkage repair.

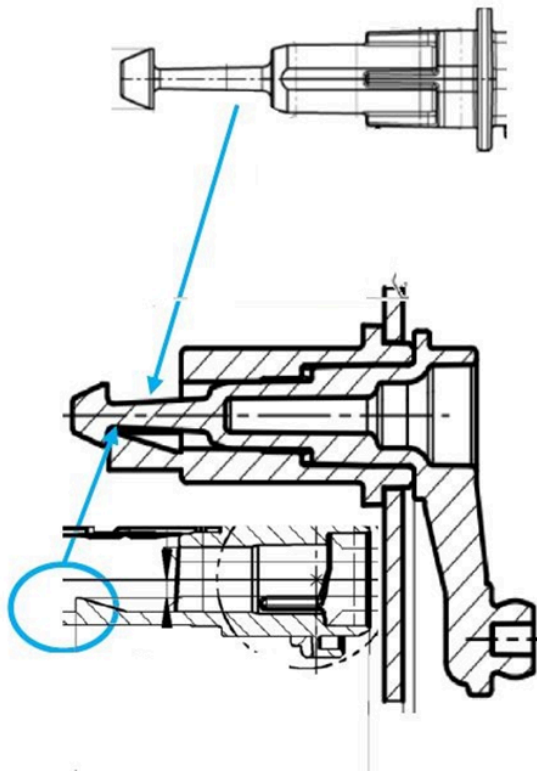
BV64 02 25 G45 Flap Linkage

There is a push-in end on the linkage that can be reinserted into the flap and fully seated.

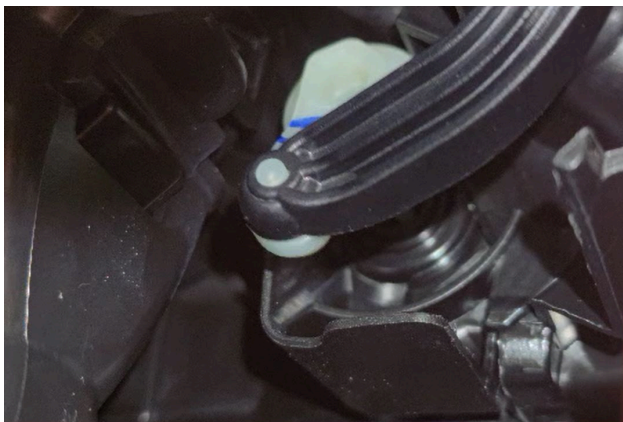
To test if the mechanism is fully seated into the HVAC flap assembly, perform a wiggle test of the white plastic (in/out). Here you can see the white plastic mechanism has backed out of the HVAC case and is not locked into the flap.

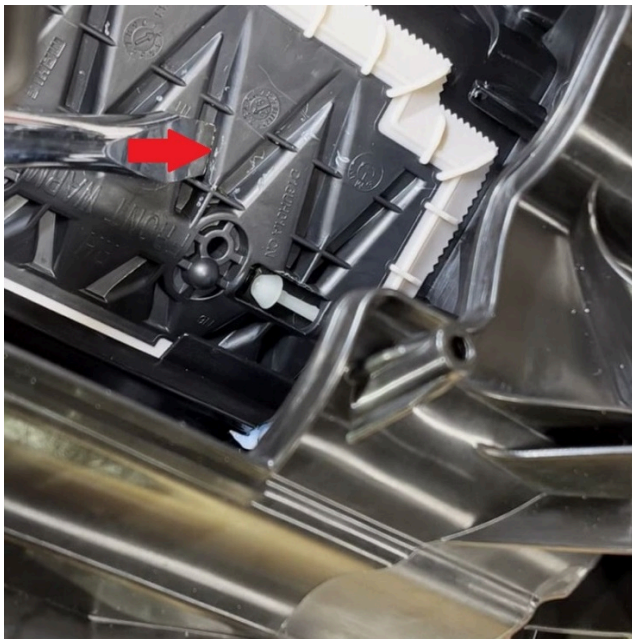
There is a push in end on the linkage that can be reinserted into the HVAC flap and fully seated. The white plastic mechanism push pin can be reinserted into the HVAC flap and fully seated.

Make sure to push in until you can feel the white plastic mechanism push pin mushroom shaped end engage into the flap ramp.

NOTE: The linkage may bottom against the HVAC case before it fully seats into the flap. This is because the flap may have some side-to-side free play. In this case apply OUTWARD pressure on the flap while pressing INWARD on the linkage until it fully engages. This may require more disassembly of the ducts to access the flap. The fresh air blend uses two linked flaps, and you may have to go around the top flap to put pressure on the lower flap.

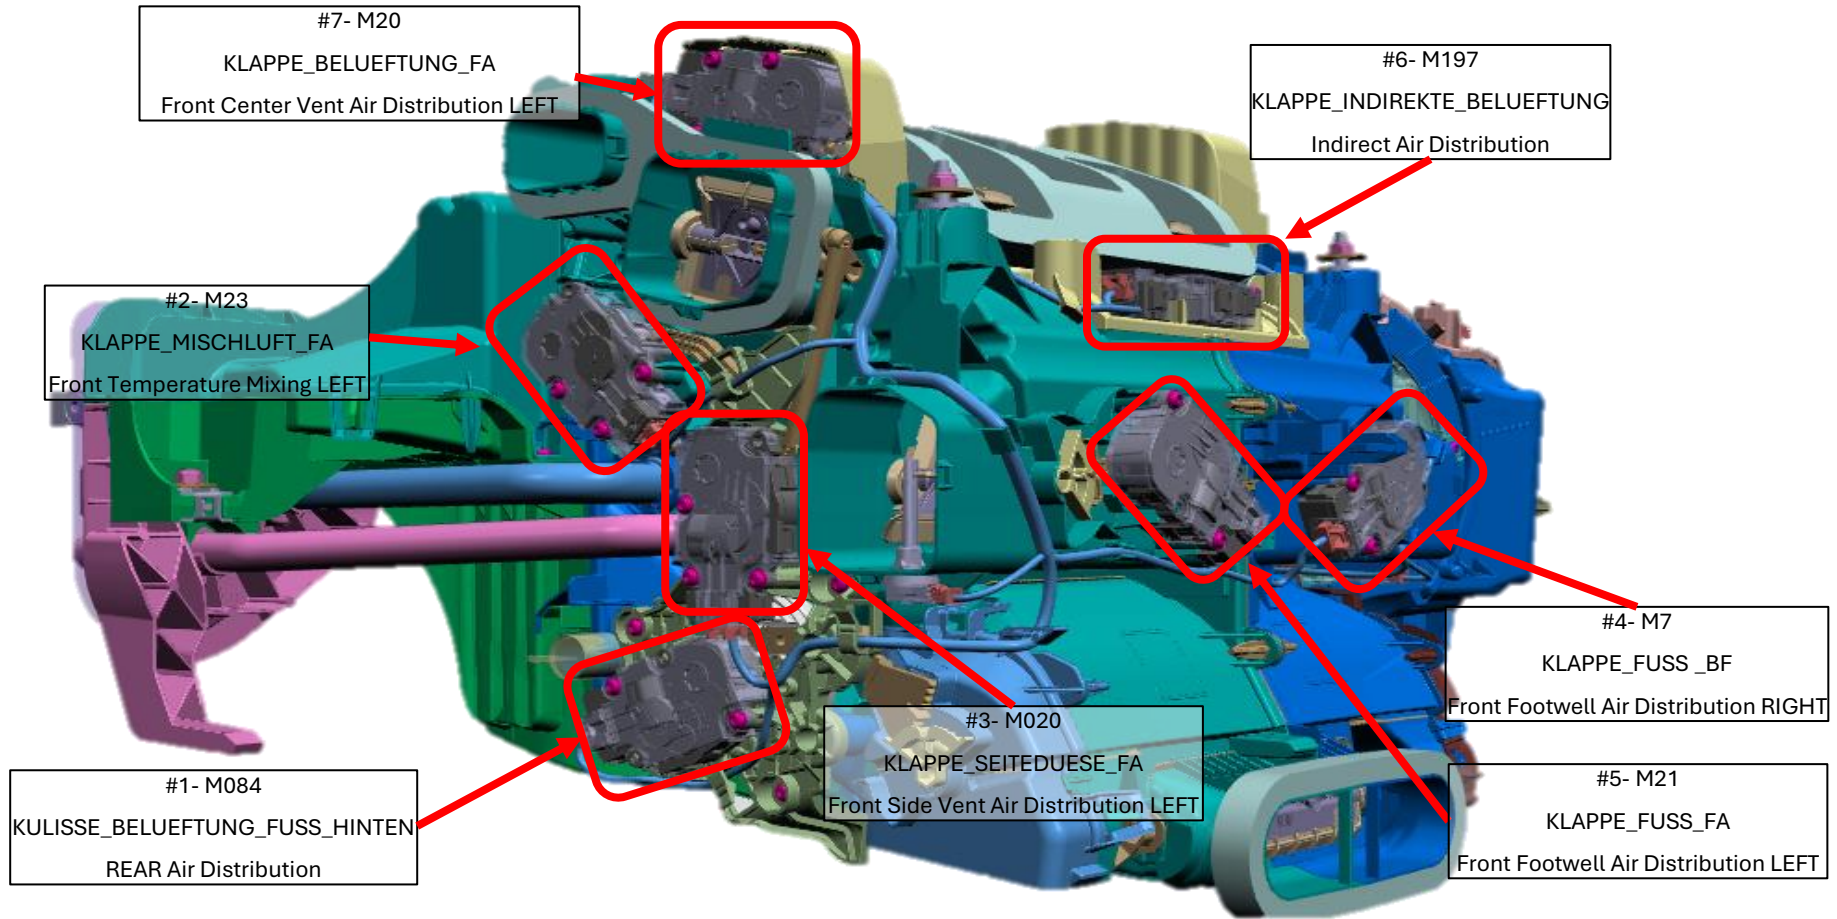
Stepper Motor Control Locations Diagram (OVERVIEW)

(LHD: Left Side VIEW)

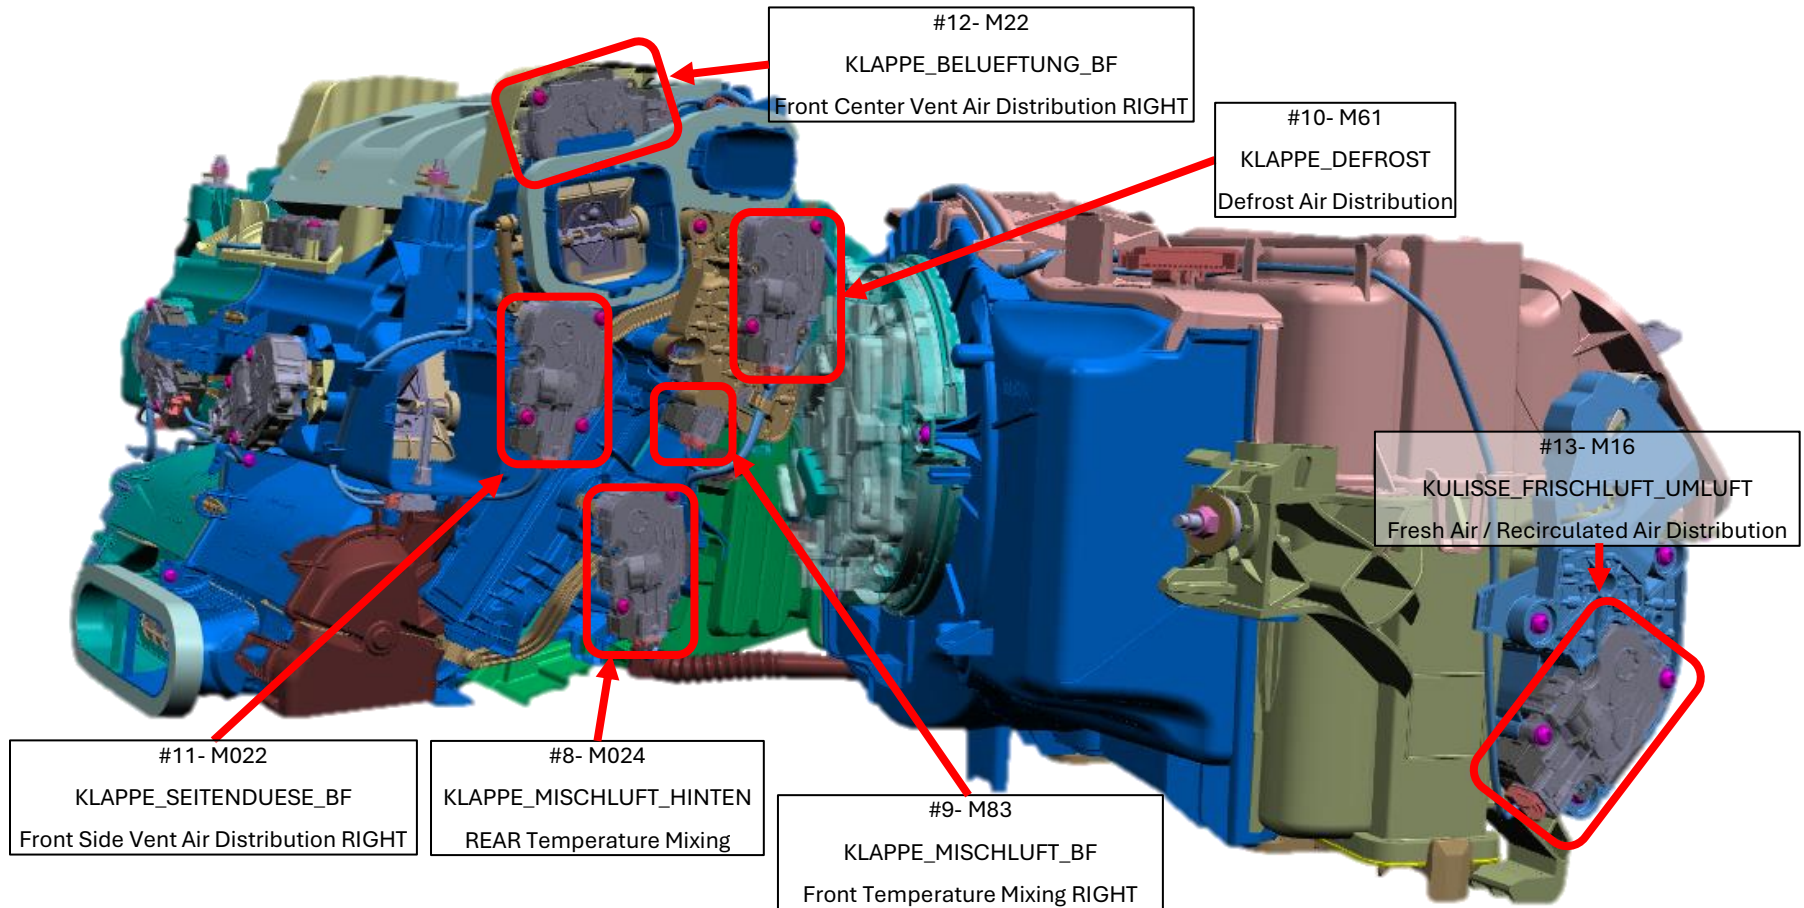
Stepper Motor Control Locations Diagram (OVERVIEW)

(LHD: Right Side VIEW)

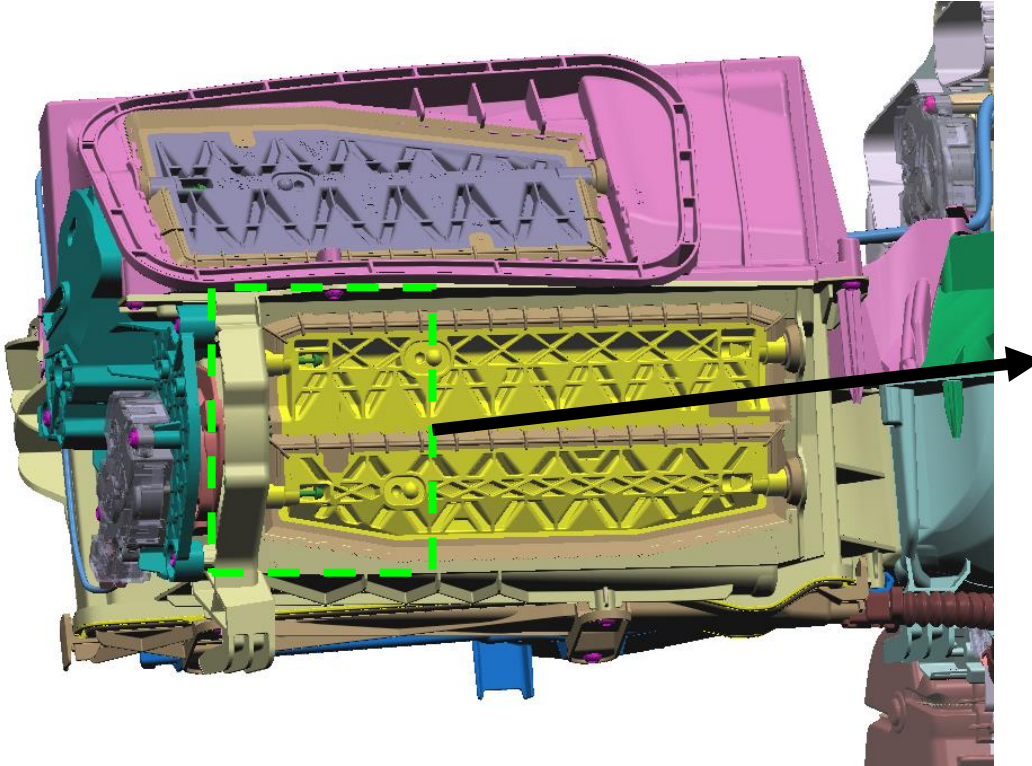
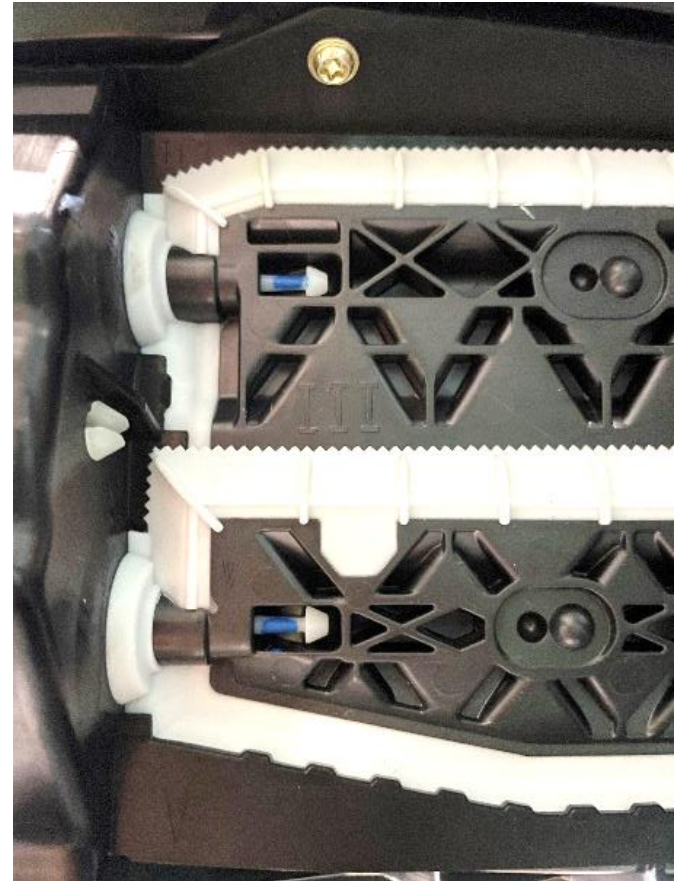
FLAP #2: Recirculated Air Flaps x2 (connected)

TWO Push Pins!

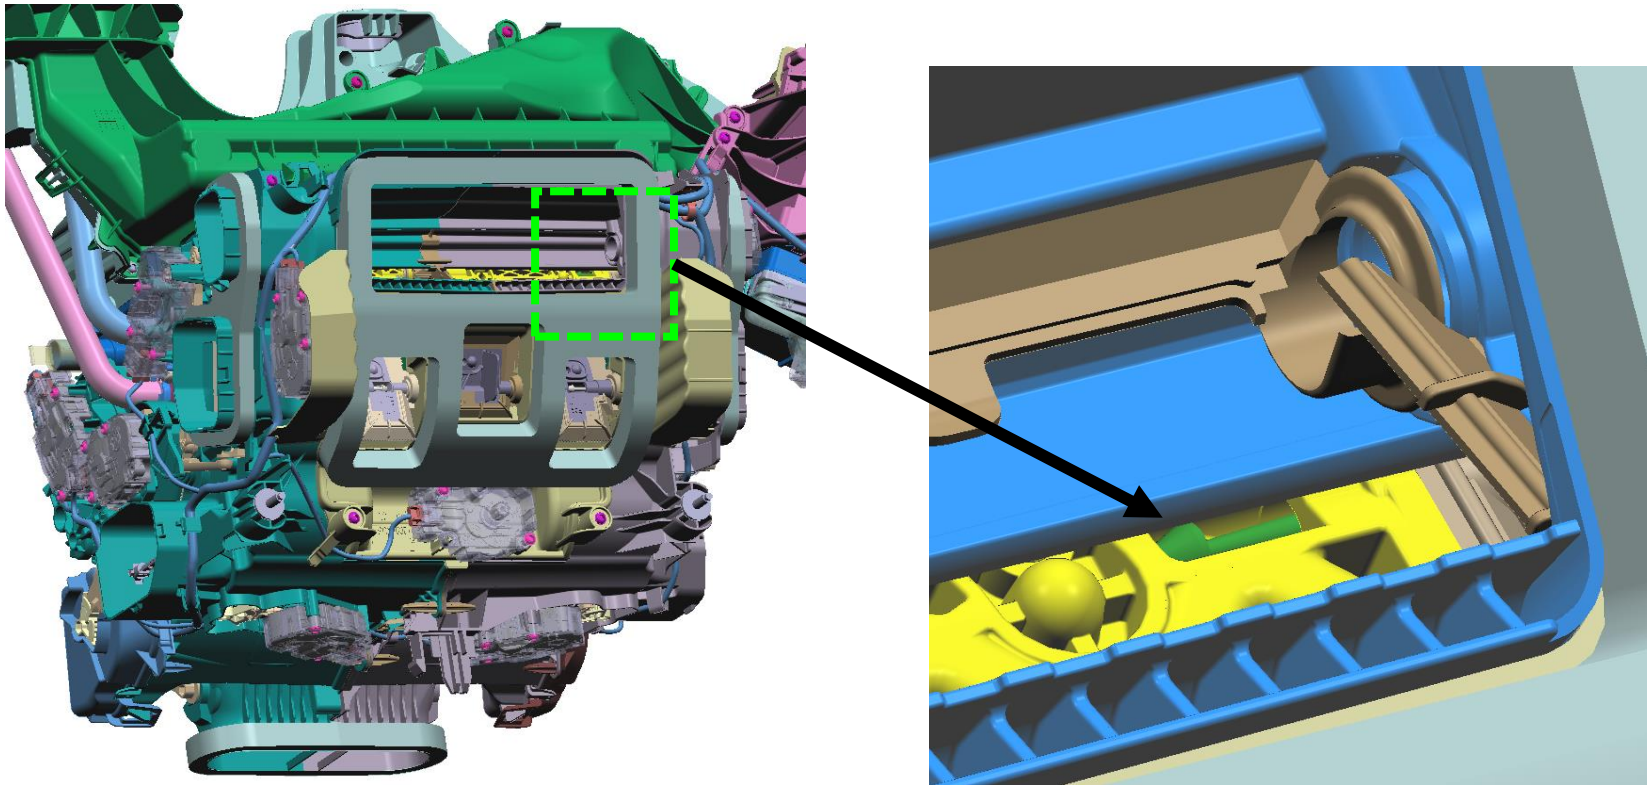
FLAP #4A/4B: Front Cold Temp. Mixing Flap Right (Mirrored Right to Left)

4B shown. #3 Defrost Air Flap removed from CAD image for easier visibility

TWO Push Pins (one on LEFT side flap & one on RIGHT side flap)!

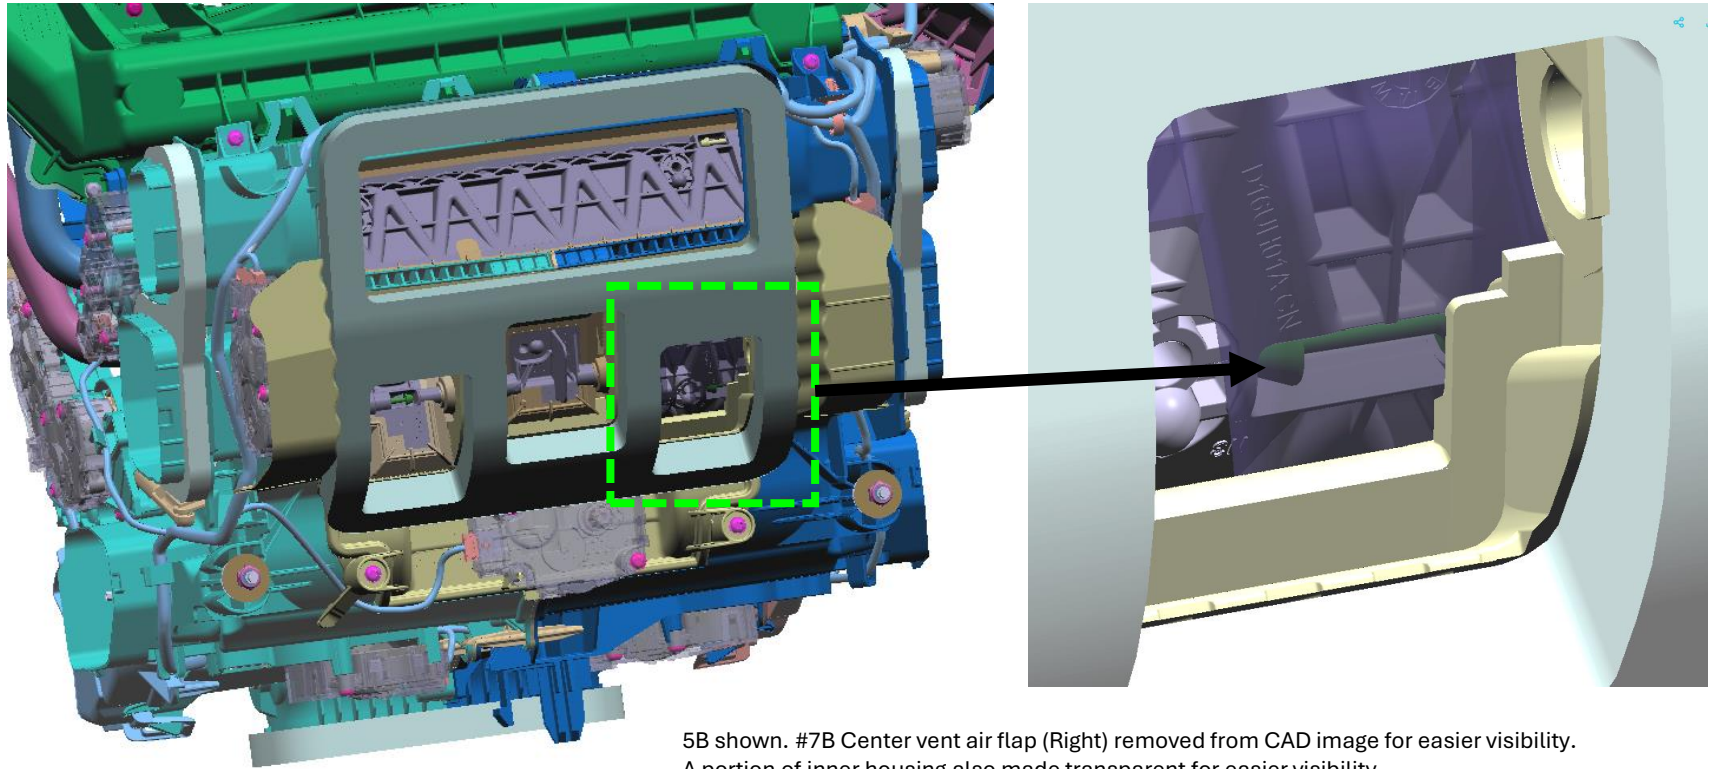
FLAP #5A/5B: Front Warm Temp. Mixing Flap Right (Mirrored Right to Left)

5B shown. #7B Center vent air flap (Right) removed from CAD image for easier visibility.
A portion of inner housing also made transparent for easier visibility.

TWO Push Pins (one on LEFT side flap & one on RIGHT side flap)!

The linkage connection to the right front mixed air flap (5B) is the one we have found loose on most vehicles. For specific instructions on how to fix this flap see **Attachment B64 05 25 RF Mix Flap**

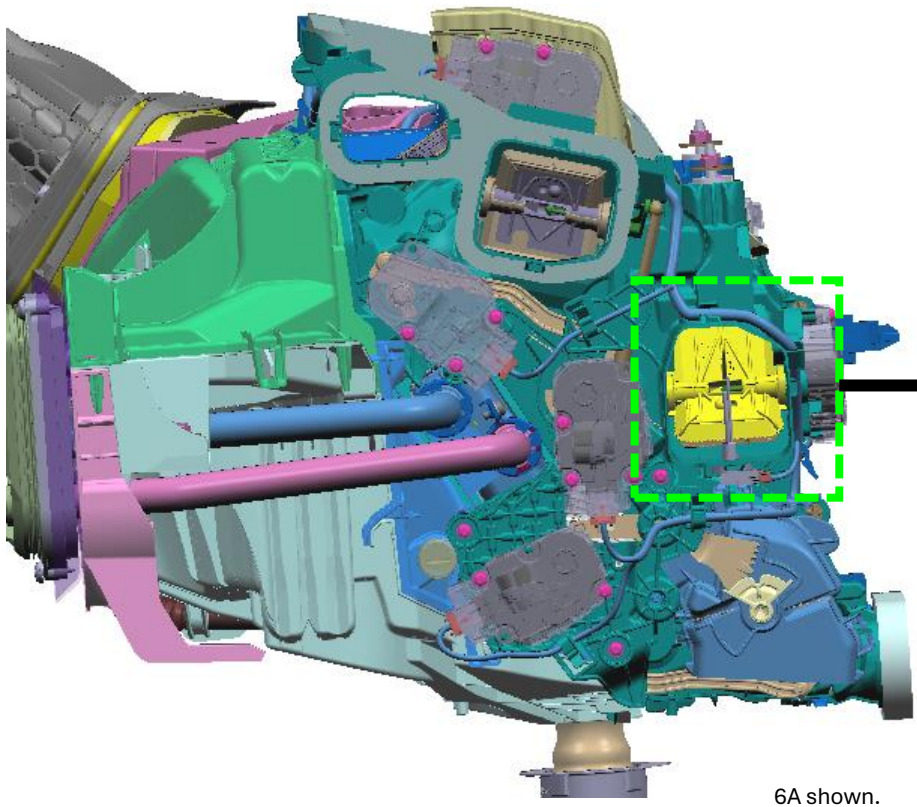
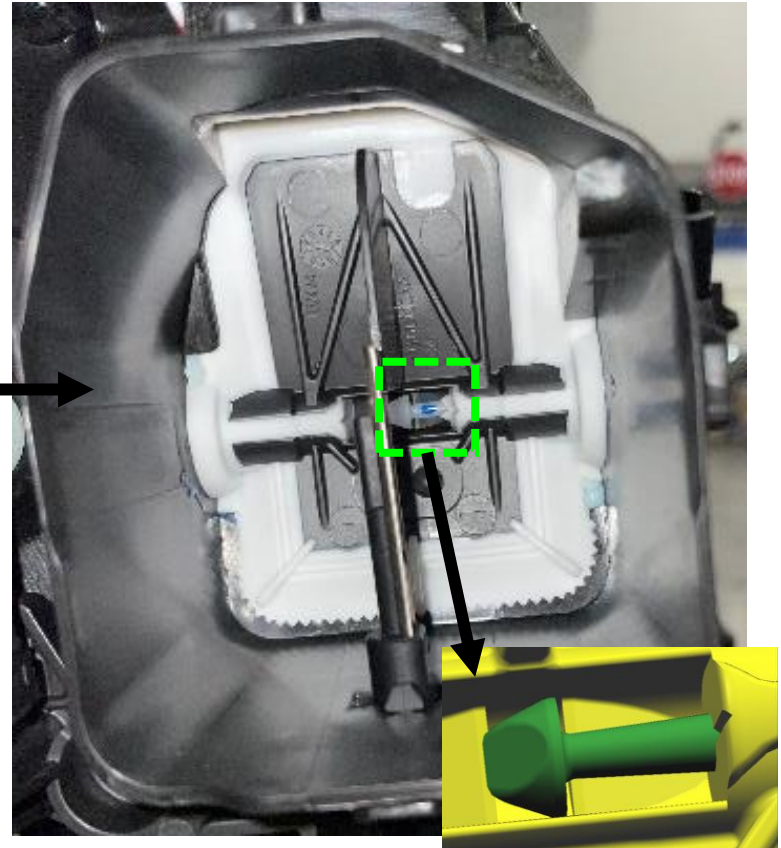
FLAP #6A/6B: Front Footwell Air Flap LEFT (Mirrored Left to Right)

TWO Push Pins (one on LEFT side flap & one on RIGHT side flap)!

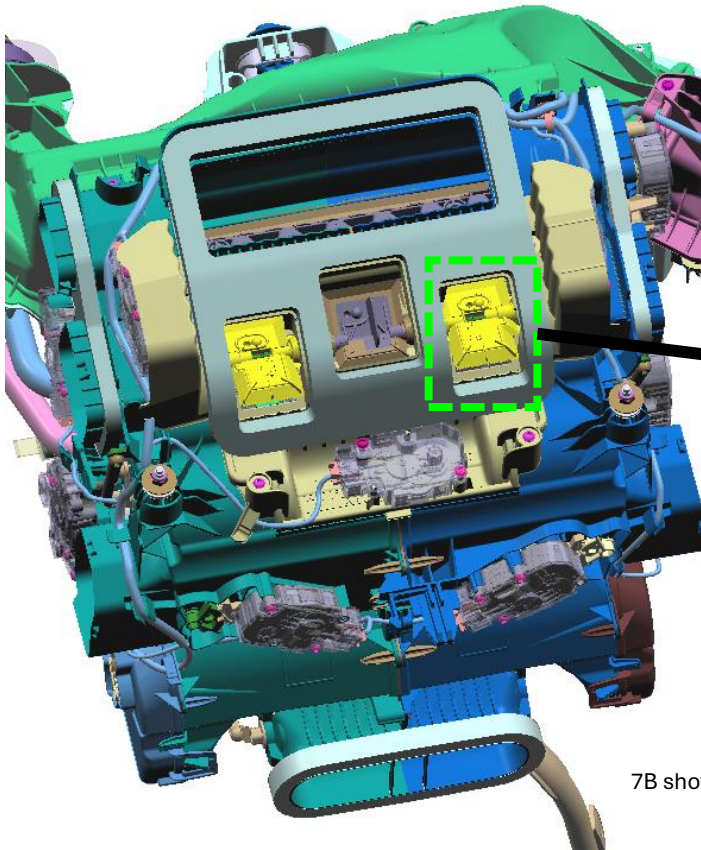
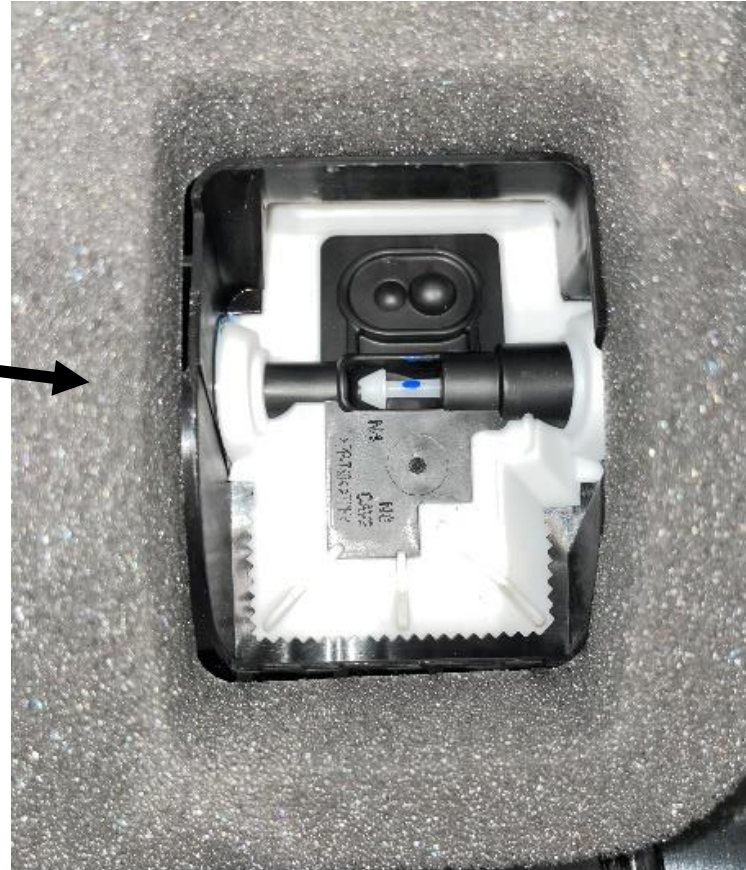
FLAP #7A/7B: Front Center Vent Air Flap Right (Mirrored Right to Left)

7B shown.

TWO Push Pins (one on LEFT side flap & one on RIGHT side flap)!

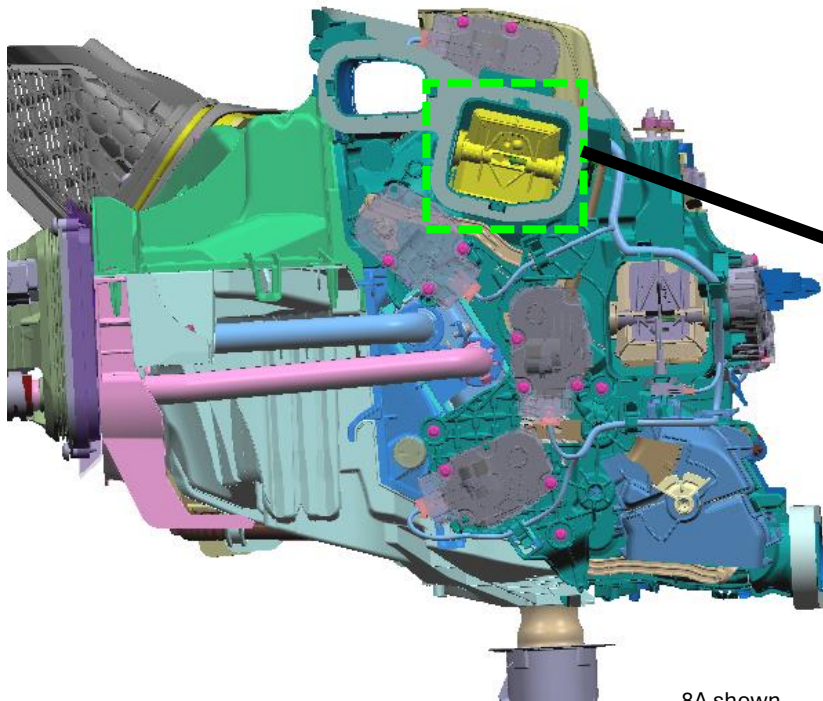
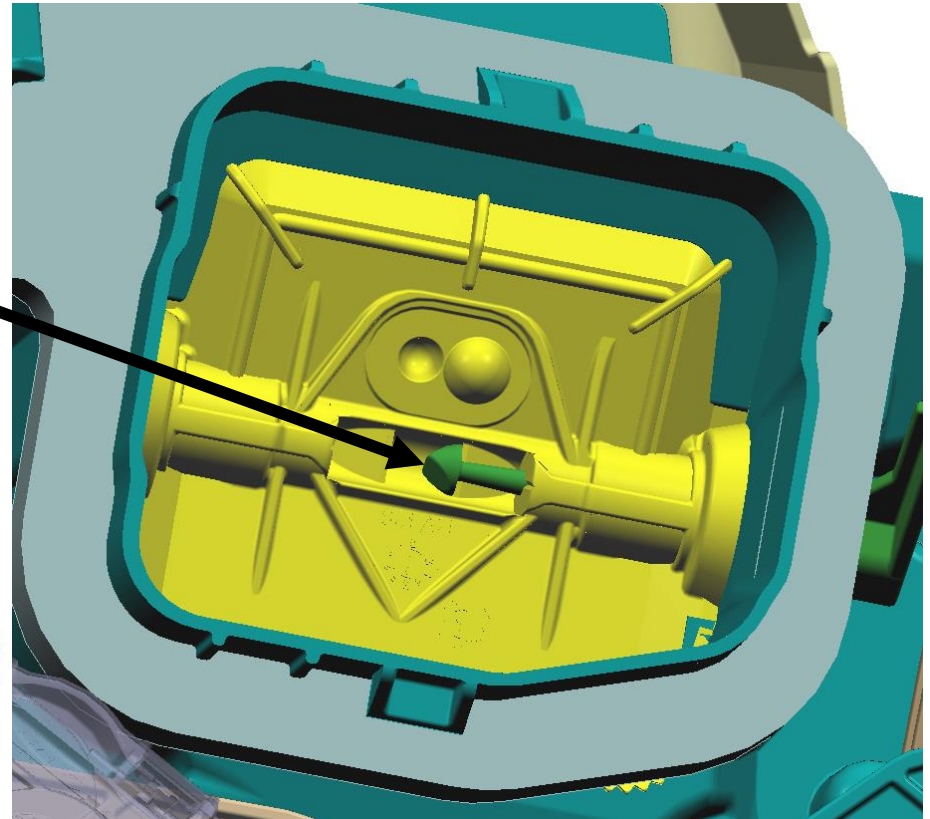
FLAP #8A/8B: Front Side Vent Air Flap LEFT (Mirrored Left to Right)

8A shown.

TWO Push Pins (one on LEFT side flap & one on RIGHT side flap)!

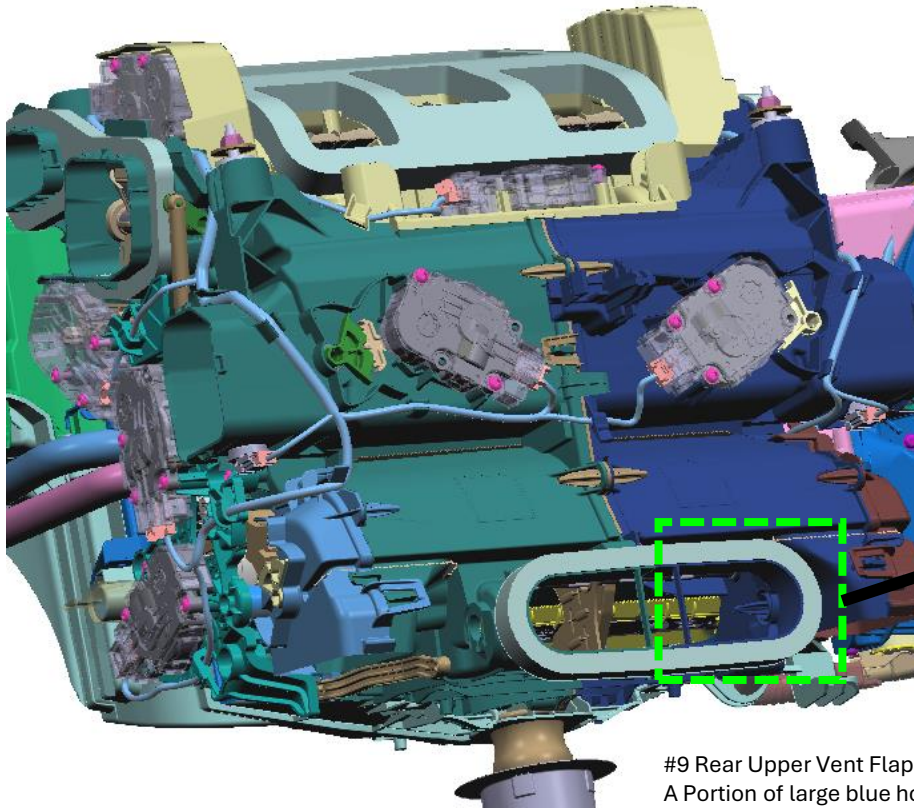
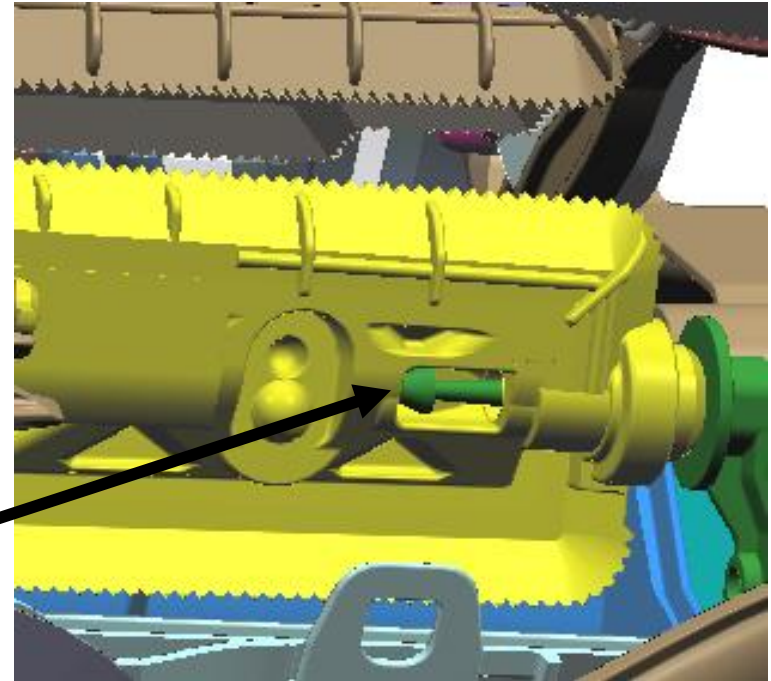
FLAP #10: Rear Cold Temp. Mixing Flap

#9 Rear Upper Vent Flap (Center Console) removed from CAD image for easier visibility.

A Portion of large blue housing also removed for easier visibility.

A bad push-pin connection on Flap #10 can also affect Flap #11. Flap #11 is connected to Flap #10.

ONE Push Pin (RIGHT side only)!

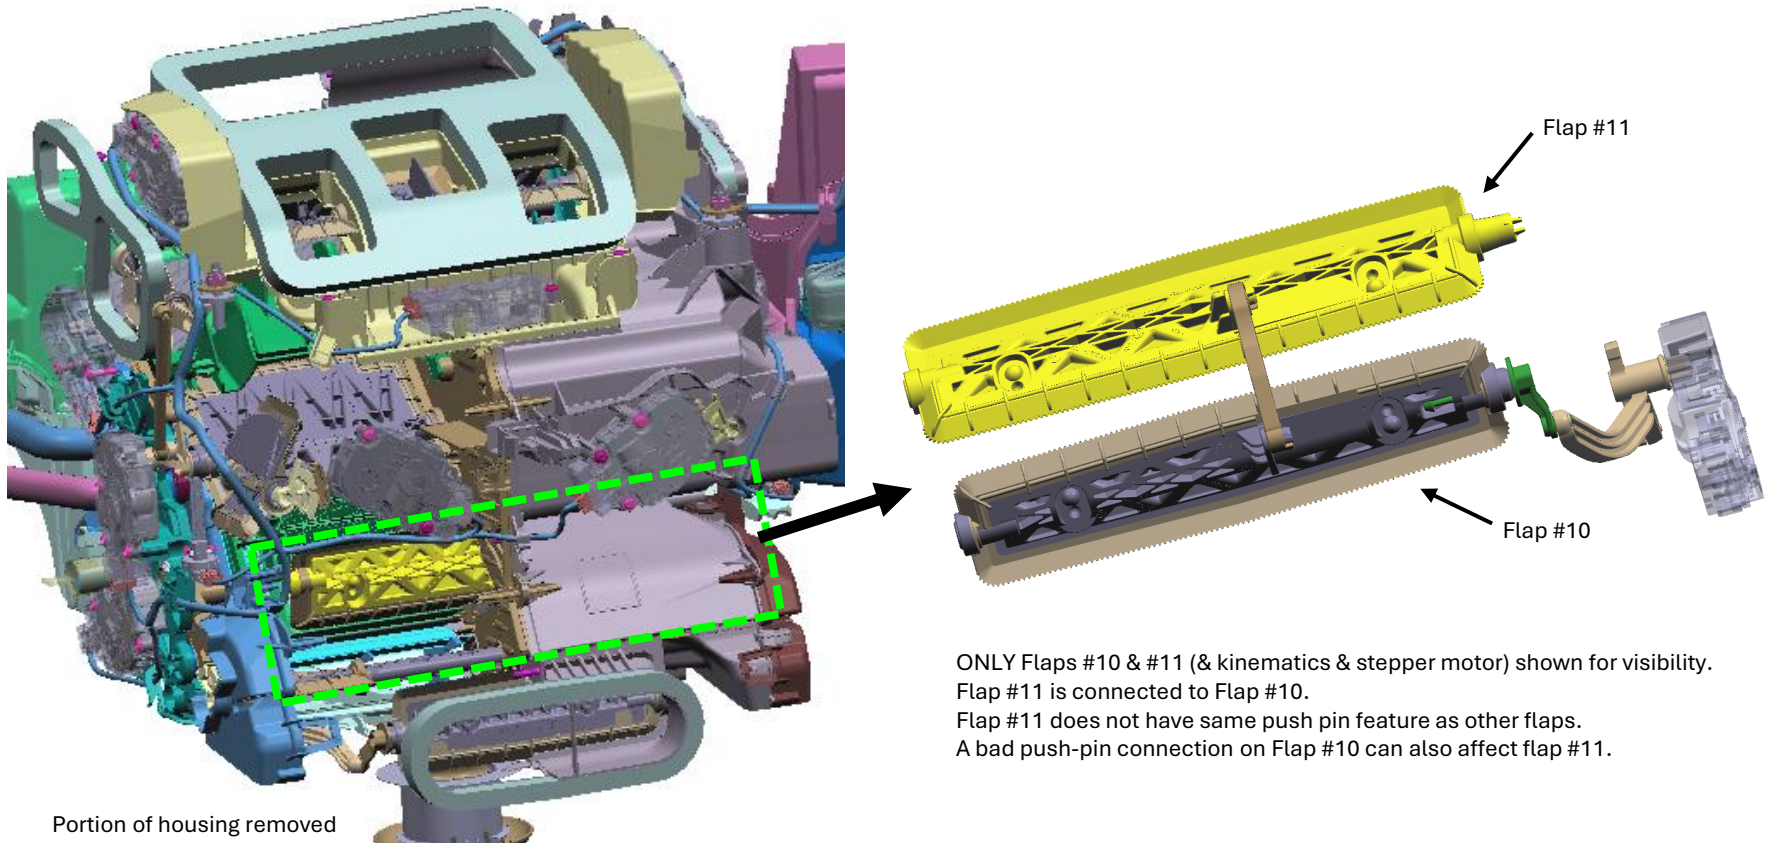
FLAP #11: Rear Warm Temp. Mixing Flap

ONLY Flaps #10 & #11 (& kinematics & stepper motor) shown for visibility.
Flap #11 is connected to Flap #10.
Flap #11 does not have same push pin feature as other flaps.
A bad push-pin connection on Flap #10 can also affect flap #11.

NO Push Pin on Flap #11 (Please see Flap #10)!

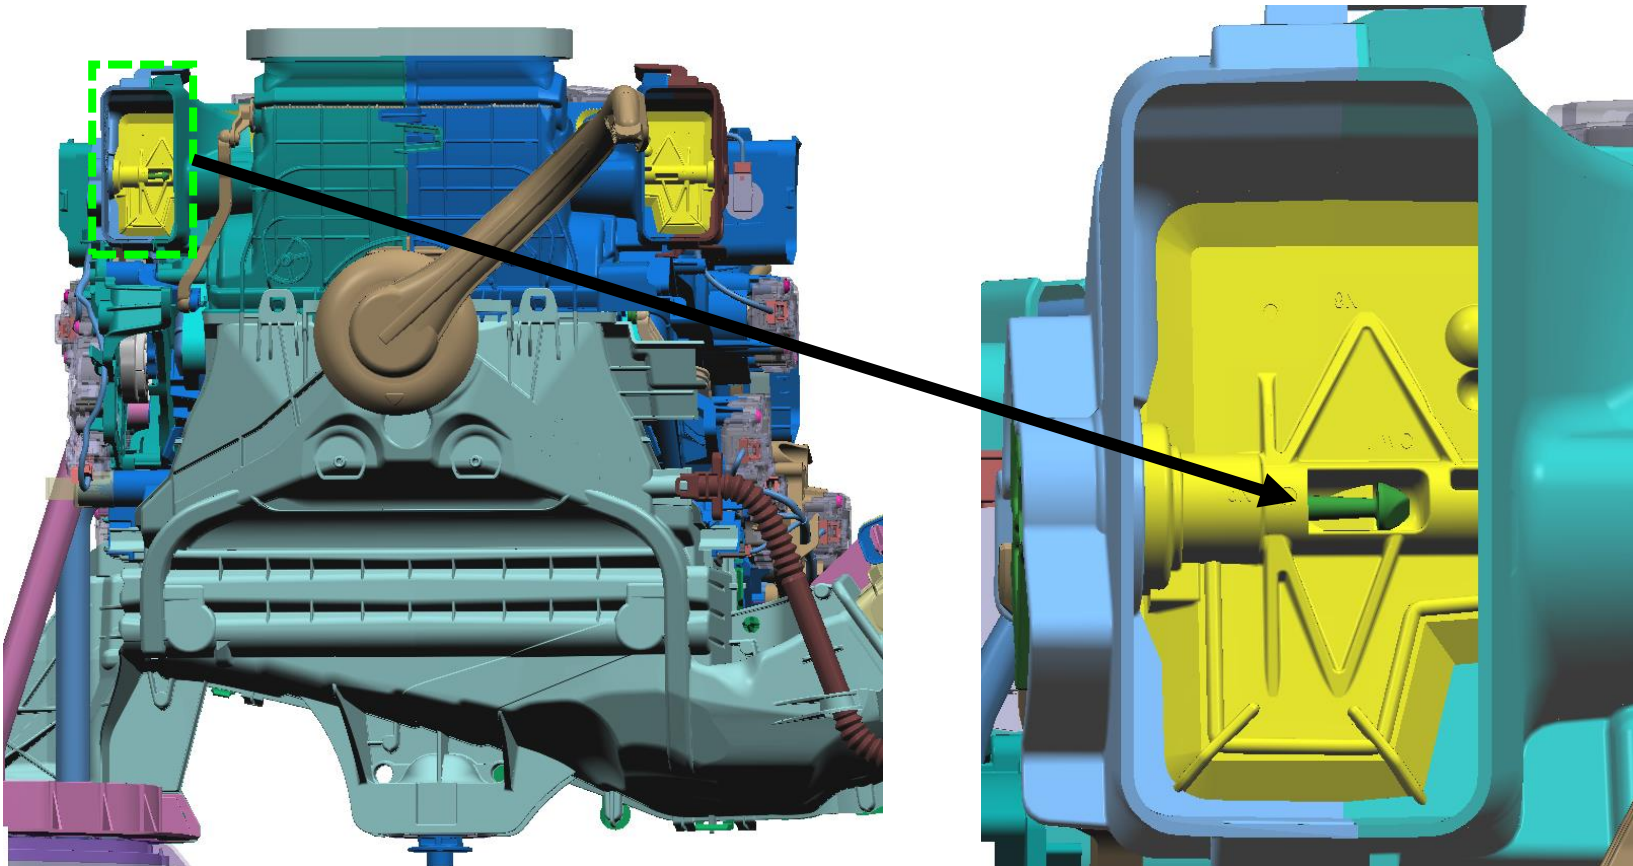
FLAP #12: Rear Footwell Air Flaps L/R x2 (connected)

ONE Push Pin (RIGHT side only)!

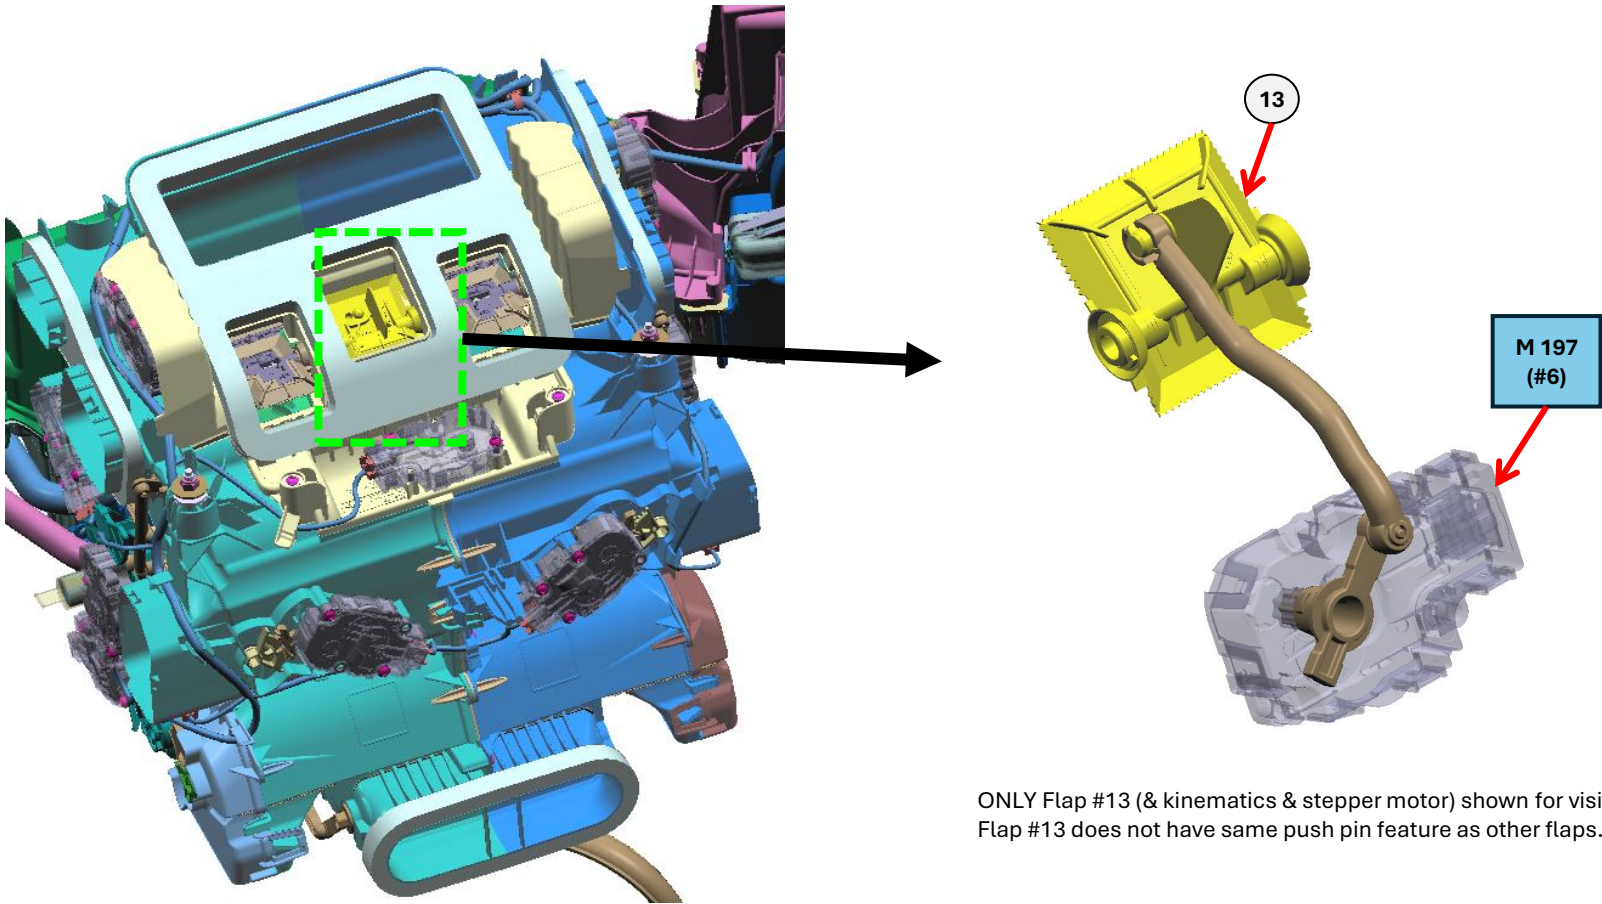
FLAP #13: Indirect Air Flap & Complete Kinematics Overview

ONLY Flap #13 (& kinematics & stepper motor) shown for visibility.
Flap #13 does not have same push pin feature as other flaps.

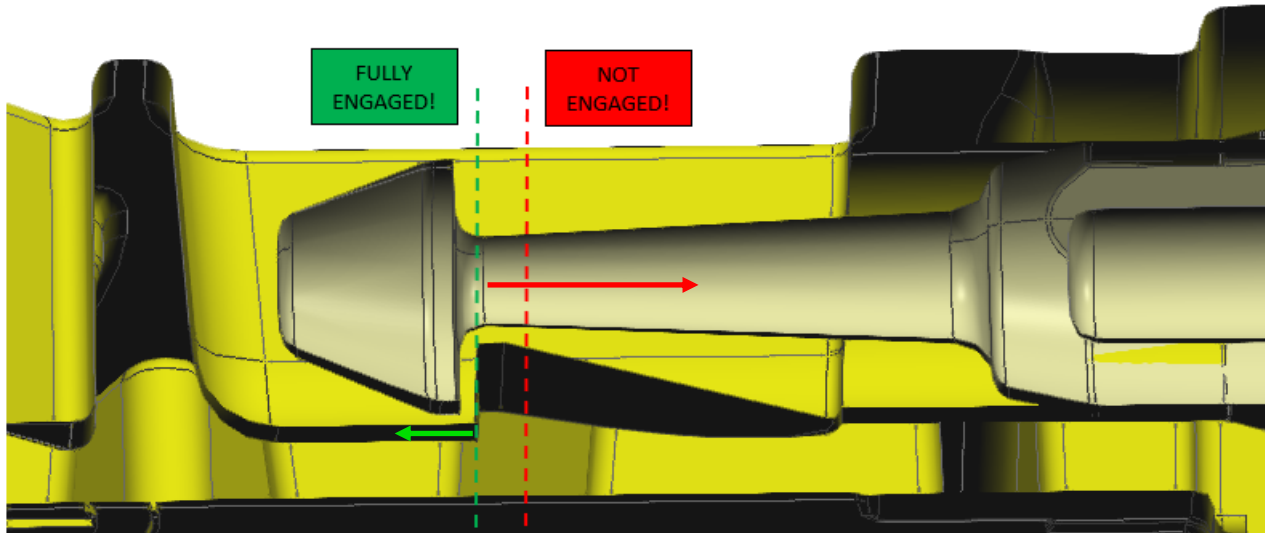
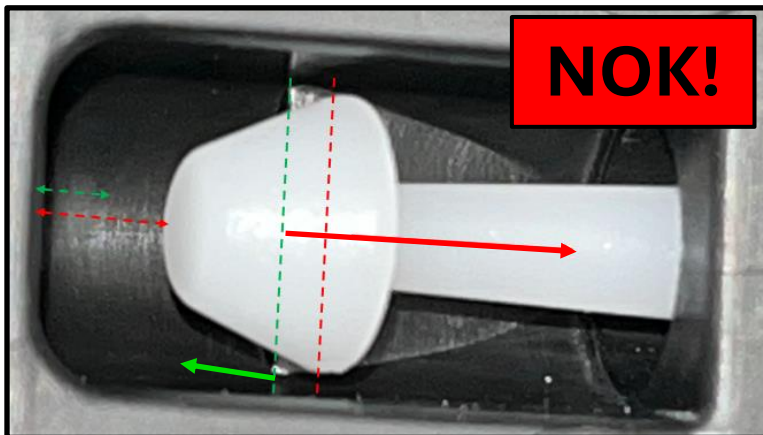
Push Pin Issue

CAD
Section
Cut

Real Part

Main References:
--- FULLY Engaged ---
--- NOT FULLY Engaged ---

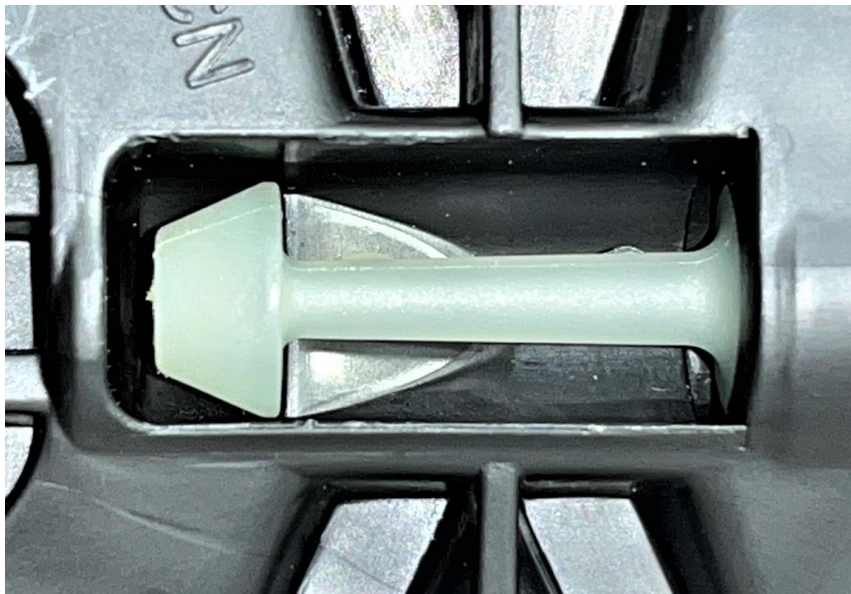
OK

FULLY ENGAGED

**Pin/Linkage Mushroom Head
Completely Over Ramp on Flap!**

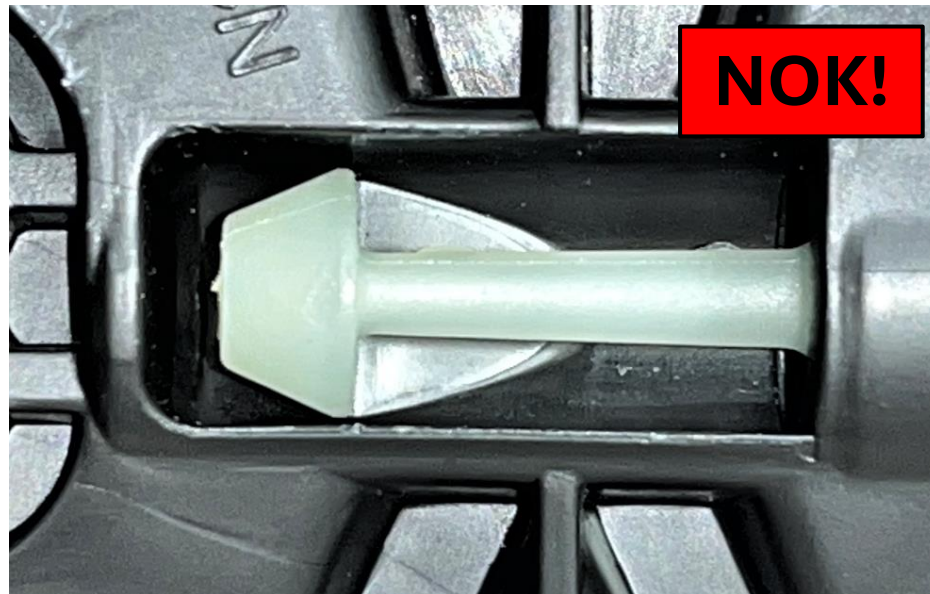
NOK!

Barely short of FULL engagement!

**Pin/Linkage Mushroom Head NOT
Completely Over Ramp on Flap!**

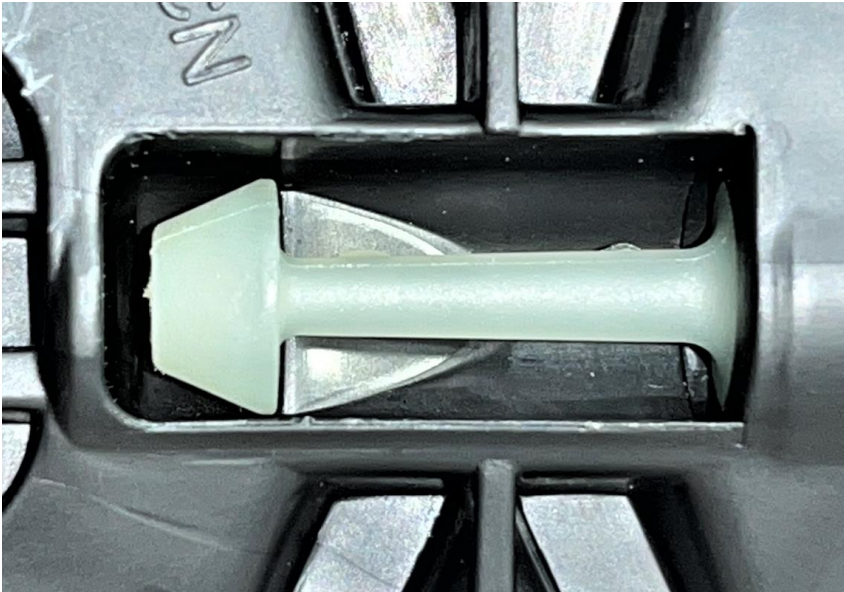
FULLY ENGAGED

**Pin/Linkage Mushroom Head
Completely Over Ramp on Flap!**

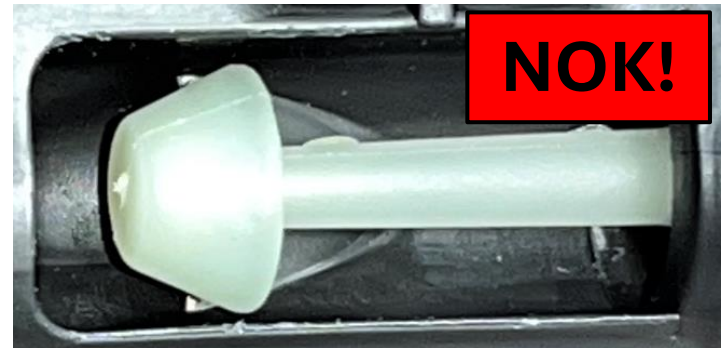
NOK!

Short of FULL engagement!

**Pin/Linkage Mushroom Head NOT
Completely Over Ramp on Flap!**

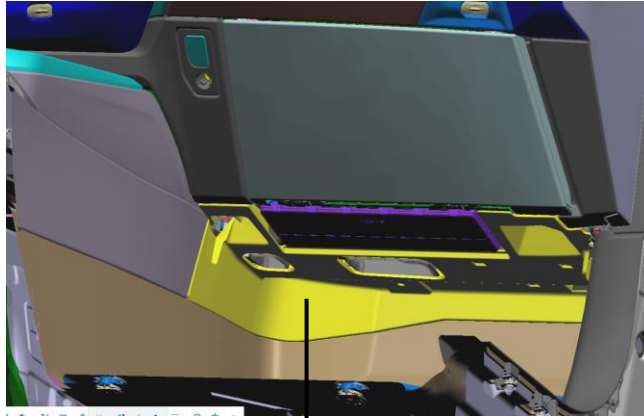
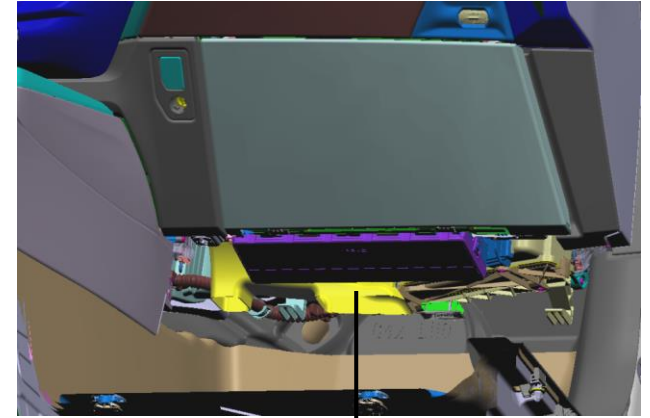
Reference Picture: **D- Under-dash & Footwell Duct**

Under-Dash Panel

Footwell Duct
