**SIB 64 05 25**

HVAC FLAP LINKAGE NOT FULLY CONNECTED

E-Series	Model Description
G45	X3 Sports Activity Vehicle

Right front warm
air mixing flap 5B
linkage repair.

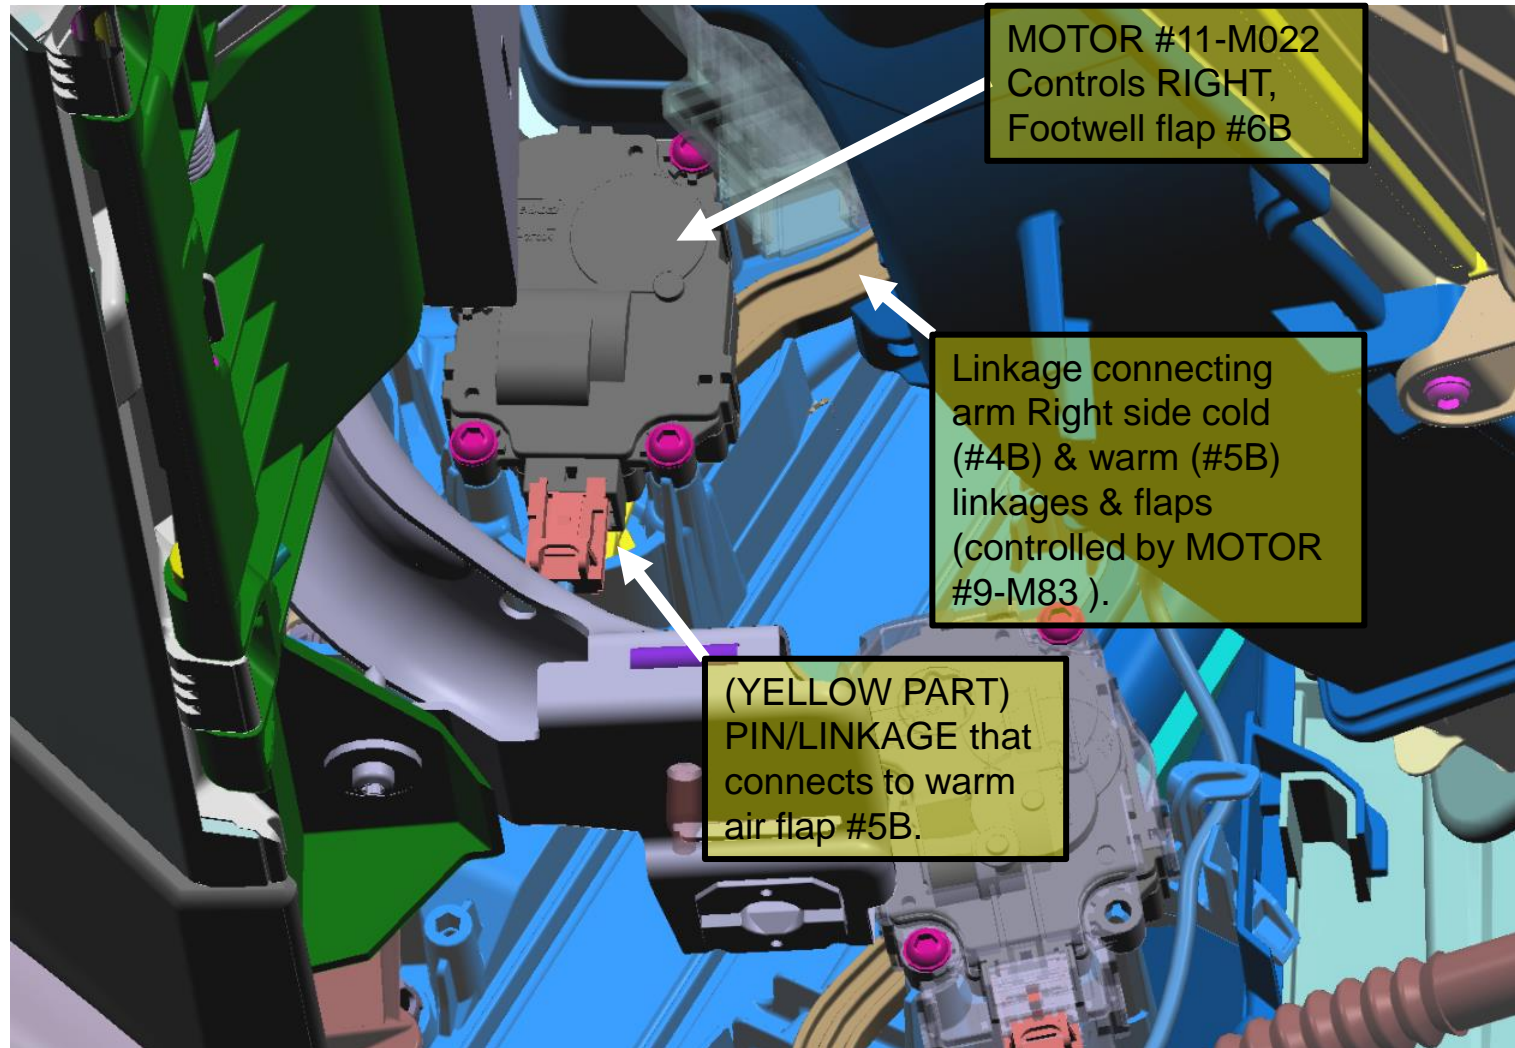
Reference Picture: E- VIEW after under-dash and footwell duct removed

B) Locate and wiggle the linkage connecting arm between the cold and warm mixing flaps and look for excessive looseness at the lower end of the linkage connecting arm and directly at the warm mixing flap pin/linkage (connection to the warm mixing flap). A boroscope could also be helpful.

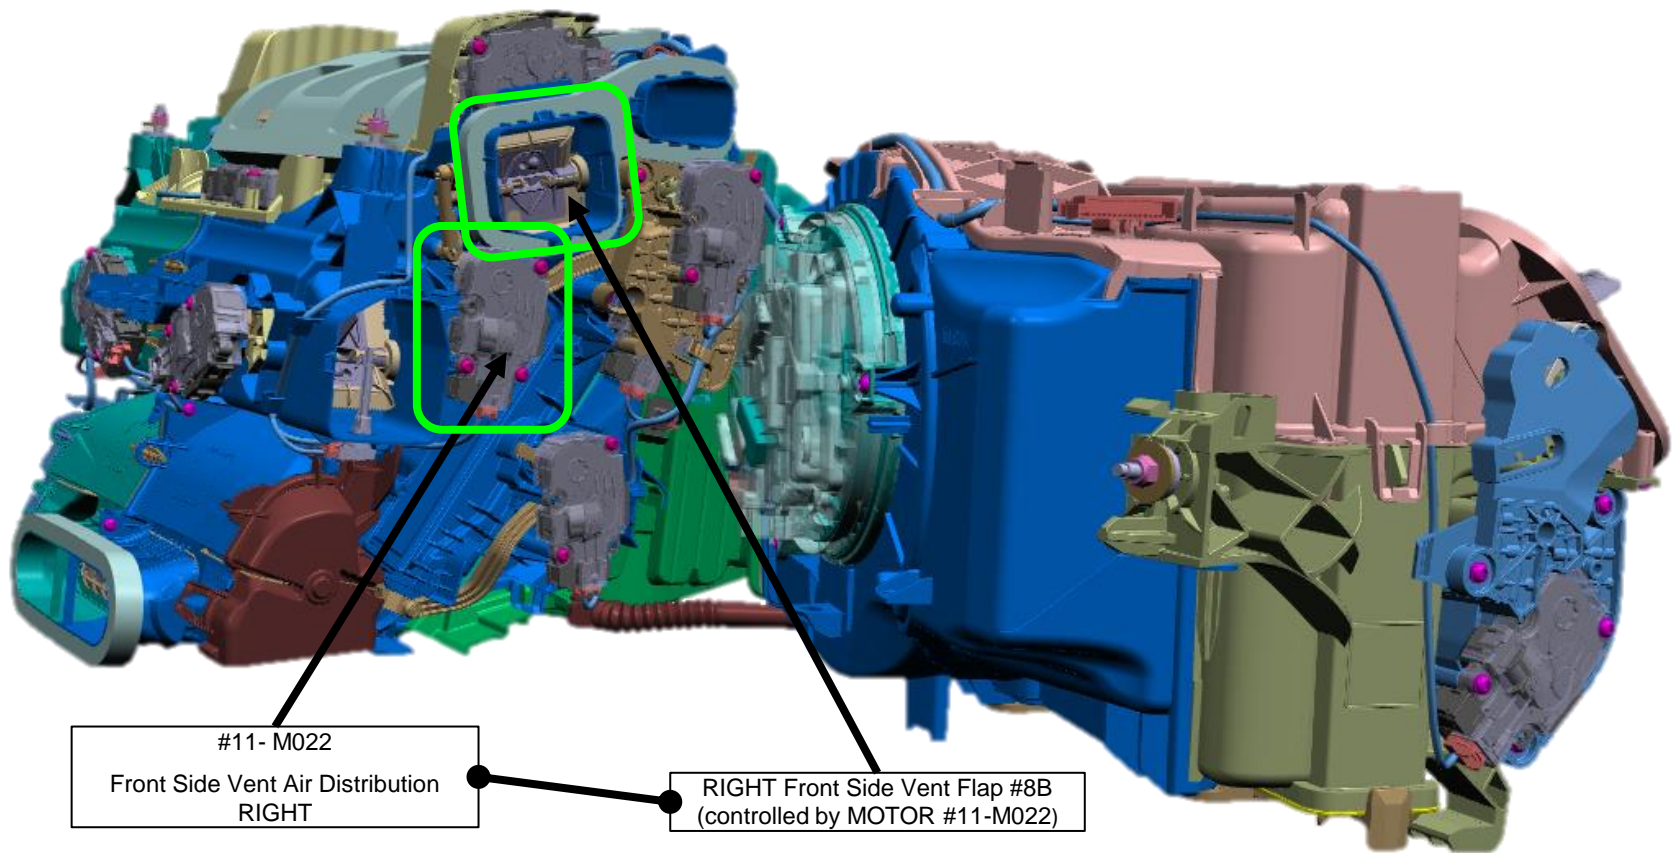
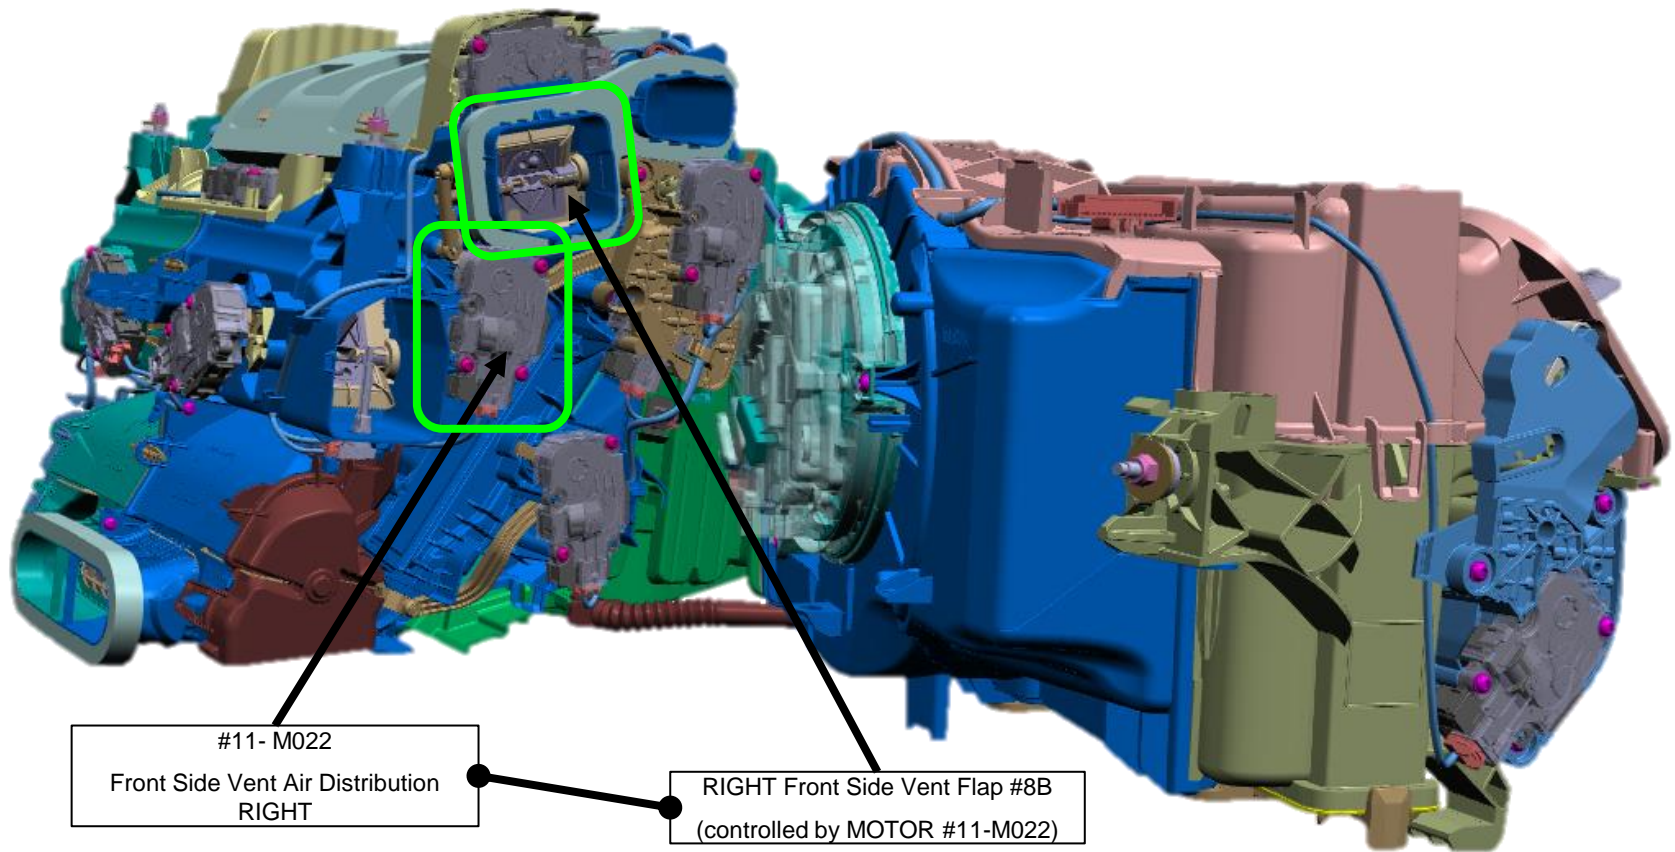
Reference Picture: **F A- Remove MOTOR #11-M022**

C) In some cases, you may find it easier to remove **motor #11/M022** for the "loose" inspection/confirmation.

Note: This not the controlling motor for the mixing flaps. It is the controlling motor for the RIGHT, side vent air flap #8B. However, this motor is in the way & partially covering up the warm mixing linkage connection to flap. Removal of this motor is ok (if needed). If the warm mixing linkage to flap is loose, this motor will have to be removed later anyway to be able to fix the loose condition.

5A) If not already completed in step #1C (above), **remove stepper motor #11-M022** (screws and motor) in order to access loose RIGHT, warm mixing flap pin/linkage & for for better visual access.

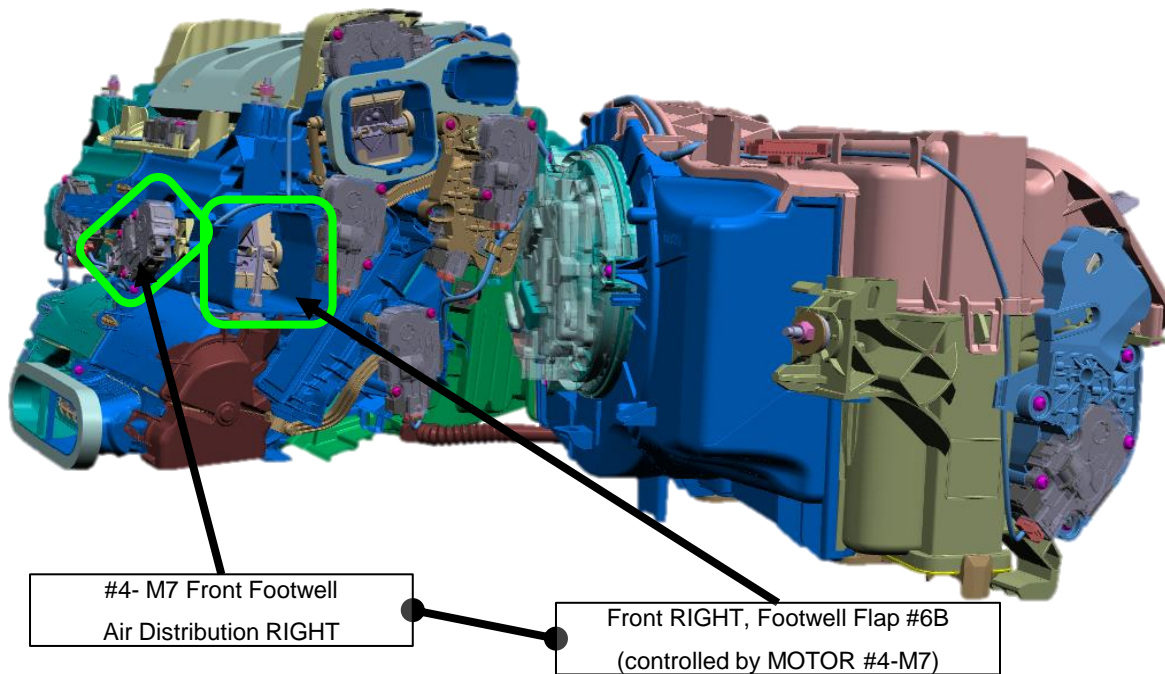
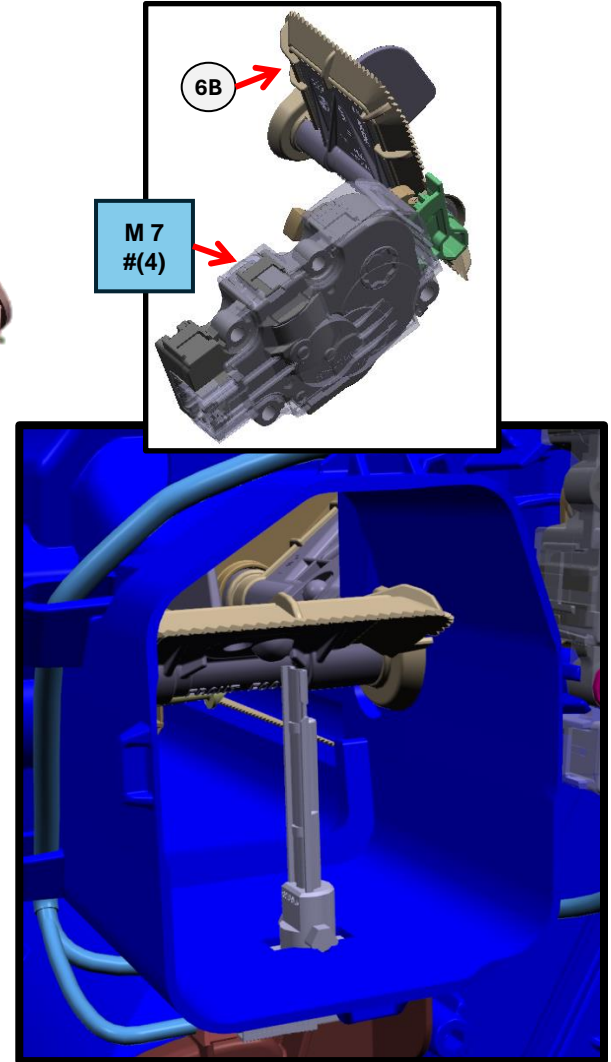
Reference Picture: **J- OPEN Front RIGHT, Footwell Flap #6B**

(LHD: Right Side VIEW)

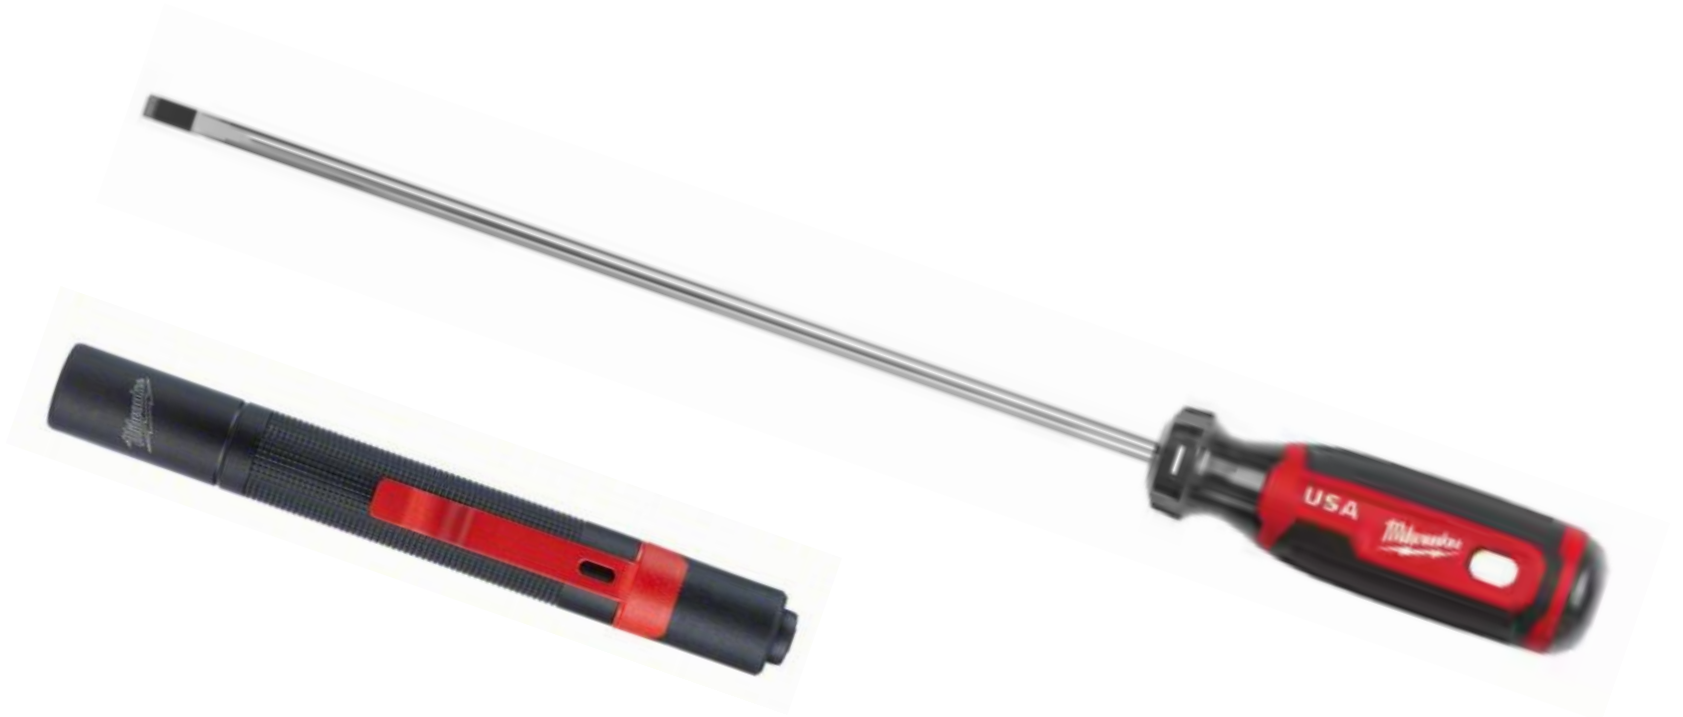
- **Provide significant outboard counterforce to the warm mixing flap #5B!**

NOTE: A flathead screwdriver (or similar) is needed for this step. A flashlight could also be helpful.

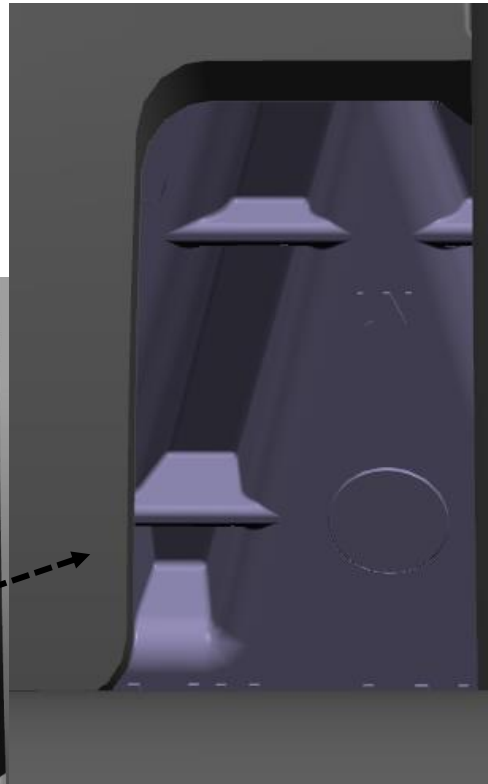
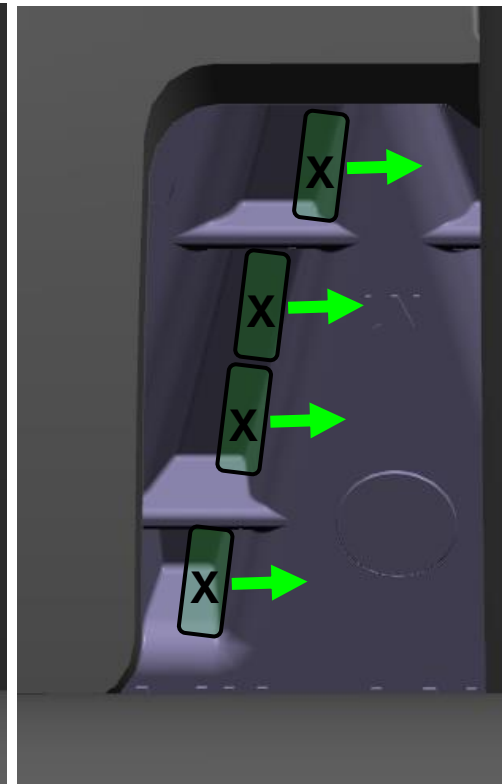
Reference Picture: M- Wedge/Pry Locations on Warm Mixing Flap #5B

Main positions to locate and wedge/pry the flathead screwdriver for needed outboard counterforce on flap!

Increasing ZOOM to show details!

Grab the warm mixing linkage and **PUSH HARD INBOARD** to **FULLY ENGAGE** the loose pin/linkage into the **warm mixing flap #5B** .

If you FAIL to secure/provide significant counterforce to the flap, at the same time you engage the pin/linkage, then it is possible for it to **NOT** fully engage even if it may feel like it is!

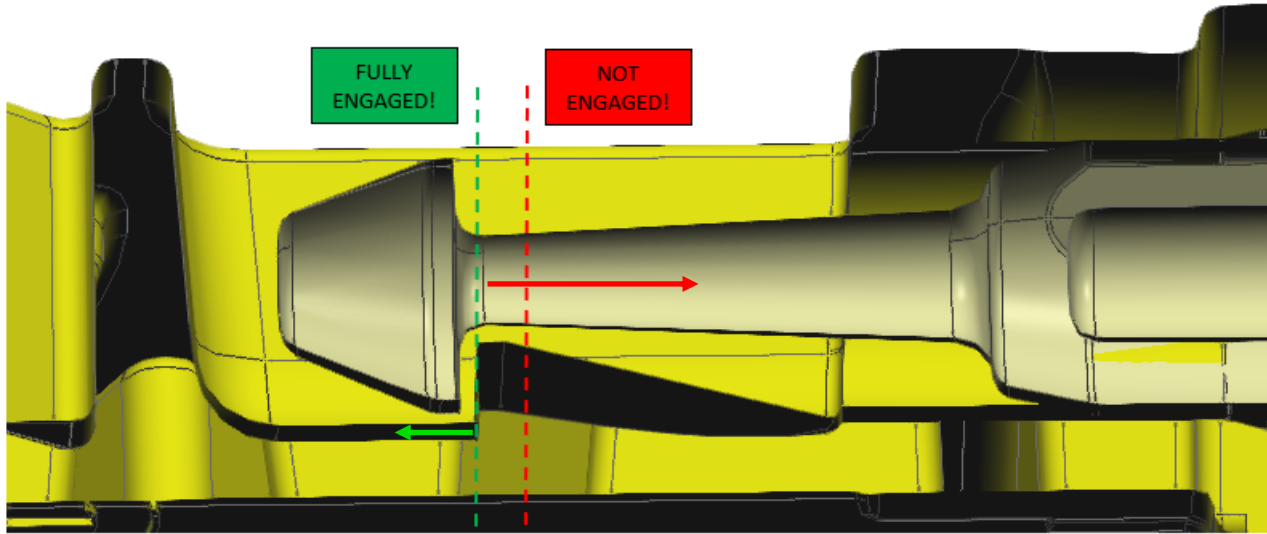
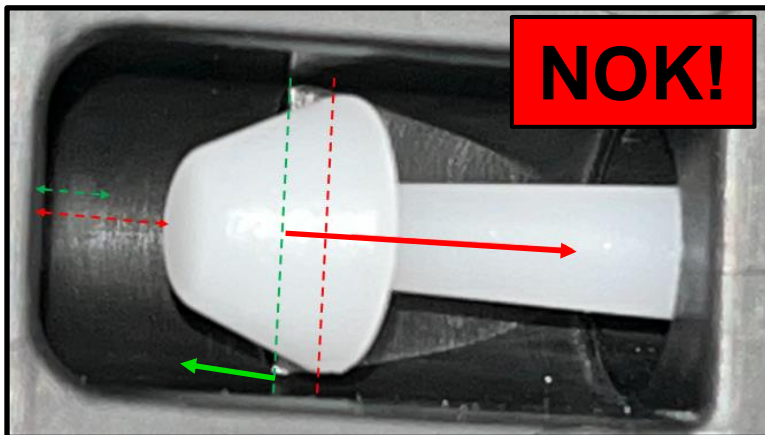
Reference Picture: A- Fully Engaged vs NOT Fully Engaged

CAD
Section
Cut

Real Part

Main References:
--- FULLY Engaged ---
--- NOT FULLY Engaged --
-

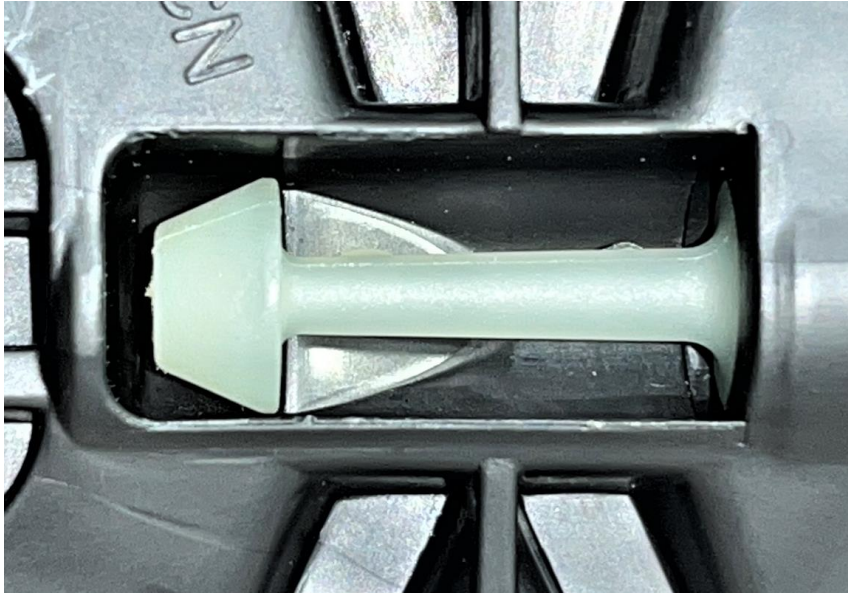
Reference Picture: **B- Fully Engaged vs NOT Fully Engaged**

OK

FULLY ENGAGED

Pin/Linkage Mushroom Head Completely Over Ramp on Flap!

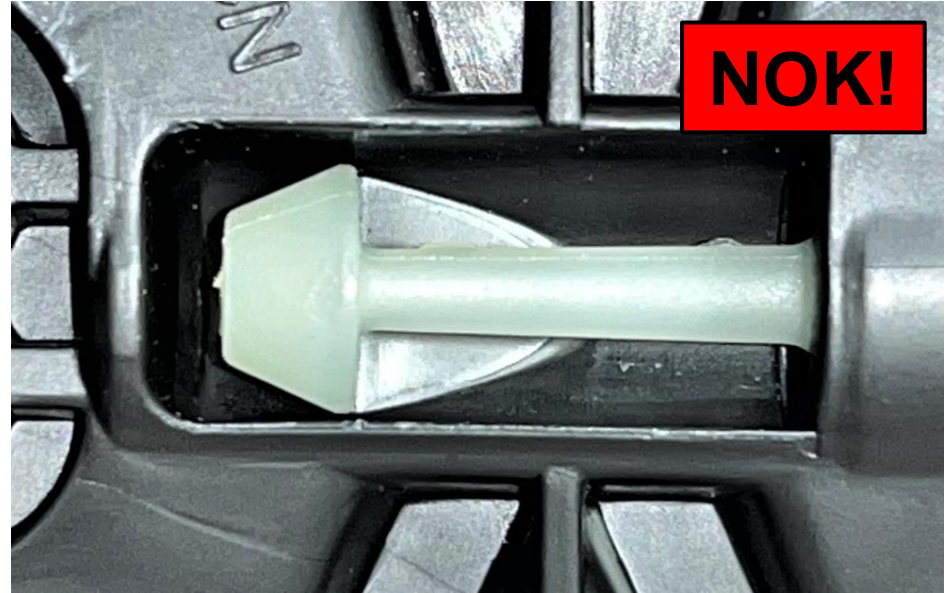
NOK!

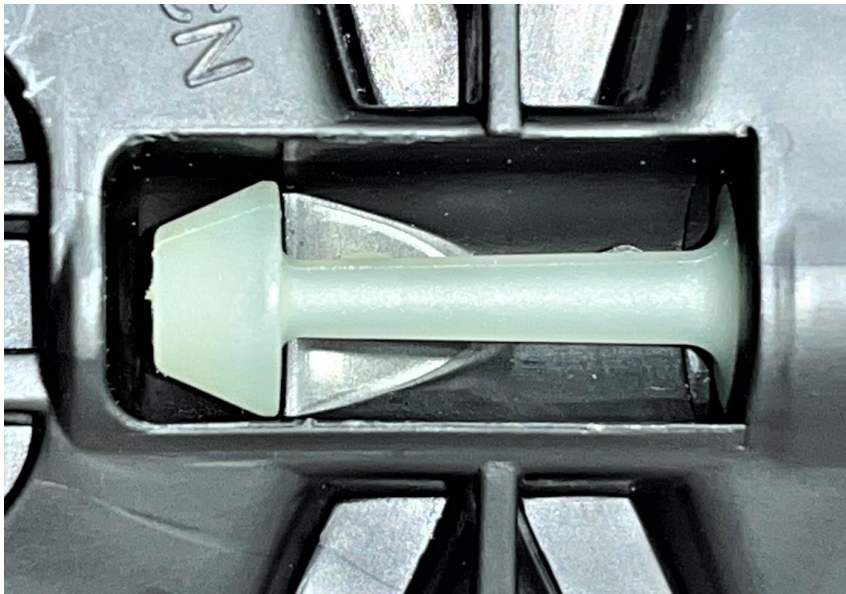
Reference Picture: **C- Fully Engaged vs NOT Fully Engaged**

FULLY ENGAGED

**Pin/Linkage Mushroom Head
Completely Over Ramp on Flap!**

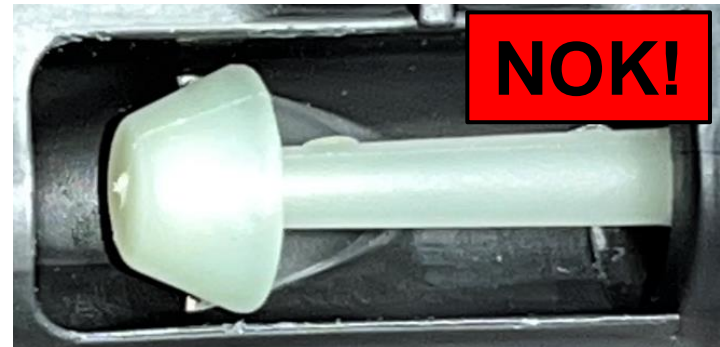
NOK!

Short of FULL engagement!

Note: Partial engagement already has some tension which may give the feeling of FULL engagement even if NOT FULLY engaged! When, not completely engaged, **the function could even be ok for several cycles/rotations before it will eventually fail again**. This is why you must be certain!

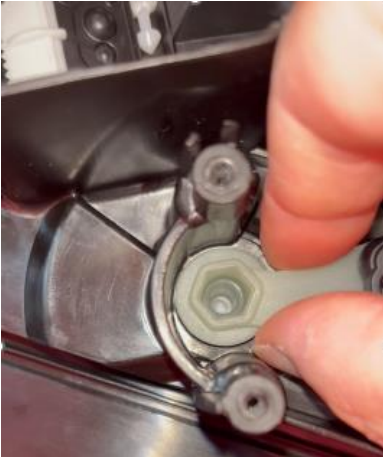
8B) Then, manually pull on the fully seated pin/linkage (detailed in step #1B/#1C above).

You should be able to pull fairly hard if the connection is completely engaged and secure.

If not fully engaged, you will be able pull it out again with only low to medium force (vs high force).
