# Newmar Corporation

**RSB 619**  
**July 07, 2025**  
**Revised**  
**8/19/2025**

## RECALL SERVICE BULLETIN

# Instructions for Baggage Door Inspection and Repair

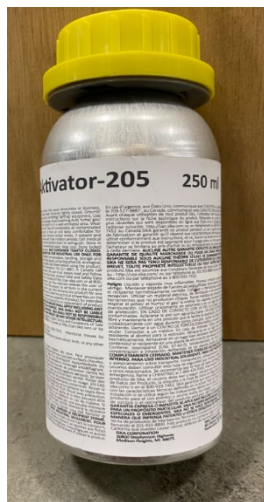
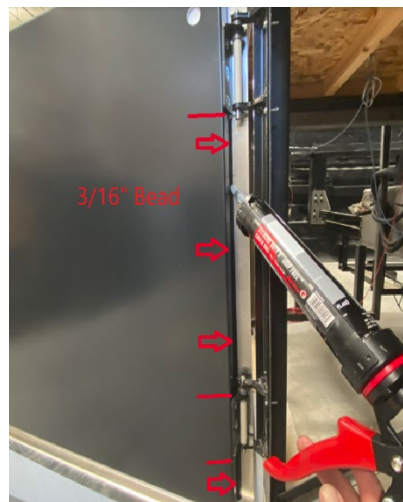
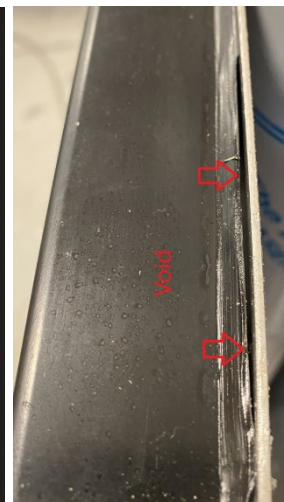
Depending on the requirements for each compartment door, clean the hinge side and/or the bottom at the corner where the outer skin and inner frame meet, making sure it is dry and free from dirt and road grime. If loose tape is present between the door skin and the door frame, remove as much as possible.

After cleaning the door frame and skin, apply the Sika® Aktivator-205 to the area(s) you plan to apply Sikaflex®-252.

Apply the Sika® Aktivator-205 using a lint-free paper towel, allowing it to flash off for a minimum of 10 minutes, but no more than 2 hours.

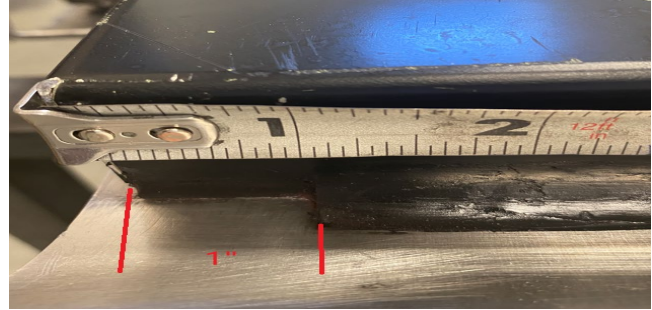
Apply a 3/16” bead of Sikaflex®-252 to the hinge side (if needed). Spray Sika® Slick on the bead of Sikaflex®-252 and tool it with a finger, making sure the bead is bonded to the door skin and frame with no voids.

Apply a 5/16" bead of Sikaflex®-252 to all compartment doors at the bottom, leaving a one-inch gap near the corners for drainage should any water get between the skin and door frame.

Spray Sika® Slick on the bead of Sikaflex®-252, tool it with a finger, making sure the bead is bonded to the door skin and frame with no voids, except the one-inch at each end.

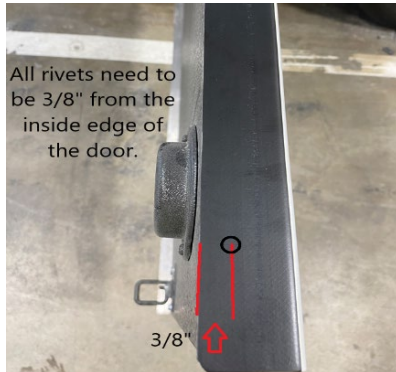
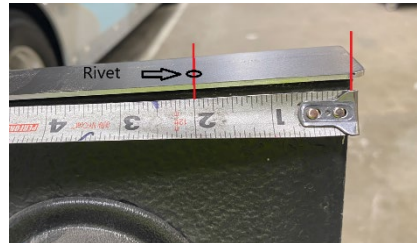
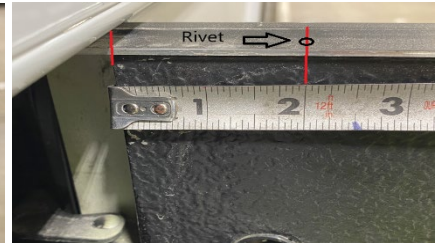
Using a 3/16" drill bit, drill and add three 3/16" rivets along the top (no rivets are needed on top-hinge doors) of each compartment door two inches from the top edge of each side and one evenly spaced in the middle of the two outer ones (measurement will vary based on size of door) and 3/8" from the inner edge of the door frame.

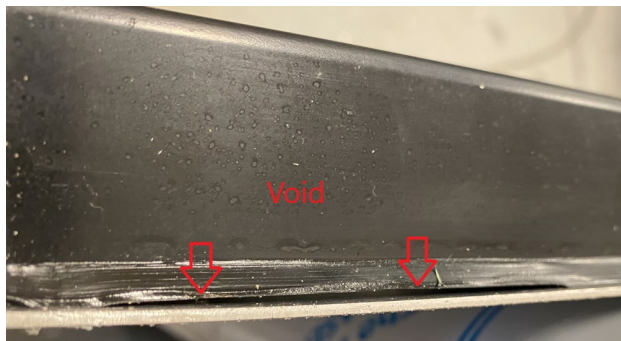
After six hours, inspect all new Sikaflex®-252 to ensure no voids are present (see example below).

All Sikaflex®-252 unclamped applications require a minimum of six hours of curing time. After six hours have elapsed, check the door for any voids. If any voids exist, clean the Sikaflex®-252 from the affected area, and apply a new bead.
