Warranty Extension: 2014–19 MDX and 2017–19 MDX Sport Hybrid - Moisture in the Inner Taillights

Supersedes 25-003 dated July 9, 2025, to revise the information highlighted in **yellow**.

BACKGROUND

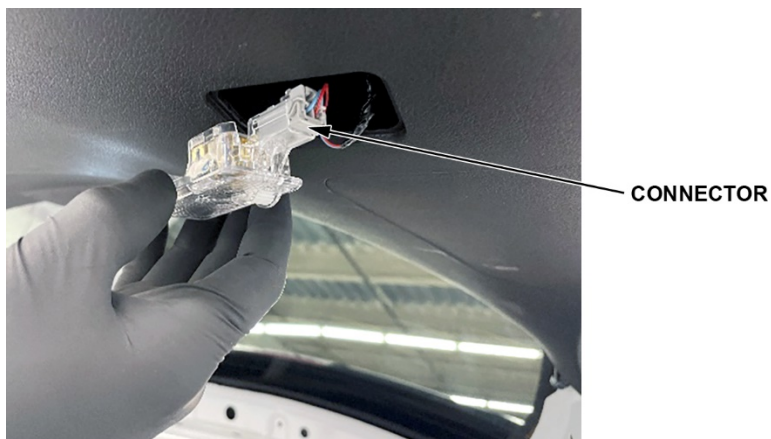
4. Remove and disconnect the tailgate light connectors.

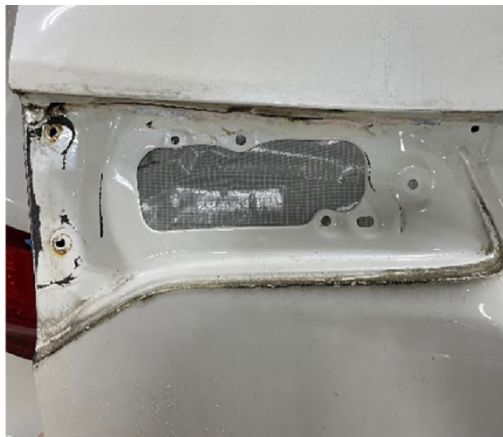
11. Once the dust sealer removal area has been marked, remove the template.
12. Seal the tailgate before doing the dust sealer removal:
 1. Place tape over the opening for the lid light.
 2. From the inside of the tailgate, place tape over the opening for the inner taillight.

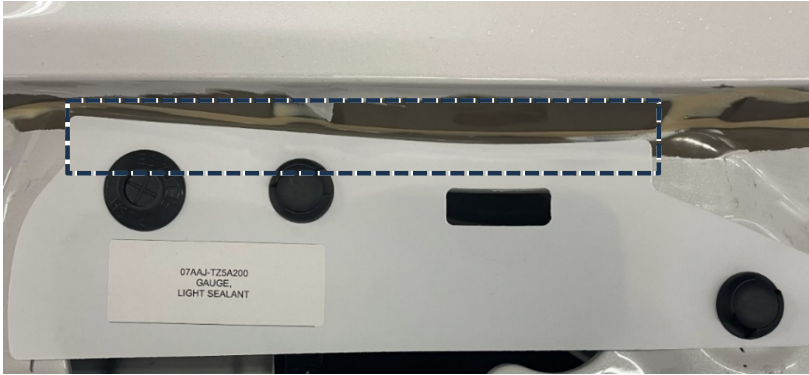
15. Use the template as a guide to ensure enough sealer has been removed.

NOTE: If the template indicates that additional sealer needs to be removed, remove the template, then continue to remove sealer as needed with the stripe off wheel.
