Oil Leak at Cam Chain Tensioner Inspection Cover

APPLIES TO

Year	Model	Trim Level	VIN Range
2025	ADX	ALL	ALL

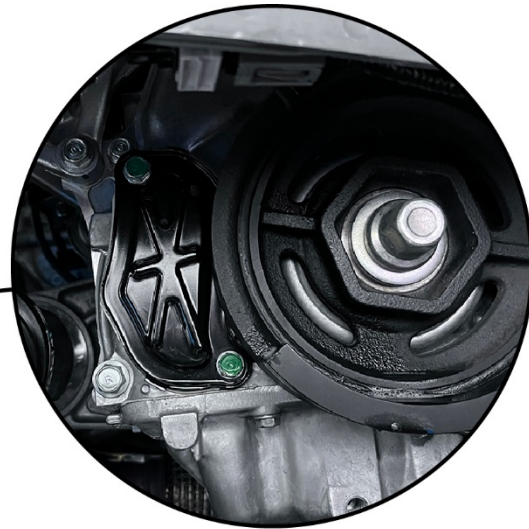
10. Remove the clips and pull down the underbody splash shield to access the tensioner inspection cover.

11. Spray the suspected engine oil leak area with soapy water.
