Technical Service Bulletin

GROUP	NUMBER
CAMPAIGN	25-01-062G
DATE	MODEL(S)
SEPTEMBER 2025	GV70 (JK1A)

SUBJECT: DTC CHECK & ELECTRIC WATER PUMP REPLACEMENT - P26CB00 (SERVICE CAMPAIGN 916G)

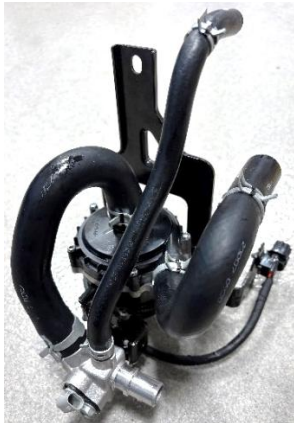
Model	Part Name	Part Number	Figure	Remarks
GV70 (JK1A)	EWP ASSY- WCAC	28275- 3N000QQH

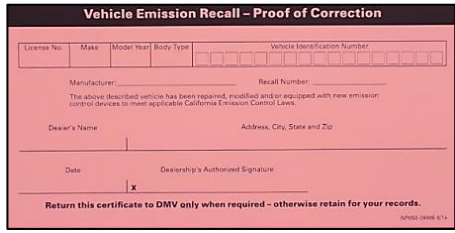
Apply to all vehicles regardless of state.
	Vehicle Emission Recall - Proof of Correction Card	NP050-09006

The Vehicle Emission Recall - Proof of Correction card must be completed by the Dealership's Service Manager using a permanent ink pen. A fine point pen is recommended. When filling in the information, copy the information directly from the vehicle, not from the repair order.

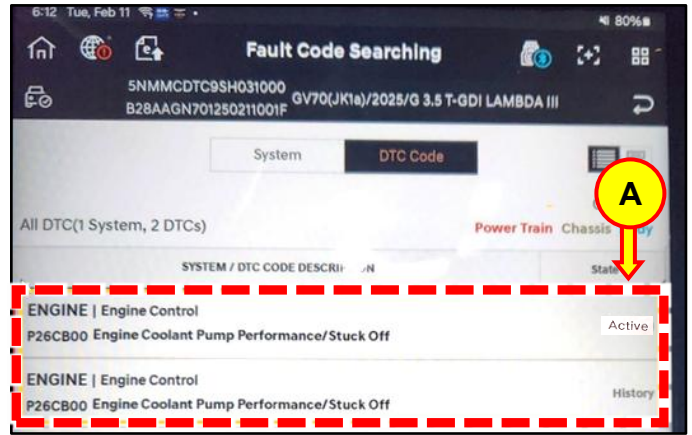
1. Using GDS, perform **Fault Code Searching** in the **Engine** system for **Active DTC P26CB00** (Engine Coolant Pump Performance/Stuck Off).
 - If DTC P26CB00 is active and stored (A), **proceed to step 2**.
 - If DTC P26CB00 is **NOT** stored, or another DTC is found, EWP replacement does **NOT** apply. Follow the normal diagnostic process, then proceed to the [Campaign Sticker Application \(for All Vehicles\)](#) procedure on **page 8**.

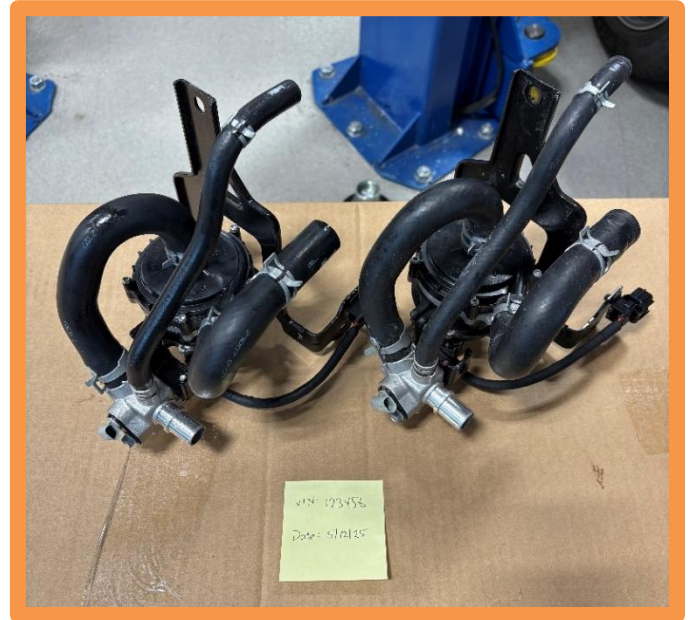
Using STUI, take a photo of the new electric water pump assembly next to the original unit along with the last 6 digits of the VIN and date of repair on a piece of paper.

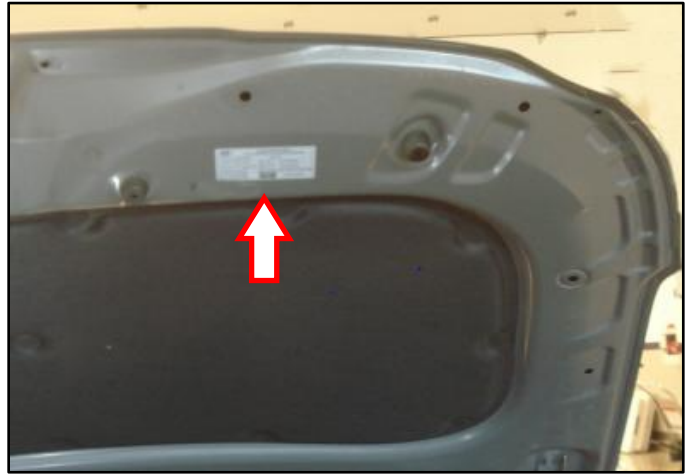
1. Fill in the Dealer Code and Date on the Campaign Sticker, and apply adjacent to the existing Emission Label, on the underside of the hood, as shown.

Be sure to clean the mounting surface to ensure proper label adhesion.
