TECHNICAL SERVICE BULLETIN

Technical Service Bulletin: 10-1978

Forest River is alerting you to an issue involving certain 2026 Flagstaff FLT25FBD & Rockwood RLT2522FB Travel Trailers. Please see the information below, which describes the issue and provides you with details on the steps you should take to have your vehicle repaired.

2522FB/25FBD Black & Grey Tank Repair

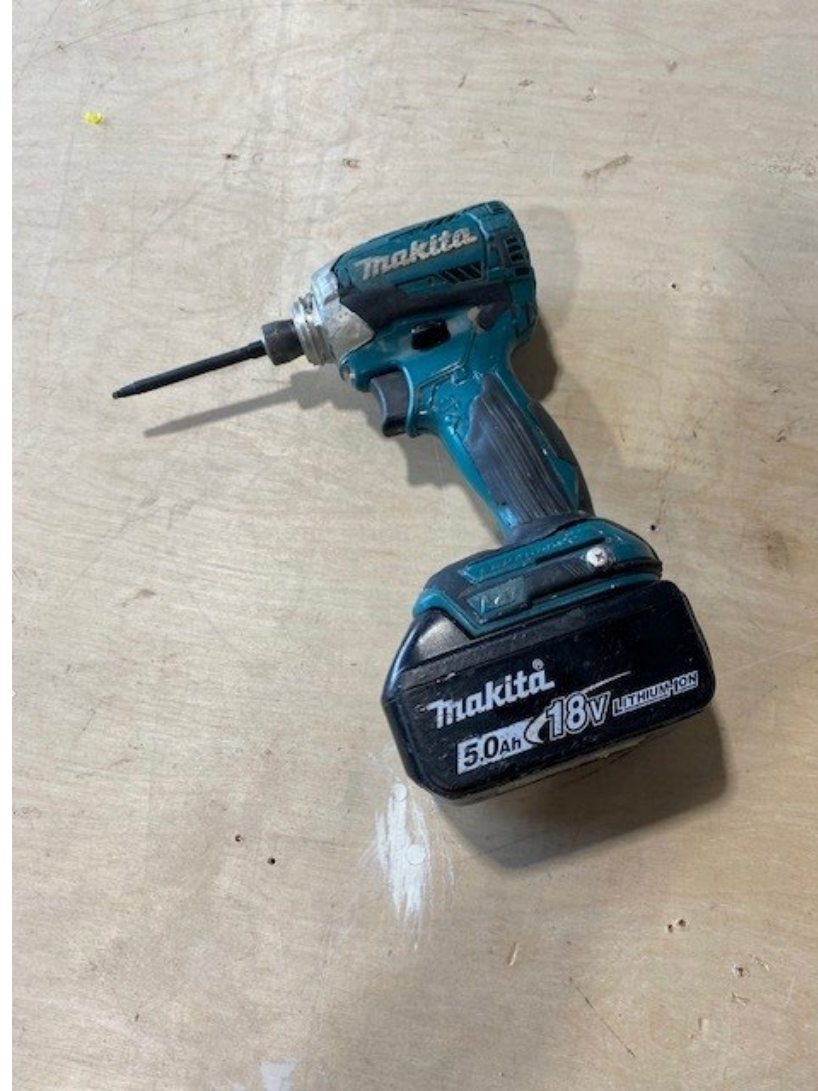
Step 1

- Open the front DS trunk door
- Remove the screws located on the top and bottom of the décor panel on the left to gain access to the control box

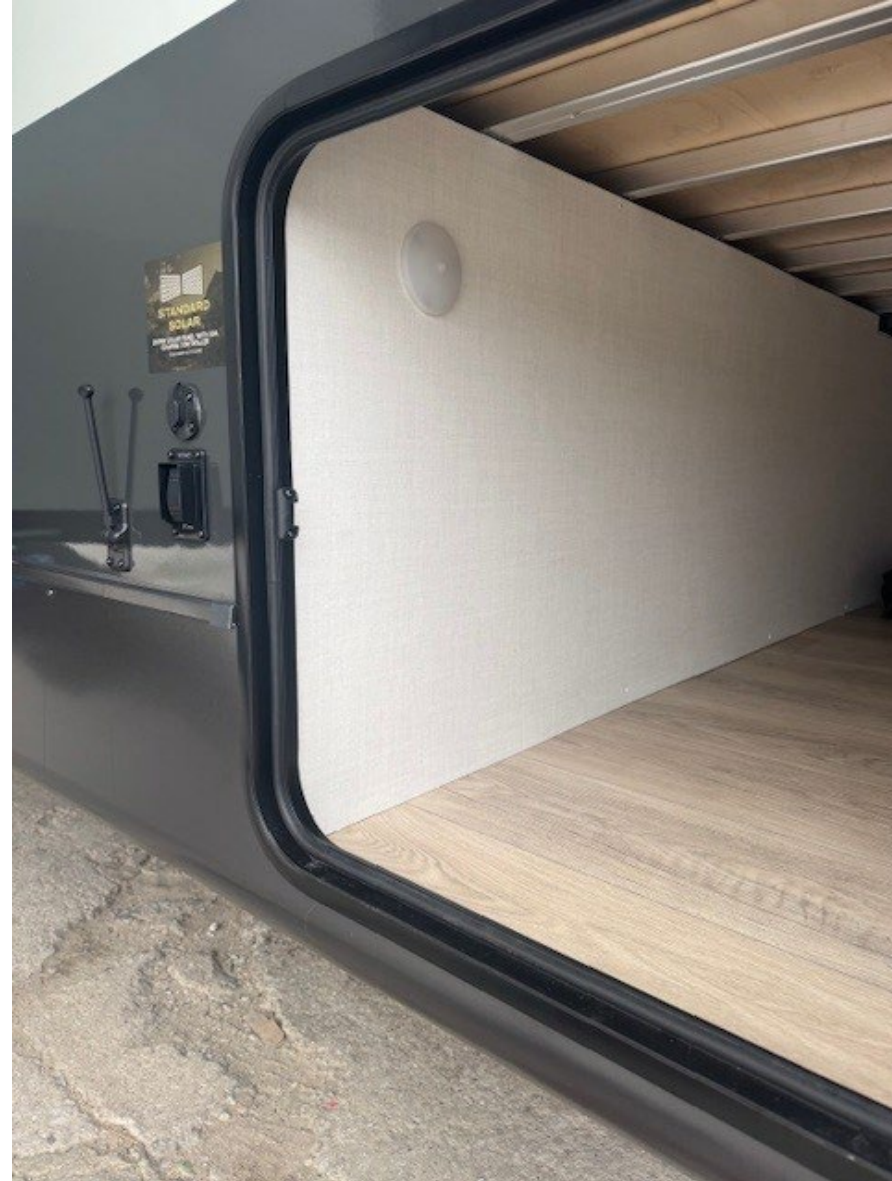
Step 2

- Carefully pull back the panel where you'll find the control Box

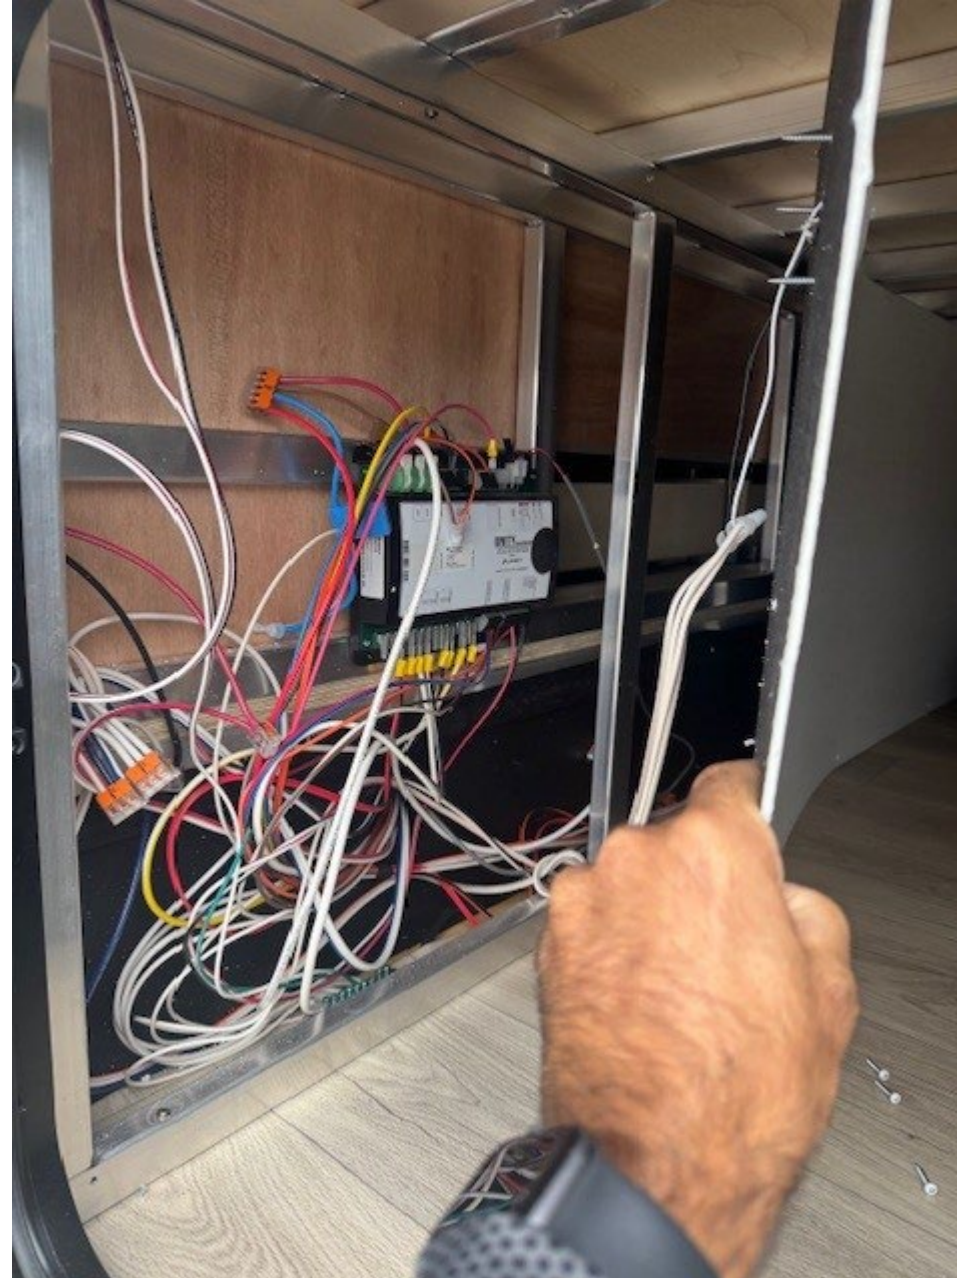
Step 3

- Find where the tank wires are attached to the controller and confirm that the brown and grey wires are reversed as shown

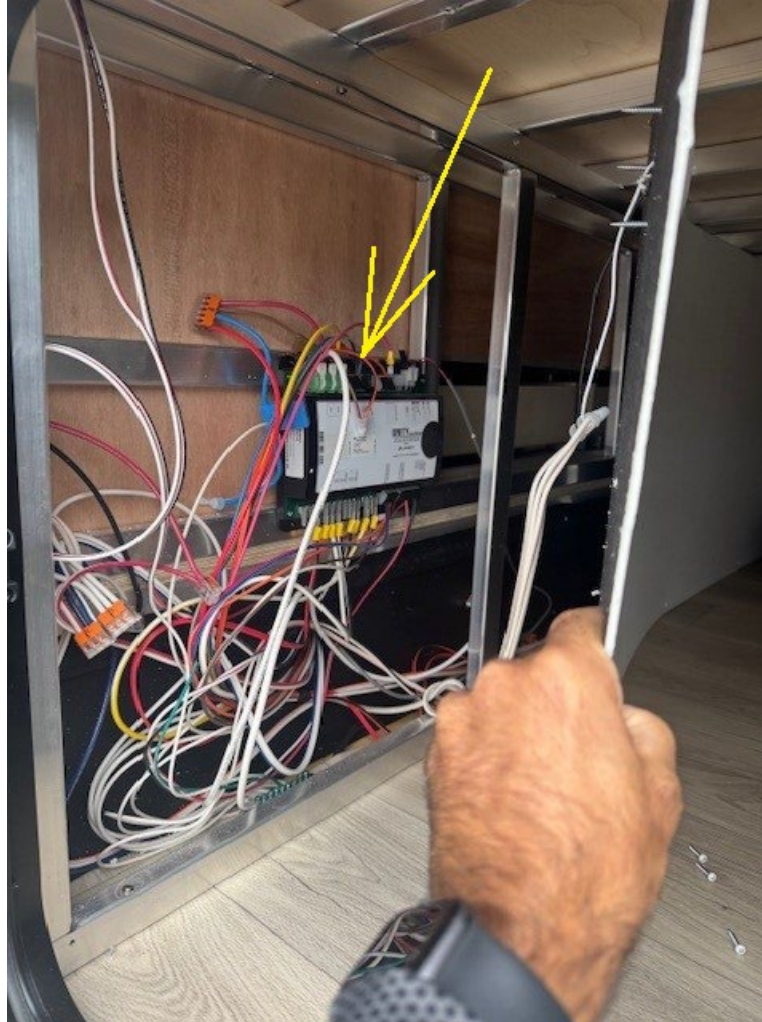
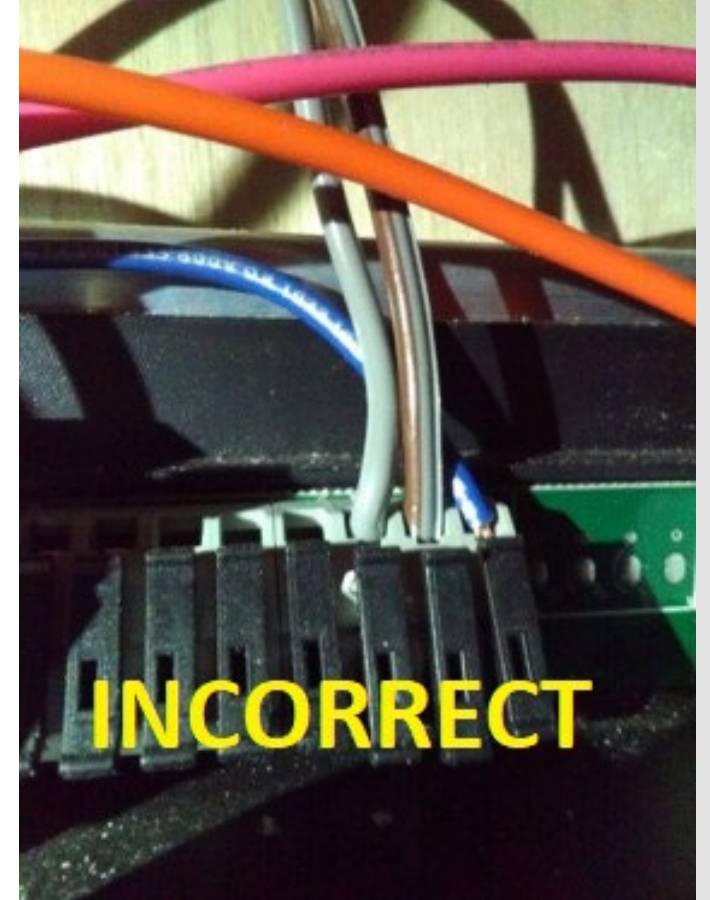
Step 4

- Reverse wires as shown
