# VEHICLE - WARRANTY BULLETIN

Can-Am On-Road

BULLETIN 2025-7 | VERSION A

## Origin Rear Central Reflector Replacement

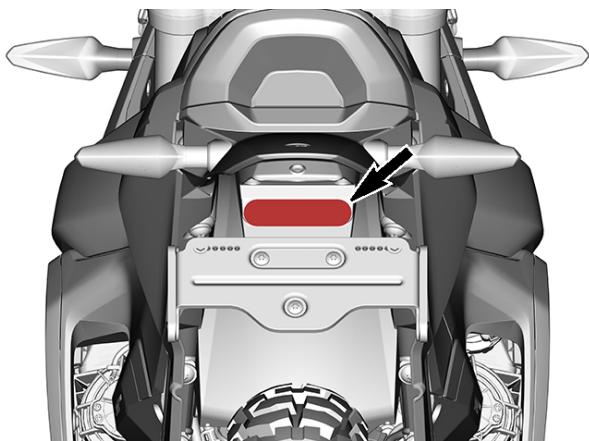
The rear reflector adhesion may not be optimal.

- 1. Remove and discard the rear reflector from the vehicle.
