## Technical Service Bulletin

25-01-064H

COOLING SYSTEM CIRCUIT DEBRIS DISCHARGE  
& COOLANT CHANGE (SERVICE CAMPAIGN T9F)

**Description:** Certain Santa Fe Plug-in Hybrid (TM PHEV) and Tucson Plug-in Hybrid (NX4 PHEV) vehicles may exhibit a restricted coolant flow condition, which may be accompanied by a warning message (e.g., Coolant Supplement, Refill Inverter Coolant) in the cluster. No related DTCs are stored, and coolant level is normal in the reservoir tank. The coolant flow may be restricted by debris, causing abnormally high Electric Water Pump (EWP) speed. This TSB contains instructions for confirming high RPMs in the EWP, then using the Coolant Flushing Equipment Set to flush and clean debris from the various cooling system circuits. The coolant will be replaced with the updated Electric Vehicle Battery System Coolant (BSC-2) low-conductivity blue coolant.

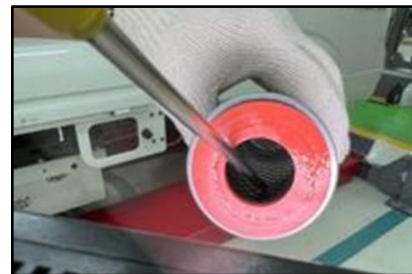
Spray the air gun into the gaps of the filter's inner wall, where sludge can get lodged. Rotate the filter to ensure even spraying and to remove as much buildup as possible.

A clogged filter may have decreased flow rate and reduced cleaning efficiency.

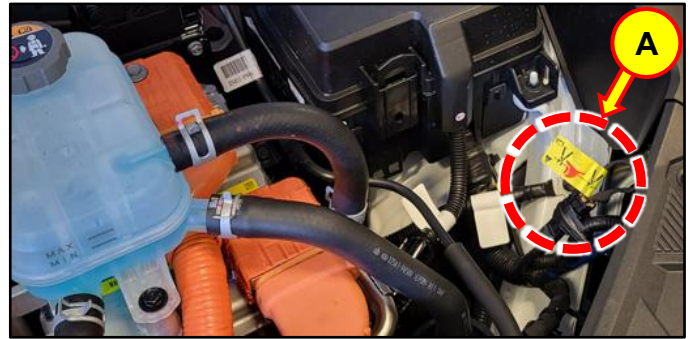
1. Turn **OFF** the ignition and remove the underhood service interlock connector (A).

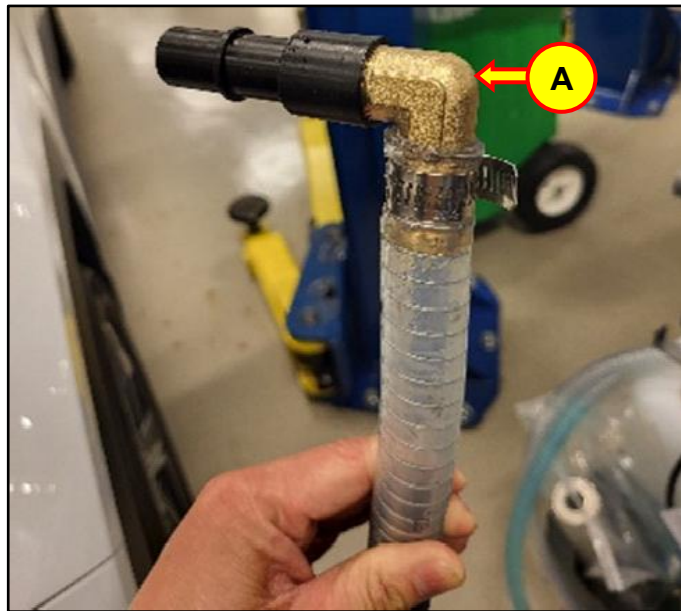
1. Verify the supplied **90 degree** angled hose fittings (A) are installed on the hose ends.
