Technical Service Bulletin

GROUP	NUMBER
STEERING SYSTEM	25-ST-001G
DATE	MODEL(S)
SEPTEMBER 2025	SEE BELOW

SUBJECT: STEERING SHAFT NOISE INSPECTION & DUST COVER REPLACEMENT

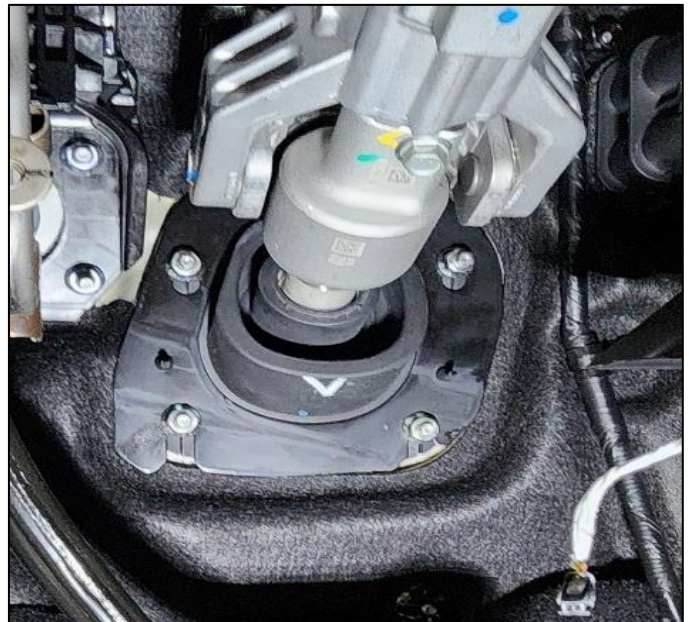
1. Start the vehicle's engine or put it in Ready mode for EVs.
2. Turn the steering wheel side to side and listen for sound coming from the steering shaft dust cover area.

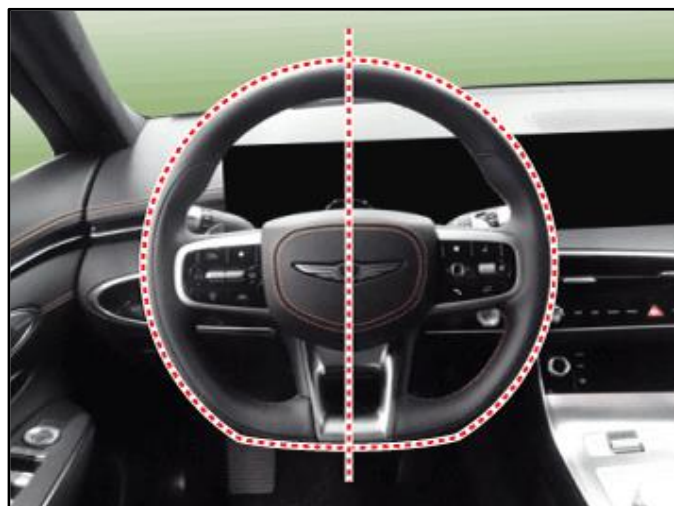
1. Center the steering wheel, front wheels pointed straight ahead. Use a steering wheel holding tool from an alignment machine to prevent the steering wheel from turning.

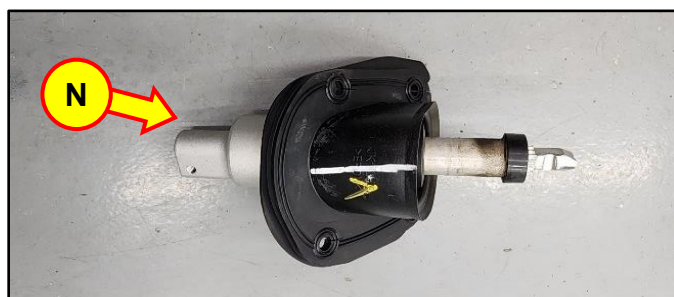
12. Remove the steering shaft dust cover nuts (M) and then the steering shaft dust cover assembly (N).

Tightening Torque:

(JK1, JK1A, JK1A EV)

lb-ft	7.3
lb-in	88
N.m	9.8

(RG3, RG3 EV, RS4, JX1)

lb-ft	11
N.m	15

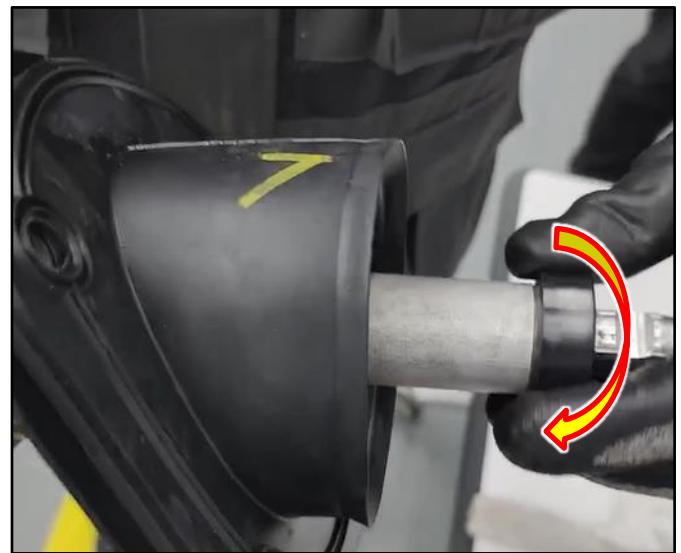
- 17. Ensure the dust cap is properly seated in the groove by rotating it by hand.

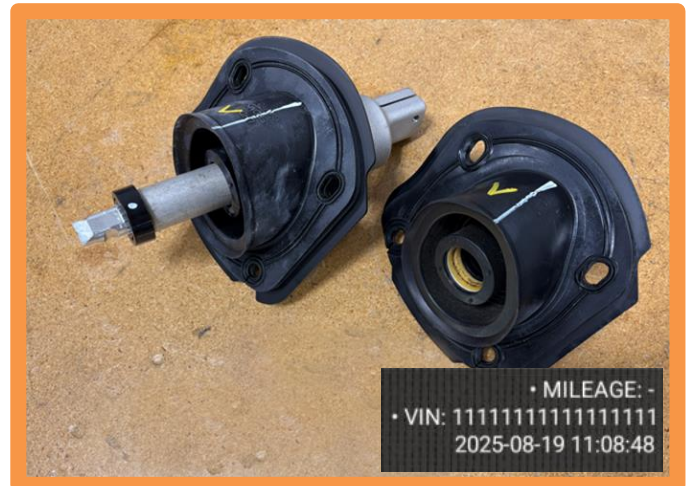
Using STUI, take a photo of the new steering shaft dust cover with the original (removed) dust cover in the same image.
