Preview Solution CBR-2482-2

## PTO Malfunction Pop Up - VN (4) - PR (4)

Published 5 September 2025

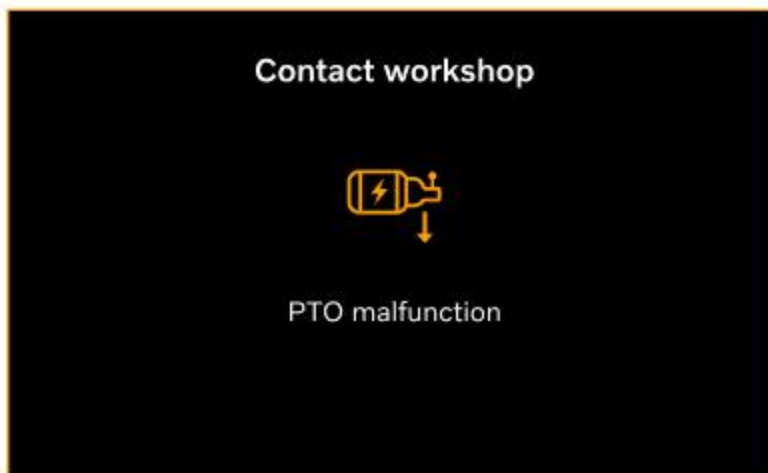
Purpose of this CBR is to address Pop up message for PTO Malfunction when there is no PTO Installed.

When encountering a unit with a pop-up message for PTO malfunction and fault code P100A15, follow steps below:

**1.** Check to see if unit has a PTO switch installed in dash. If there is a switch, check to see if there is a PTO solenoid installed on transmission.

2. If there is no solenoid installed on transmission please order parts below and install solenoid.

3. Once solenoid is installed, please clear faults and release unit to service.
