Service Bulletin

Bulletin No.: 23-NA-151

Subject: Hybrid/EV Battery Stability, High Priority DTCs, Potential Loss of Isolation, Vehicle Handling and Battery Pack Return Shipping Requirements

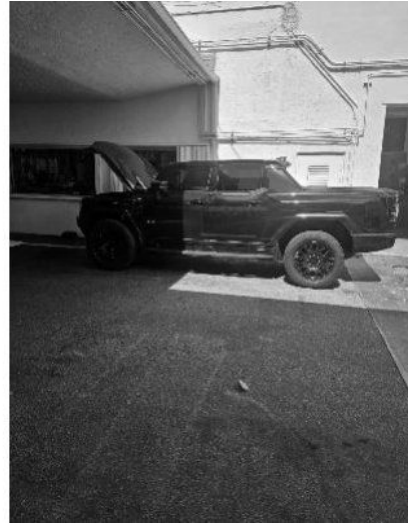
Figure 4 (Vehicle and Battery Pack Isolation – Passed)

8. Move the vehicle to a stable location outdoors: isolated and away from buildings, vehicles, and foot traffic while waiting direction to diagnose/repair. Recommended distance is 50 feet (15M). Document isolated location via photo (Fig 4 and 5). Refer to 'Neutral Service Mode' in electronic transmission range select service information if required.
9. Start a TAC case and upload all photos and your GDS2 session log per Document ID: 6385557 / PIP4902 and reference this bulletin. Additionally, provide any previous diagnosis work performed based on the DTC(s) set or inability to collect the data.

11. Place the High Voltage Battery in the provided DDR Crate & move outdoors: isolated and away from buildings, vehicles, and foot traffic. Cover high voltage battery/DDR crate with a tarp to protect from the elements while awaiting further direction (Fig 4). Take picture of location and upload into TAC Case. Report all results to TAC for Engineering review.

Move vehicle to stable location away from buildings and other vehicles. Recommended isolation distance is 50 feet (15M) Photograph results. <i>Warning: Never leave a vehicle or battery pack with an applicable DTC indoors overnight, plan all work to be completed during normal business hours.</i>	Passed Example Refer to Figure 4	Failed Example Refer to Figure 5	Vehicle Isolated Outside and Picture Captured/Submitted _____
Start TAC Case (submit all the above).	Vehicle to stay isolated outdoors until Hybrid/Electric Vehicle Battery Pack Removal and Installation or under the direction of TAC during any required diagnosis procedure.		TAC Case Created Case # _____

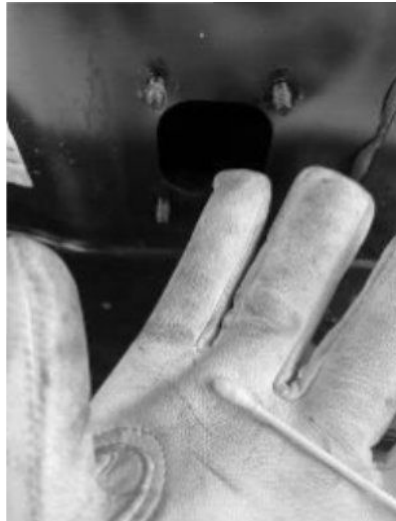
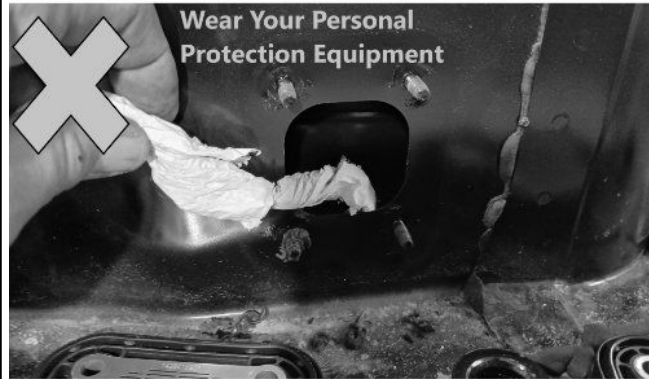
Figure 11 (Battery Pack Swab Test – Passed)

- 10.3. Remove the High Voltage Battery Pressure Equalizer Vent and Battery Inspection plug (if equipped) (Fig 11 and 12). The equalizer vents have 4 fasteners and are located at the base of the battery. Wearing your personal protection equipment use a cotton swab or paper towel to swab inside the enclosure for moisture/coolant and/or soot. Take photos and attach to TAC case.

Note: If fluid/soot is observed, continue but contact TAC immediately upon completion.

Hybrid/Electric Vehicle Battery Pack Analysis			
Steps	Results		Submission Check list
Remove the HV battery pressure equalizer vent and inspection plug (if equipped). Insert a cotton swab as an aid to detecting moisture/coolant. Photograph and advise TAC of findings.	Passed Example Refer to Figure 11 On some vehicles the pressure equalizer vent is accessible prior to battery pack removal.	Failed Example Refer to Figure 12	Pass Fail Pictures Captured/Submitted
Hybrid/Electric Vehicle Battery Pack Replacement and Shipping Preparation Remove coolant from the HV battery internal coolant circuit.			Pass Fail Pictures Captured/Submitted
Hybrid Battery Pack Coolant Passage Leak Test. Inspect coolant passage for leaks, should maintain 20 inches of vacuum for 2 minutes. Photograph and advise TAC of findings.	Passed Example Refer to Figure 13	Failed Example Refer to Figure 14	Pass Fail Pictures Captured/Submitted

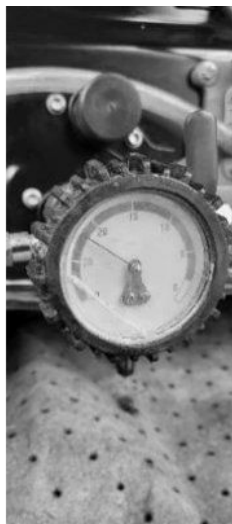
Figure 13 (Coolant Passage Vacuum Leak Test – Passed)

- 10.5. Vacuum test the High Voltage Battery coolant circuit for leaks. See Hybrid Battery Pack Coolant Passage Leak Test (Fig 13 and 14). Attach photos to the TAC case.

Note: If the High Voltage Battery coolant circuit does not hold vacuum, continue but contact TAC immediately upon completion.

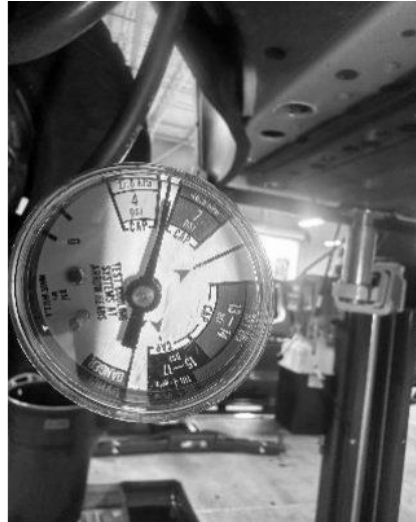
Figure 15 (Coolant Passage Pressure Leak Test – Passed)

- 10.6. Pressure test the High Voltage Battery coolant circuit for leaks (Only complete if passes vacuum test). See Hybrid Battery Pack Coolant Passage Leak Test (Fig 15 and 16). Attach photos to the TAC case.

Hybrid Battery Pack Coolant Passage Leak Test. Inspect coolant passage for leaks, should maintain 5 psi of pressure for 2 minutes. Photograph and advise TAC of findings. Note: ONLY PERFORM PRESSURE TEST IF VACUUM TEST WAS PASSED	Passed Example Refer to Figure 15	Failed Example Refer to Figure 16	Pass Fail Pictures Captured/Submitted
Stable to Ship determination			RESULTS
If moisture/coolant/soot was detected at the HV connectors the HV battery is NOT STABLE. If moisture/coolant/soot is detected at the equalizer vent and/or inspection plug the HV battery is NOT STABLE.			
NOT STABLE		STABLE	
Immediately Place the HV battery in the provided DDR Crate (if available) and move to a stable location outdoors, away from buildings, vehicles and foot traffic. Cover the HV battery or DDR crate with a tarp. Photograph location and immediately advise TAC.		Place the HV battery in the provided DDR crate. Advise TAC of the results and request the core return process.

Note: If the High Voltage Battery coolant circuit does not hold pressure, continue but contact TAC immediately upon completion.
