SERVICE INFORMATION BULLETIN

APPLICABILITY: All Models **NUMBER:** 10-105-25R
SUBJECT: New Procedure and Fail Code for First-Time Undetected A/C Refrigerant Leaks **DATE:** 05/01/25
REVISED: 09/05/25

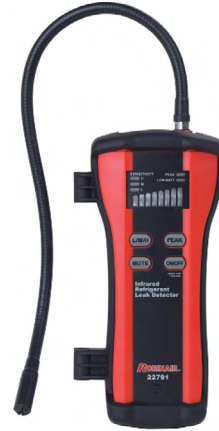
Subaru of America recommends the [Robinair™ LD7 Infrared Leak Detector](#) to be used when diagnosing refrigerant leak concerns.

- **Detection Capability:**
 - R134a is 0.05 ounces per year.
 - R1234y is 0.01 ounces per year.
- **Proper Technique:**
 - Move the probe at 1-2 inches per second in a double-pass method.
 - Keep probe approximately ¼ inch from the component.
 - Focus on low-lying areas. Refrigerant is heavier than air.
