STAR ONLINE PUBLICATION

Case Number: S2323000020 Rev. B

Symptom/Vehicle Issue: Power Side Steps Reverse, Stop In Motion, And/Or Do Not Deploy Or Stow

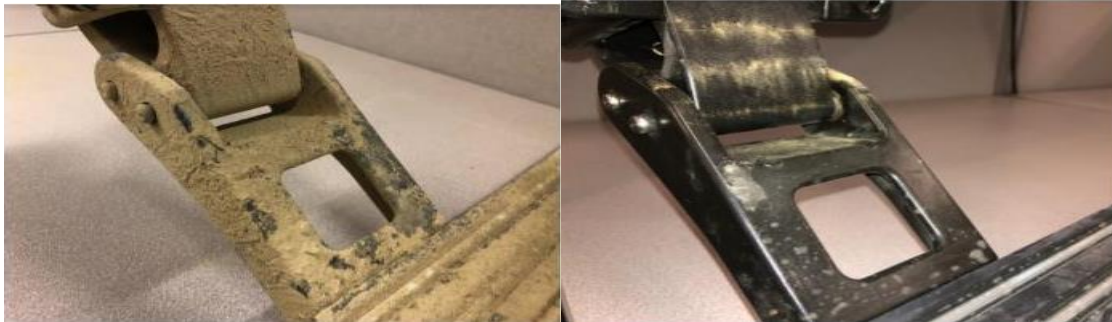
Fig 1
Before and after pressurized water cleaning

2. Inspect the pivots and linkage of the PSS. If there is dirt/debris buildup, clean between the links and bushing ends/tracks using high-pressure water. The use of a car wash wand is best to prevent excessive water pressure from damaging nearby components. See Fig 1

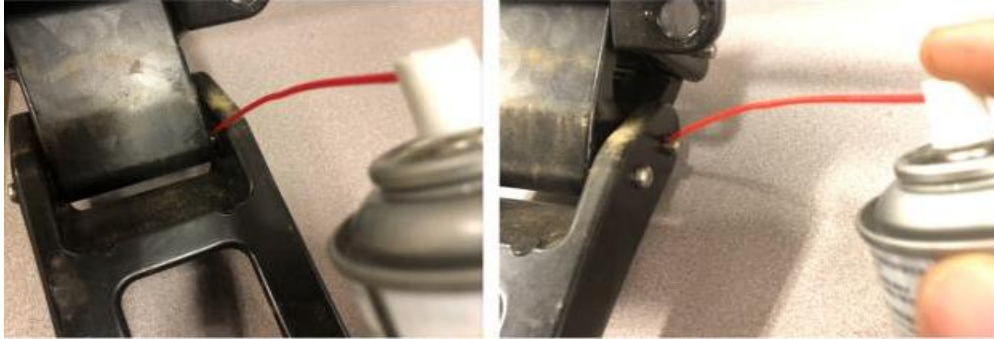
Fig 2

3. Use a Penetrating spray like MP-50 MOPAR Rust Prevention Lubricant 04549626AD and continue to clean the bushing/pivot locations of both running boards. This will help remove any embedded corrosion/debris that pressure washing may not have removed. If any leftover corrosion/debris is present after using the penetrating spray, perform step 2 again followed by step 3 until corrosion/debris is completely removed from the pivots.
4. Use compressed air to dry the surfaces and remove further debris from the pivots and linkage.
5. Once clean and dry, cycle (extend and retract) the PSS 5 to 10 times to verify operation.
6. Apply MOPAR Spray White Lithium Grease 04318066AE to the pivot points (Fig 2 and 3). Remove excess lubricant with a shop towel. Deploy and retract the PSS 5 to 10 times.
