Title: Next Gen CE Bus Entrance Door Troubleshooting Tips

Applies To: Next Gen CE Bus

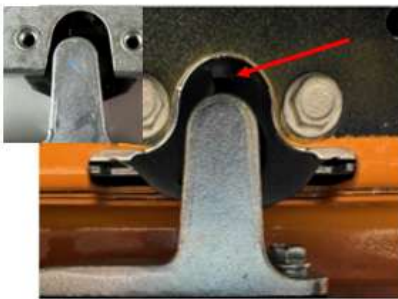
Misaligned Striker Example

Under normal operating conditions, each door will have two audible clicks when properly latched, this a 2 stage latch design similar to most personal vehicles door latches. When checking manually, the force required to latch is <80N applied at the outside handle, and can be as low as <50N if there is proper alignment.

**Note:** Red arrow is pointing to internal switch which provides input to gauge cluster. The misaligned switch is not making contact.

Step(s) for **Striker adjustment** (For steps below reference image below steps)

1. Ensure upper pivot set screws are tight using 1/8" Allen wrench. The specific torque value for 4586323c1 (red loctite) is 6.8-7.3 Nm (60-65 inlbs) and for 4586323c2 (blue loctite) is 9.04 Nm (80 inlbs)
  - o **Note:** While tightening the set screw, rock (push/pull) the door with your hand until you feel the set screw seat against the flat edge of the spindle
  - o If set screw is loose and you have original set screw 4586323c1 (red loctite), then replace with new set screw 4586323c2 (blue loctite), see pictures above for distinguishing between the two.
2. Loosen the striker bolts to allow the striker to move for alignment.
3. Close the doors using the normal door control switch
4. Hand tighten or snugly tighten with wrench striker bolts
5. Open doors to gain tool access for torque wrench and tighten to 9.7-10.7 Nm.

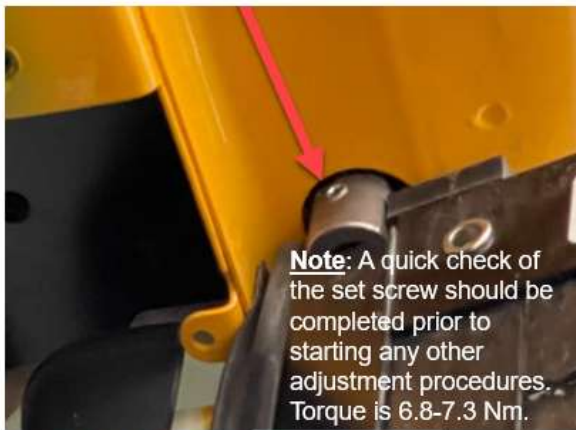
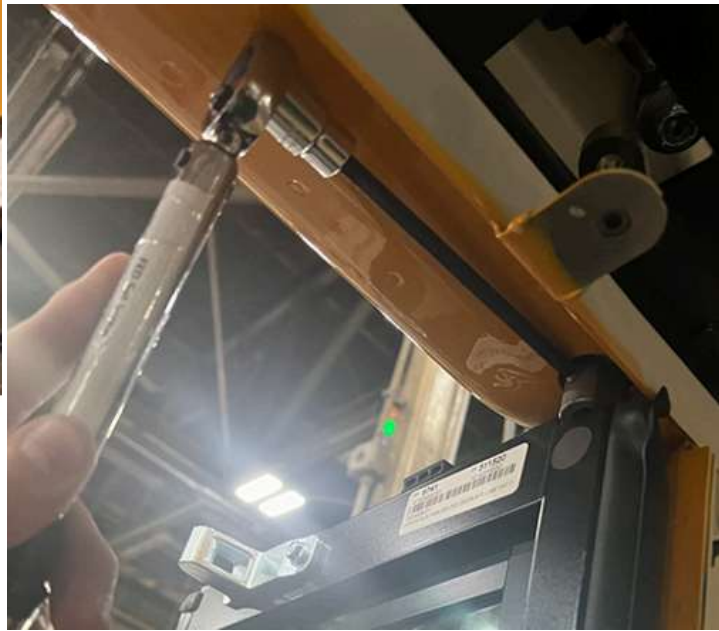
Loosen Striker Bolts

Tighten accessible bolt to Locate Striker on door while closed

Torque to 9.7 - 10.7Nm

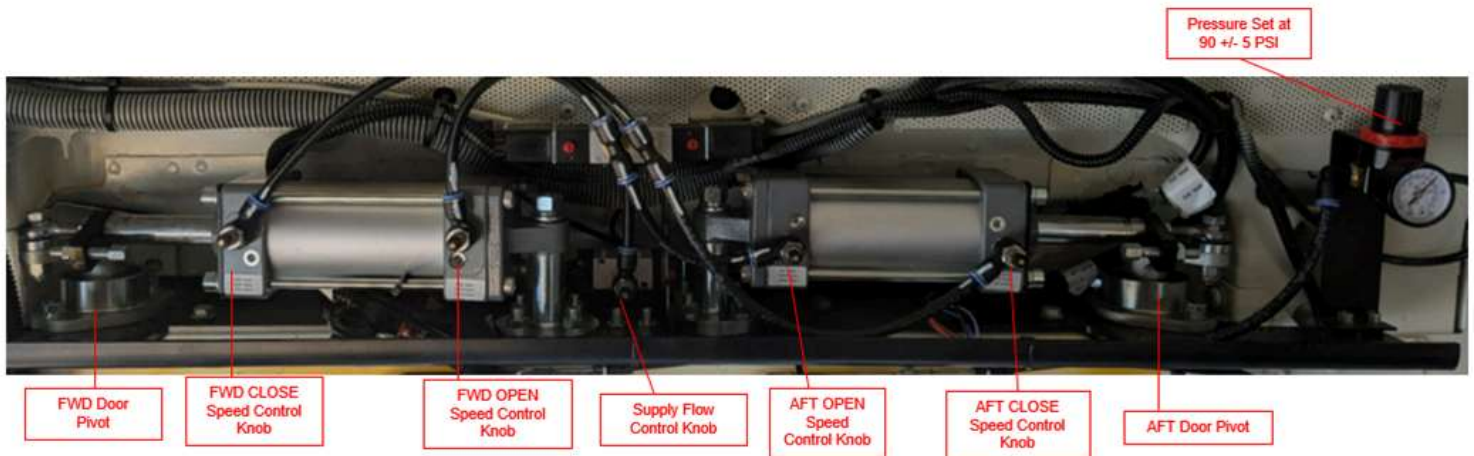
Door Pressure should be 90 +/- 5 PSI

Target closing speed is approximately 3 to 3.5 seconds (2-2.5 seconds for the rear door and forward starts 1 second after the rear)

See the repair section below or the Service Manual for adjustment guidance.

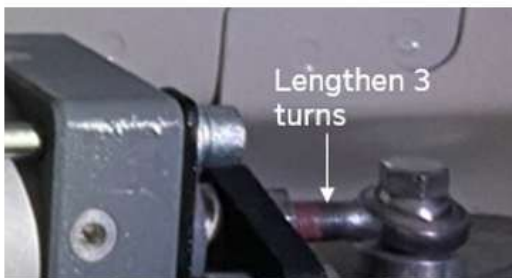
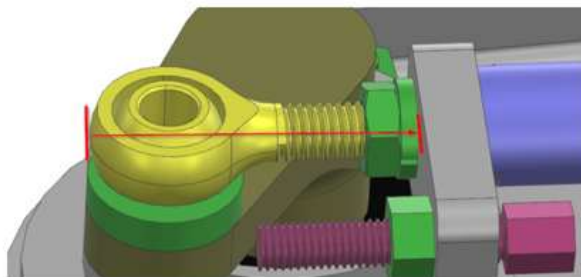
Air door only. If forward door is not latching, then lengthen the eye bolt by loosening the nut and turning the eye bolt 3 times, see below for illustration. This may seem hard to do as it has loctite on the threads. Once lengthened, retighten nut. If uncertain if this adjust has been made previously, see diagram below for measurements to check.

If it has not been adjusted out, it will be 52.7mm +/-1mm. If it has been adjusted, it will be ~55.7mm.

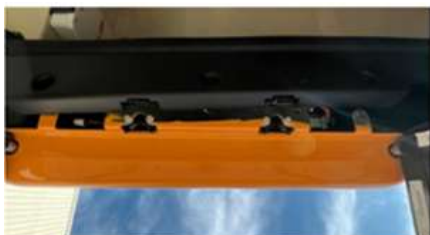
Remove Bottom Cover Fasteners

Loosen Latch Bolts

Torque to 6-8Nm w/ Door Fully Latched

1. Remove the bottom fasteners from the cover and pull back the cover to expose the latch bolts
2. Loosen bolts securing the latches to allow the latch to move.
3. Close one door leaf and maintain 6-14 Nm (5-10lb-ft) to fully engage the striker in the latch
4. While holding pressure on the door, tighten the latch bolts to 6-8 Nm
5. Repeat for the other door if required and then test the operation of the doors.

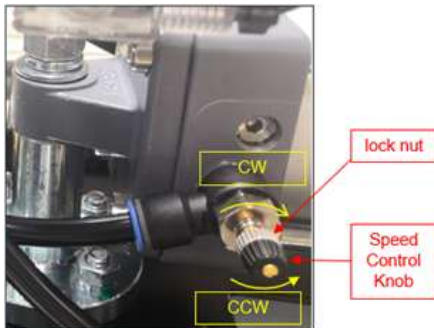
Door opening/closing speeds can be adjusted with the control knobs on each air cylinder, see adjustment procedure and visual example shown below.

1. Ensure pressure is at 90 +/-5 PSI
2. Clockwise rotation = Slows down speed
3. Counterclockwise rotation = Speeds up speed
4. Rotate speed control knobs clockwise to their extreme position to set both knobs to their closed "zero" position, and then rotate 2.5 turns counterclockwise, this will be our starting knob locations.
5. In increments of 0.5 revolutions (180 degrees), turn the speed control knobs CCW. In between increments, open/close the doors and observe time taken. Target closing speed is approximately ~3.5 seconds. Repeat this step until the doors close/open at the preferred speed.
6. Rear Door Closes in 2-2.5 Seconds.
7. Forward door starts to close 1 second after rear (staggered close).

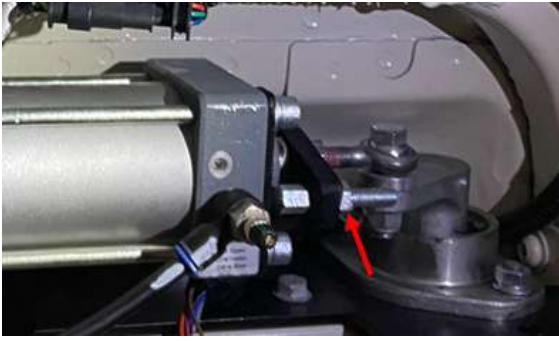
Some contact with Body is acceptable as there are bumpers on the body to prevent the door from hard contact to the body, however if the doors are hitting the body or opening past 90 degrees when fully opened, adjust the door stop on each cylinder, see picture below, this will limit the travel of the doors when opening.
