# Technical Service Bulletin

<b>Subject:</b>  <b>SEAT FABRIC FRAYING</b>	<b>Bulletin No.: 09-036/25</b>
	<b>Last Issued : 09/24/2025</b>

2023-2024 CX-50 (with cloth seat trim) with VINS lower than 7MMVA\*\*\*\*\*221374 (produced before April 29, 2024)

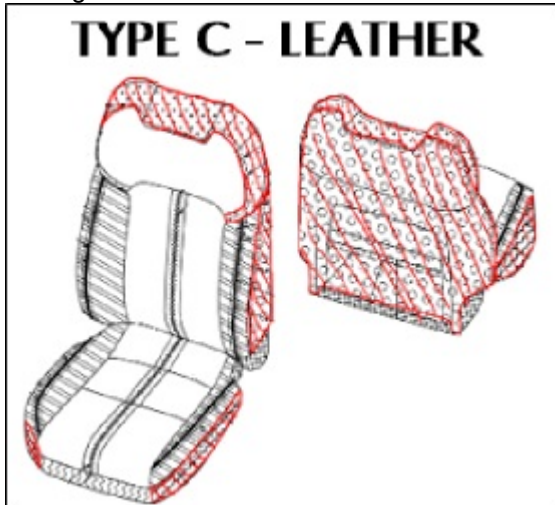
**CAUTION:** DO NOT use a steam iron on areas made of leatherette (red areas in the image below) or the trim will be damaged and will not be covered under warranty.

3. After installing the seat trim, check for wrinkles and remove if any are found.
