## Technical Service Bulletin

| <b>Topic</b> | 66 Loose trim strip |

### Audi Q6 e-tron

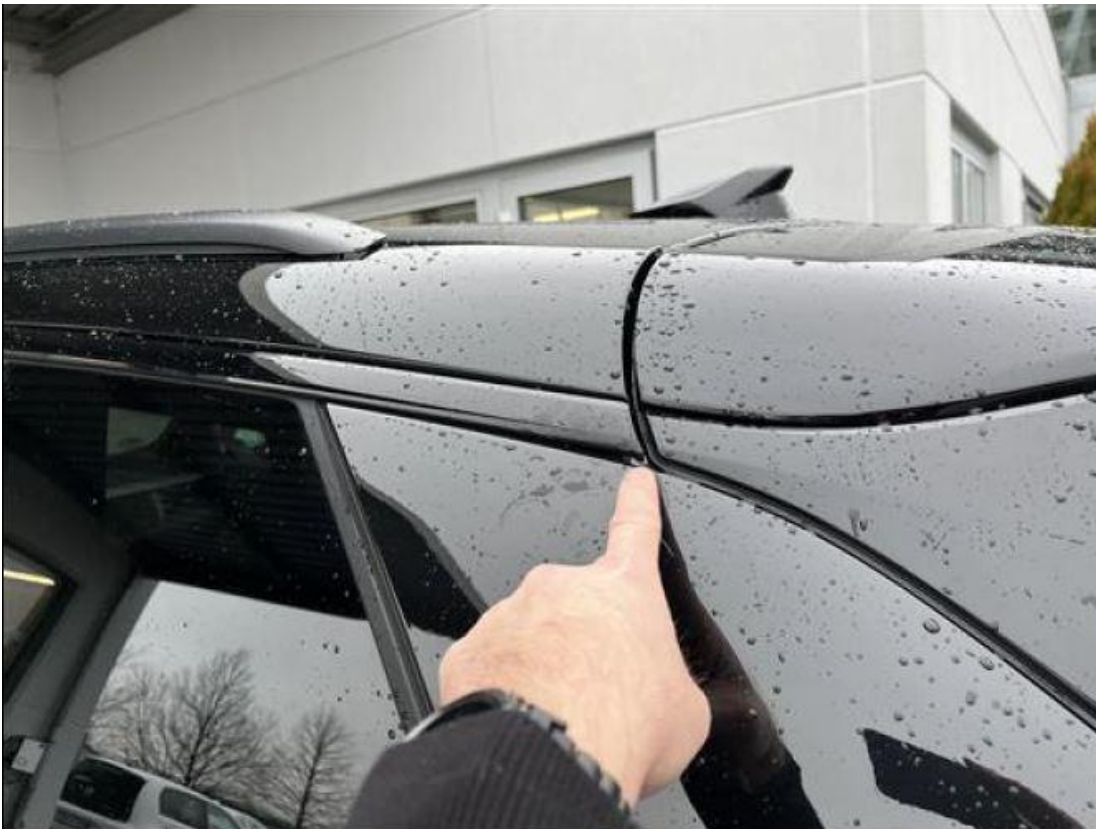
- The C-pillar trim is not flush with the vehicle at the front or rear end. The clip has not engaged properly.
- This issue may affect the left or right side of the vehicle.

**Figure 1.** Example of the protruding trim.

If the trim strip protrudes at the front or rear (see pictures), it must be renewed.

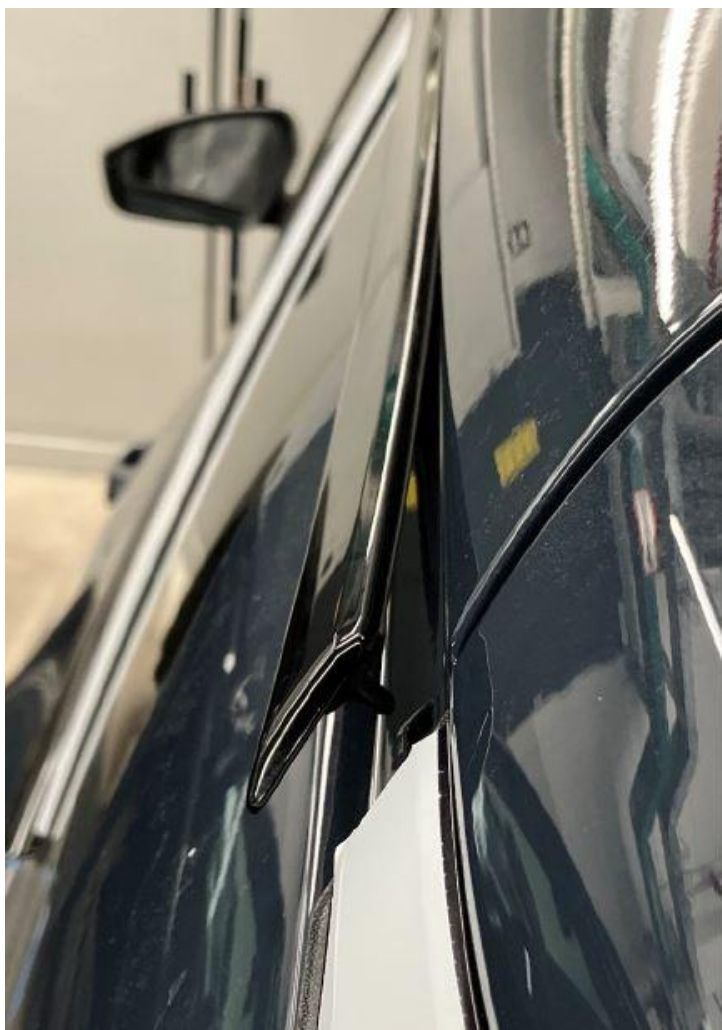
**Figure 2.** Example of the protruding trim.
